Subject: A1641_VN_20240122 Rule 912 Deviation Report

General Motors LLC (GM) Lansing Grand River (LGR) is submitting this letter in response to Violation Notice No. A1641_VN_20240122 issued by the Michigan Department of Environment, Great Lakes, and Energy (EGLE) Air Quality Division (AQD) that GM received via email on January 22, 2024.

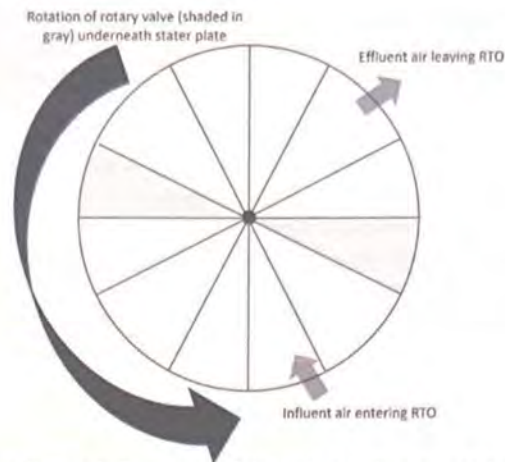
Figure 1: Top view of the rotary valve and stater.

When the RTO was started up on Tuesday, January 16th (no production on Monday the 15th for MLK Day), the rotary valve would not properly index. Further investigation found that four of the 2" x 2" x 37" stainless steel bars on the stater plate had deflected down to the point where the rotary valve could not rotate underneath as designed. No vehicles were in process at the time and no production in the Paint Shop occurred on the 16th.

On Wednesday, January 17th, the deflected metal was removed from the four defective stater bars. The initial plan was to grind down the deflected sections, but grinding proved ineffective. The deflected sections of the four affected bars were removed as a temporary repair to allow the RTO to continue to operate pending complete repairs. The space vacated by these removed sections allows a path where some air entering the RTO could cross from the influent to the effluent side without first flowing into the combustion chamber. This cross-over path was only available during six of the twelve index cycles of the rotary valve.

The RTO was operating the week of January 8th despite having no production to keep the equipment moving during cold weather. On January 12th, the regulator valve on the air spring failed. The air spring is designed to push the rotary valve up tight against the stater plate. The regulator valve was replaced and the RTO resumed operation into the weekend. On the morning of Sunday, January 14th, the rotary valve failed to index. It is believed that the the air spring replacement may have slightly changed the distance between the rotary valve and stater plate, causing it to catch on a minor defect on a stater bar. During the failure to index, the automated shutdown of the RTO did not commence as designed, and the temperature of the exhaust air rose to levels where the four stater

bars positioned in the effluent sections for an abnormal period of time were able to deflect. The RTO did not run until attempts to start it up for production on the morning of Tuesday January 16th, when multiple failed start up attempts revealed the deflected bars. The cause of the error in the shutdown was an error in the RTO controls logic. This logic error has been corrected.

No violations are ongoing. A new stater plate was installed January 26 – 28, 2024. No production occurred during this time. GM resumed painting operations on January 29, 2024, with the RTO operating as designed and in compliance with the requirements of the ROP.

A replacement stater plate has been installed. The error in the RTO controls logic has been corrected. The GM LGR Malfunction Abatement Plan has been revised to more clearly define the requirements set by Rule 910 that are not explicitly defined in the ROP.
