DEPARTMENT OF ENVIRONMENTAL QUALITY
AIR QUALITY DIVISION
ACTIVITY REPORT: Scheduled Inspection

FACILITY: DIAMOND CHROME PLATING INC		SRN / ID: A2931
LOCATION: 604 S MICHIGAN, HOWELL		DISTRICT: Lansing
CITY: HOWELL		COUNTY: LIVINGSTON
CONTACT: John Wagner, Director - Health, Safety & Environmental Affairs		ACTIVITY DATE: 08/30/2017
STAFF: Daniel McGeen	COMPLIANCE STATUS: Compliance	SOURCE CLASS: MINOR
SUBJECT: Unannounced, scheduled inspection.		
RESOLVED COMPLAINTS:

On 8/30/2017, the Michigan Department of Environmental Quality (DEQ), Air Quality Division (AQD) conducted an unannounced, scheduled inspection of Diamond Chrome Plating, Inc. (DCP).

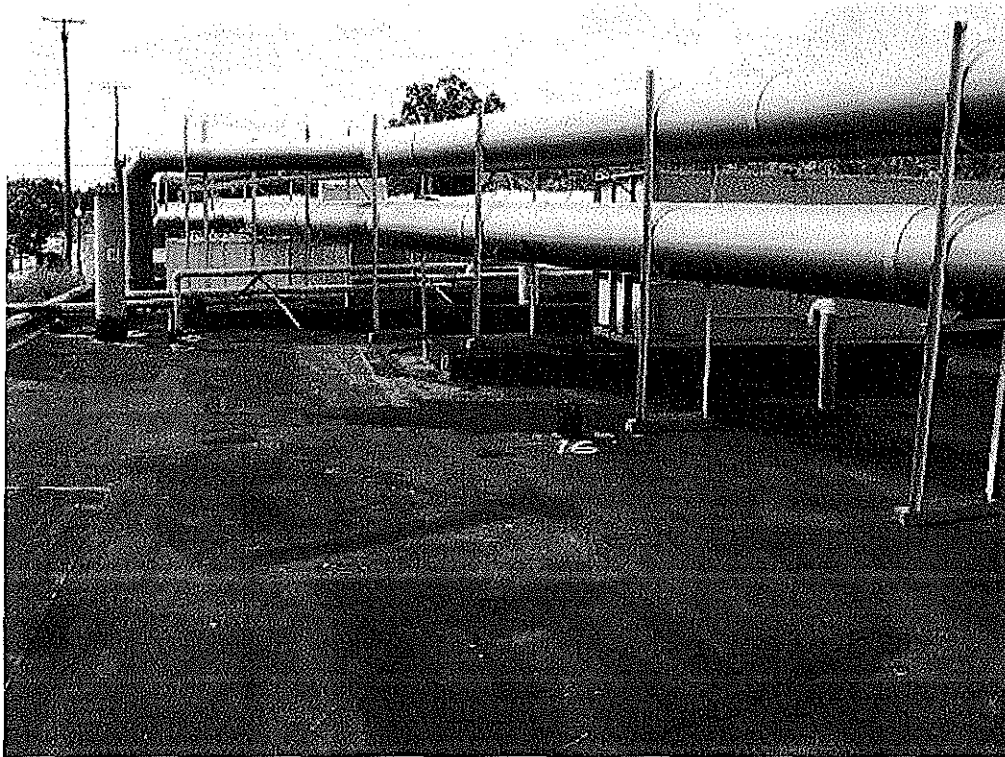
The east ductwork on the east roof was replaced in October 2015, with twin parallel 24 inch extruded PVC ductwork replacing a single 54 inch diameter duct of sectioned PVC plastic. The new ductwork, which is gray in color, was free of any leaks or "weeps". Please see attached photo 001. The east ductwork leads to the north scrubber, #4. The ductwork has had identification numbers spray painted on for each section. These correspond to the current diagram of east roof ductwork, which was submitted to AQD in early 2016.

Image 1(001) : East ductwork atop east roof.

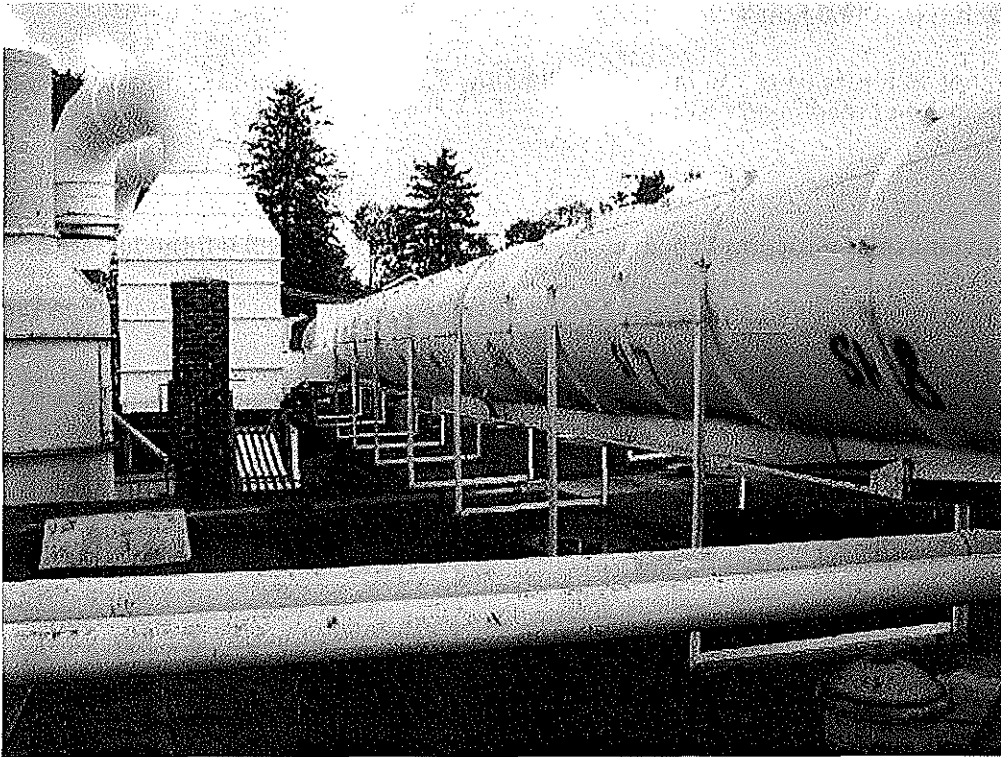
The west ductwork on the east roof is sectioned 54 inch diameter white plastic. This ductwork leads to the south scrubber, #3, and is of the same vintage as the scrubber itself. I examined this ductwork for leaks. Please see attached photos 002 through 004. This ductwork has also had the identification numbers spray painted on.

Image 2(002) : West ductwork on east roof, and scrubber #3.

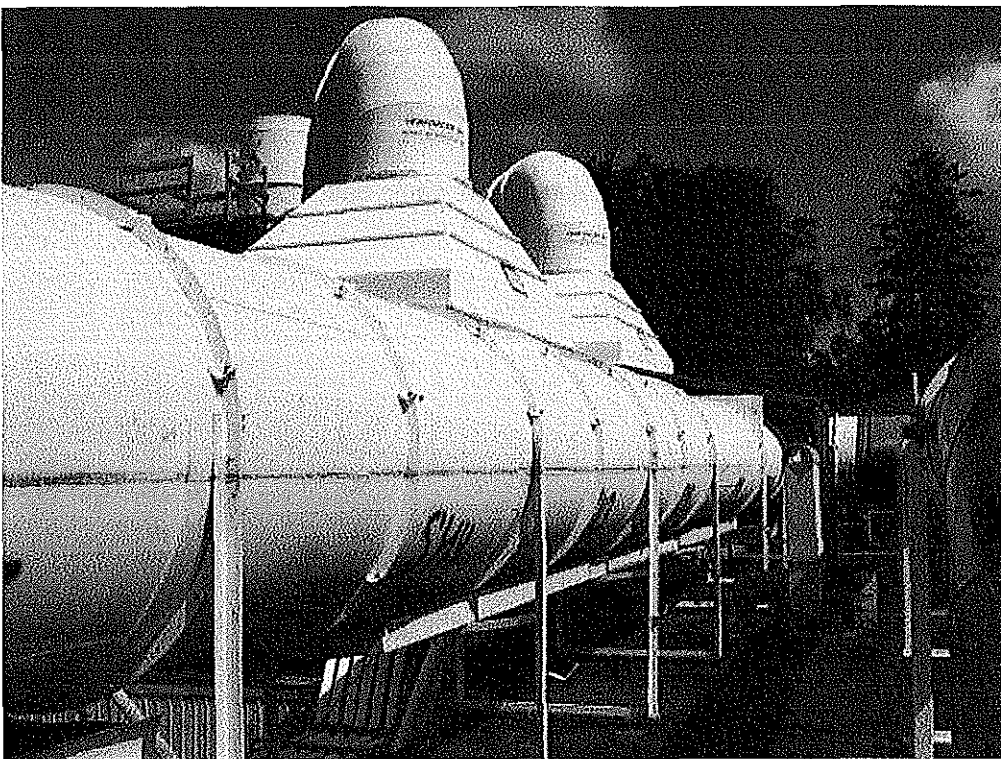
We walked out onto the plant's east roof. Scrubber #3 is the south unit, and #4 is the north unit. Neither had any visible emissions. The scrubbers showed no indications of any chromic acid leaks. At 12:04 PM, scrubber #3 pressure drop was 2.4 inches water column (w.c.), and scrubber #4 pressure drop was 2.7 inches, w.c.

Image 3(003) : West ductwork on east roof, scrubbers #3 and 4.

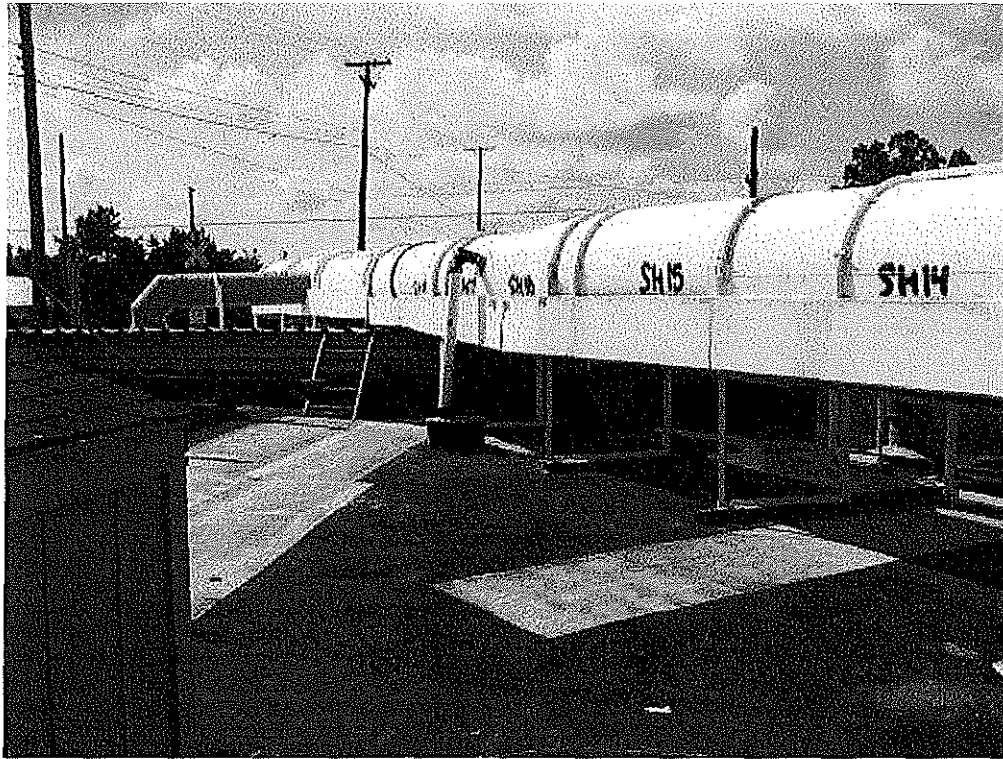
Image 4(004) : West ductwork on east roof, looking south.

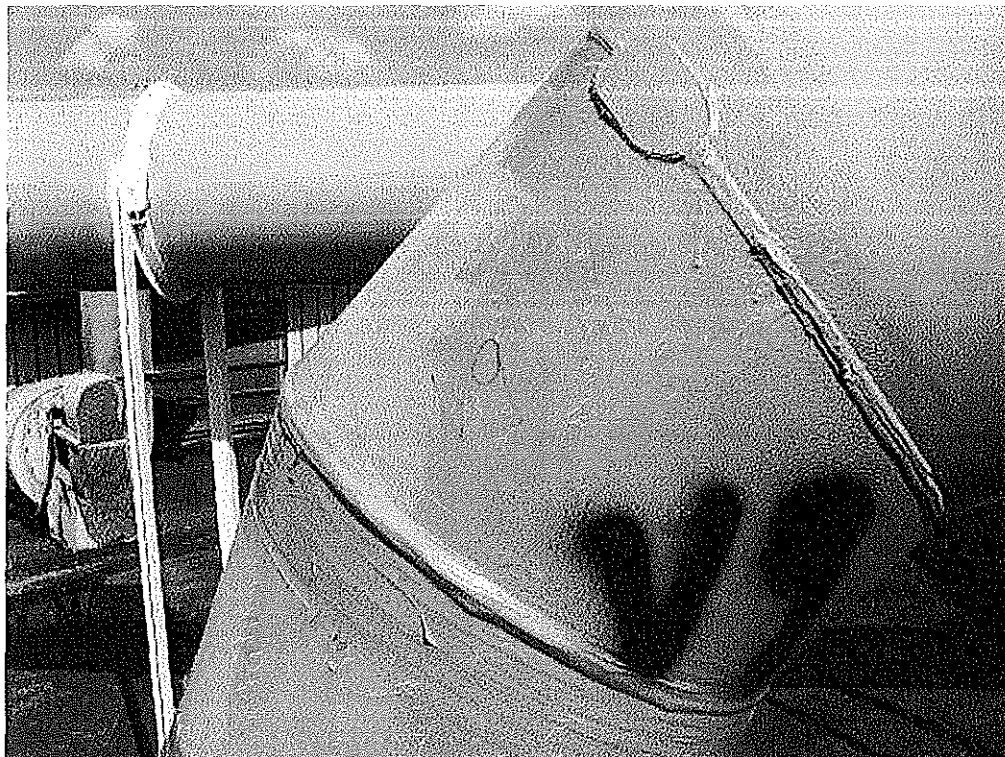
I checked on the status of the V9 "drop", a vertical section of ductwork with an elbow that connects to the horizontal west ductwork on the east roof. I verified that a dried leak which had been identified on 4/12/2017, during the mid-year inspection, had been repaired. This appeared to be the case, as shown in photo 005. The fixed area also looked to have been repainted. It is my understanding that even after cleaning, traces of chromic acid stains may remain visible on a duct's surface, so it is not uncommon for plant personnel to apply a new coat of paint.

Image 5(005) : V-9 drop, where dried leak was found on 4/12, and was repaired.

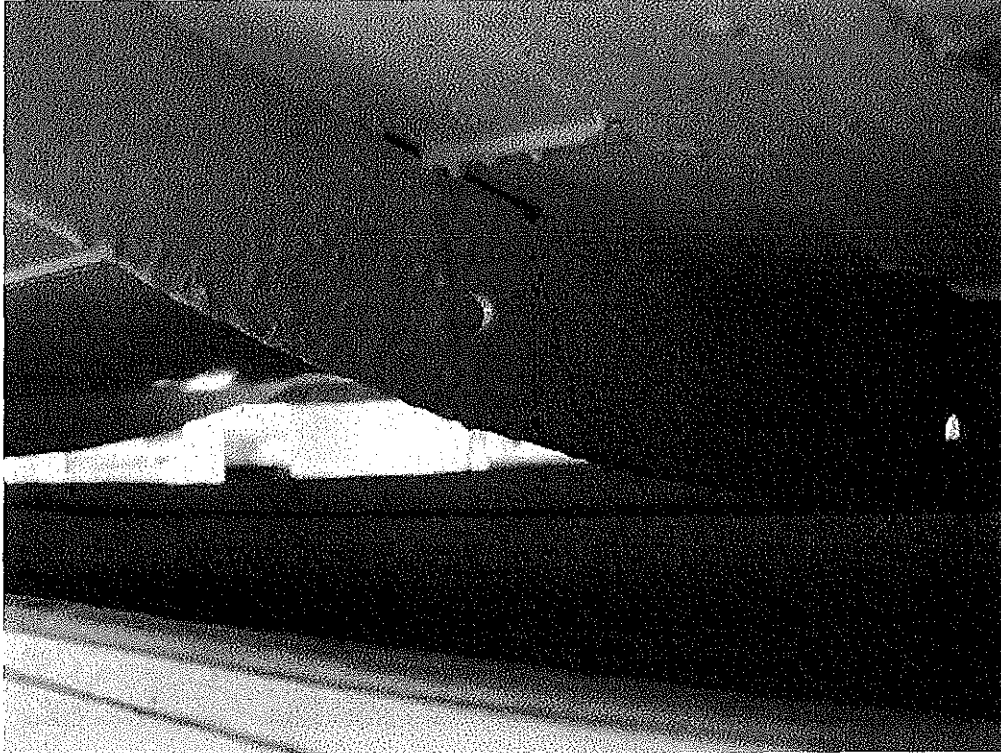
The only leak I could find today was a small, dried leak on the underside of duct section SH15 (please see attached photo 006). It is not a violation in itself for a leak to be found. The FACD gives DCP 24 hours to clean the leak, and 48 hours to repair it. To AQD's most recent knowledge, SH15 had 9 documented instances of leaks since the 7/28/2015 start date of the FACD. Upon reaching 10 leaks, an individual duct section is to be replaced within 60 days, under Paragraph 5.(e) of the FACD.

When I brought the above leak to Mr. Wagner's attention, he advised me that yesterday, 8/29, they had actually found the 10th leak for SH15, in a different location. He explained that they are putting a letter together to inform AQD of reaching the 10-leak milestone, and of their proposed actions. I was advised that in mid-October 2017, all of the east roof ductwork leading to scrubber #3 will be replaced. It is my understanding that it would be more economical to replace all the ductwork at once, than to replace individual duct sections, one at a time. They will clean and repair today's leak, he informed me, as the FACD requires.

Image 6(006) : Underside of SH15, with small, dried leak.

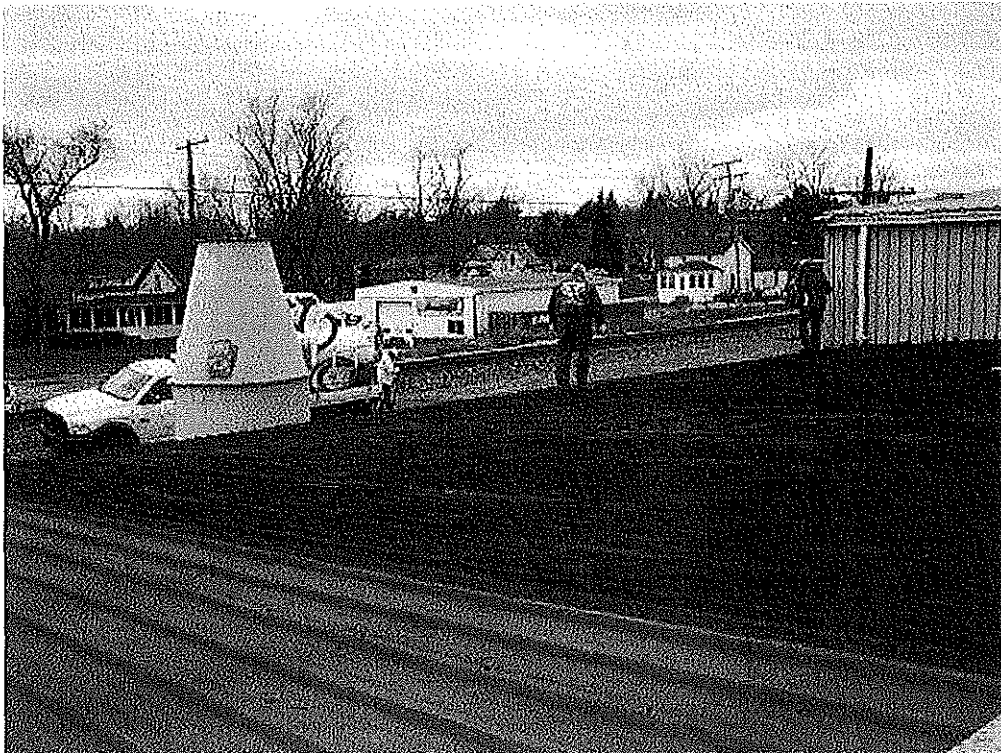
Image 7(007) : 2012 photo w/cadmium scrubber stack at upper right.

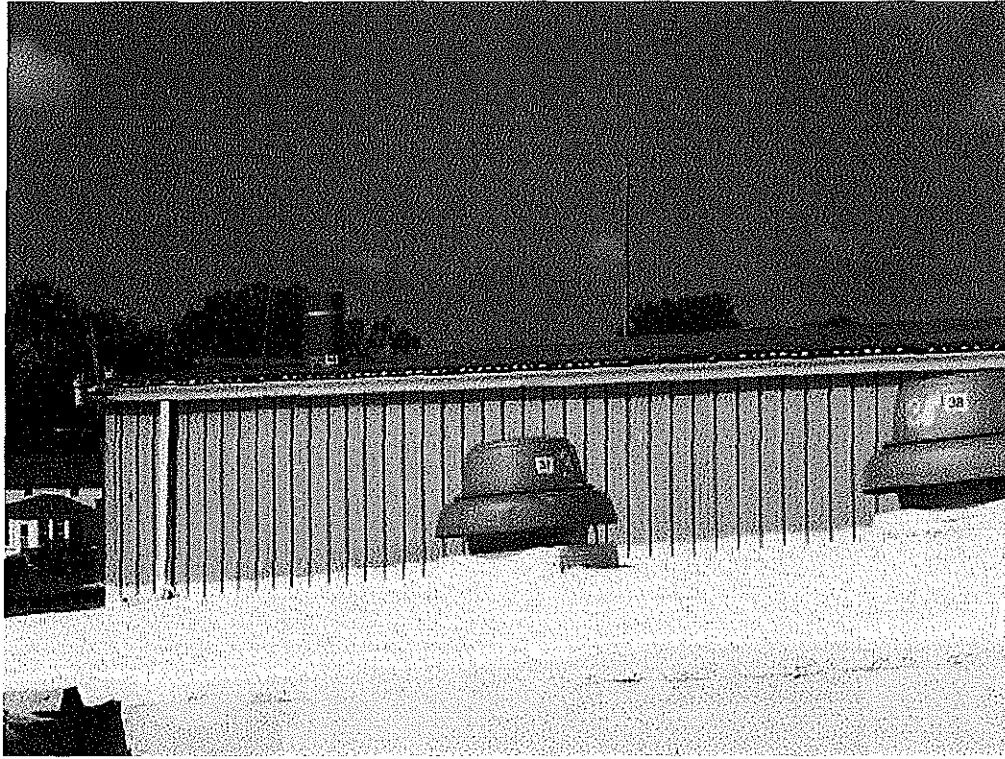
From atop the east roof of the plant, Mr. Wagner showed me the vertical exhaust stack, which is labeled 64. It appears to be gray PVC plastic, and was free of stains. Please see attached photo, taken from atop the east roof. There were no visible emissions from the stack. The permit requires the exhaust be discharged unobstructed vertically upwards from an exit point not less than 11 feet above ground level, and this requirement appears to be met.

Image 8(008) : 8/30/2017 photo of taller cadmium scrubber stack, at left.
