DEPARTMENT OF ENVIRONMENTAL QUALITY
AIR QUALITY DIVISION
ACTIVITY REPORT: Self Initiated Inspection

FACILITY: ROBBINS INC		SRN / ID: B1838
LOCATION: 445 GREENWOOD ST, ISHPEMING		DISTRICT: Upper Peninsula
CITY: ISHPEMING		COUNTY: MARQUETTE
CONTACT: Frank Misale , Safety Coordinator		ACTIVITY DATE: 08/20/2014
STAFF: Joe Scanlan	COMPLIANCE STATUS: Compliance	SOURCE CLASS: SM OPT OUT
SUBJECT: Unannounced inspection of wood waste management system, boiler and wood preservative dip tank.		
RESOLVED COMPLAINTS:

Facility: Robbins Flooring, Ishpeming

Inspection Date: 8/20/2014

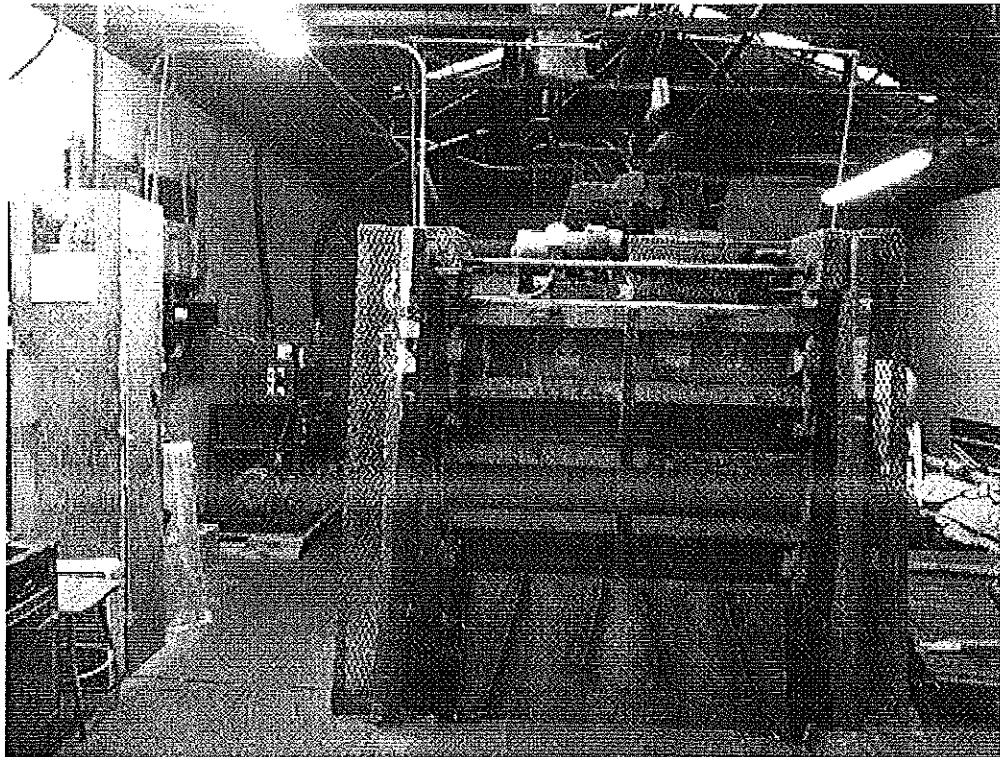
The plant has a dip tank, used only for maple, containing clear Woodlife F--a water repellent that provides anti-fungal protection as well. Mr. Misale stated that they had utilized 1167.372 gallons that month, which is about average for this time of year. The storage tank for the Woodlife has a capacity of 6000 gallons, however it usually holds a maximum of 2000.

Image 1(8/20/2014) ; Dip tank with recycling pump and system visible on left side. 6000 gallon AST containing Woodlife F is on the other side of the wall (not visible) from the recycling system.

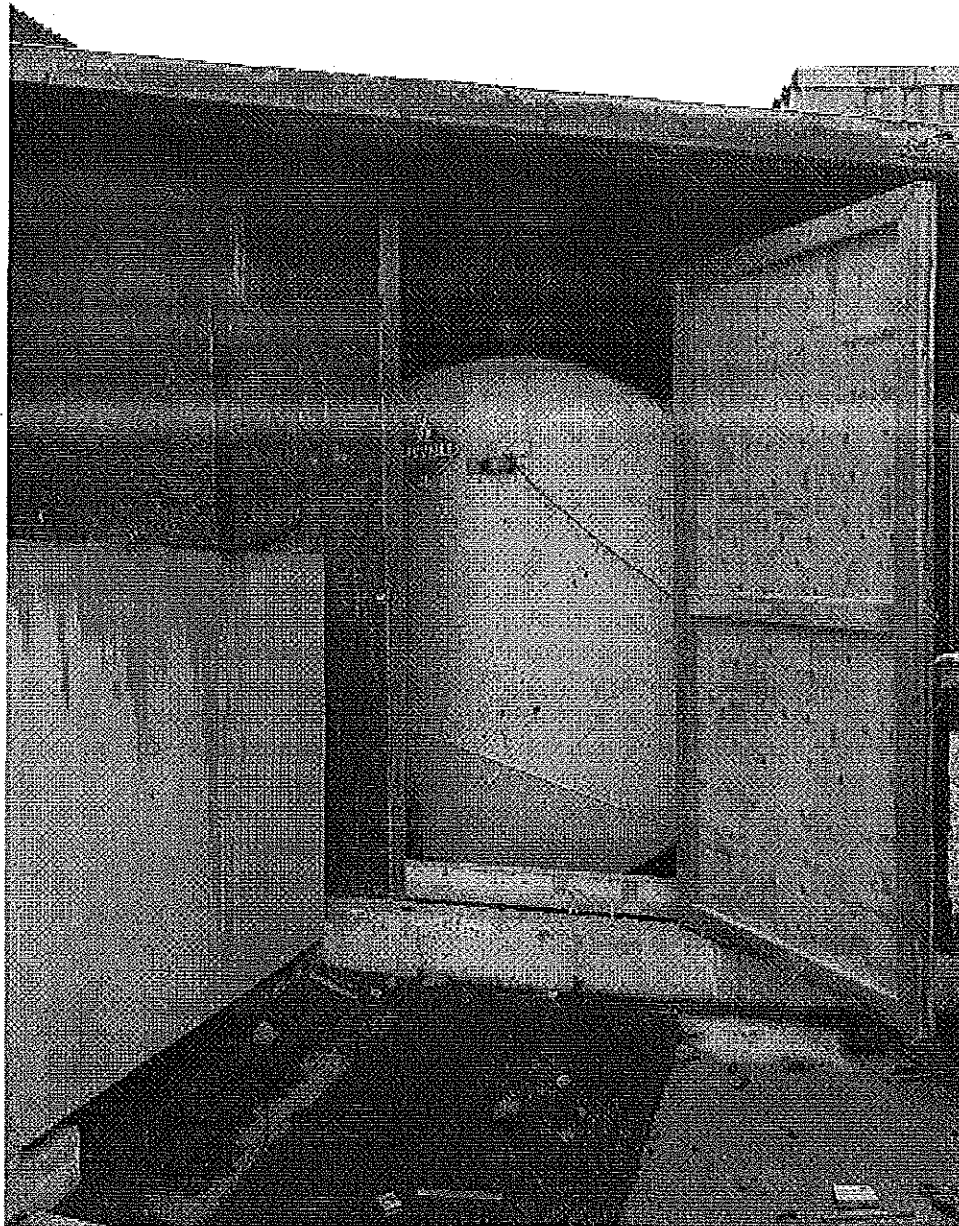
Image 2(8/20/2014) : 6000 gal. AST containing Woodlife F preservative.

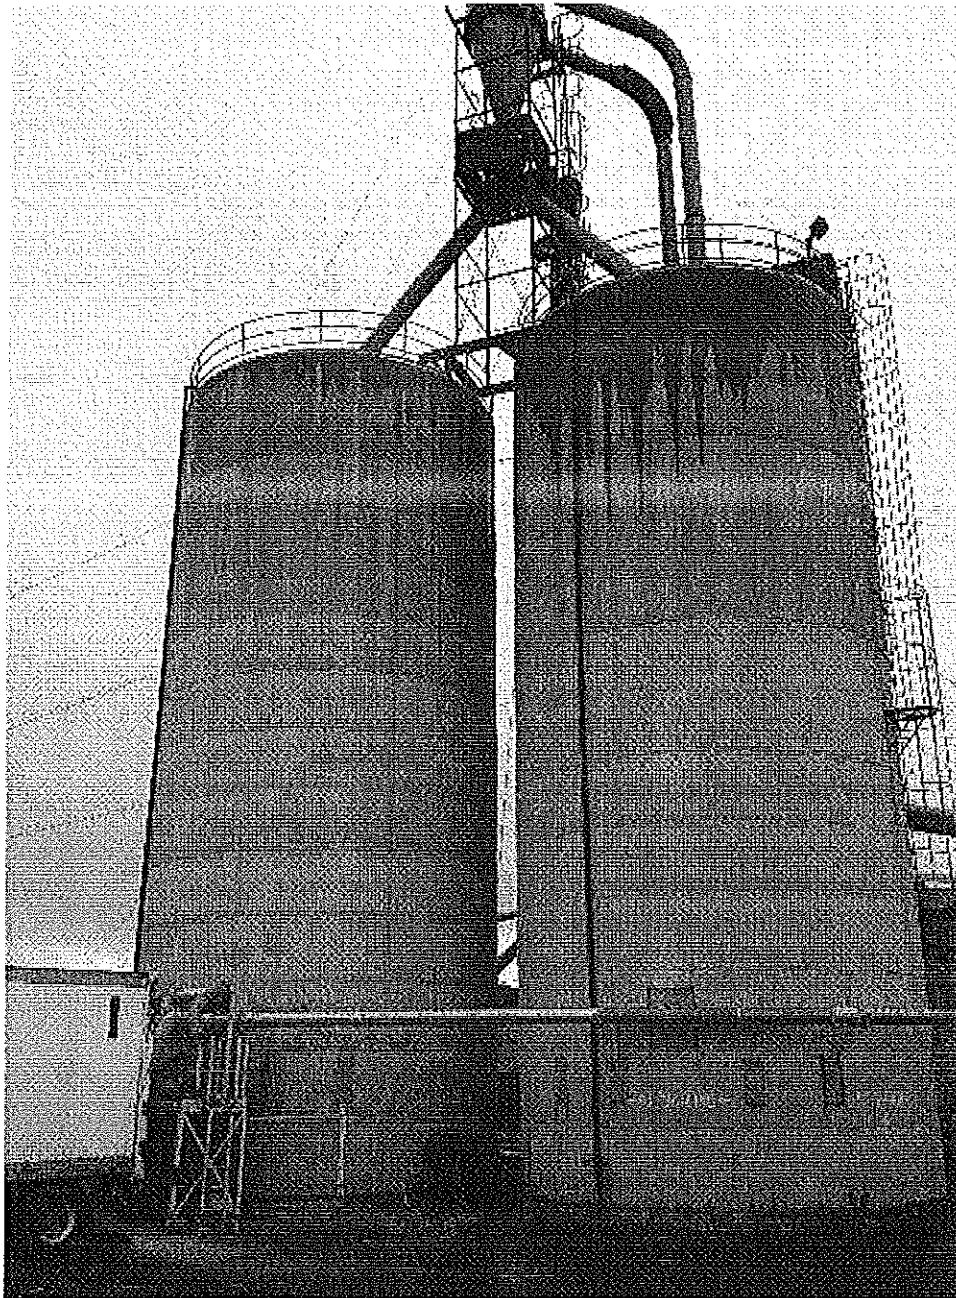
Image 3(8/20/2014) : Wood waste storage silos

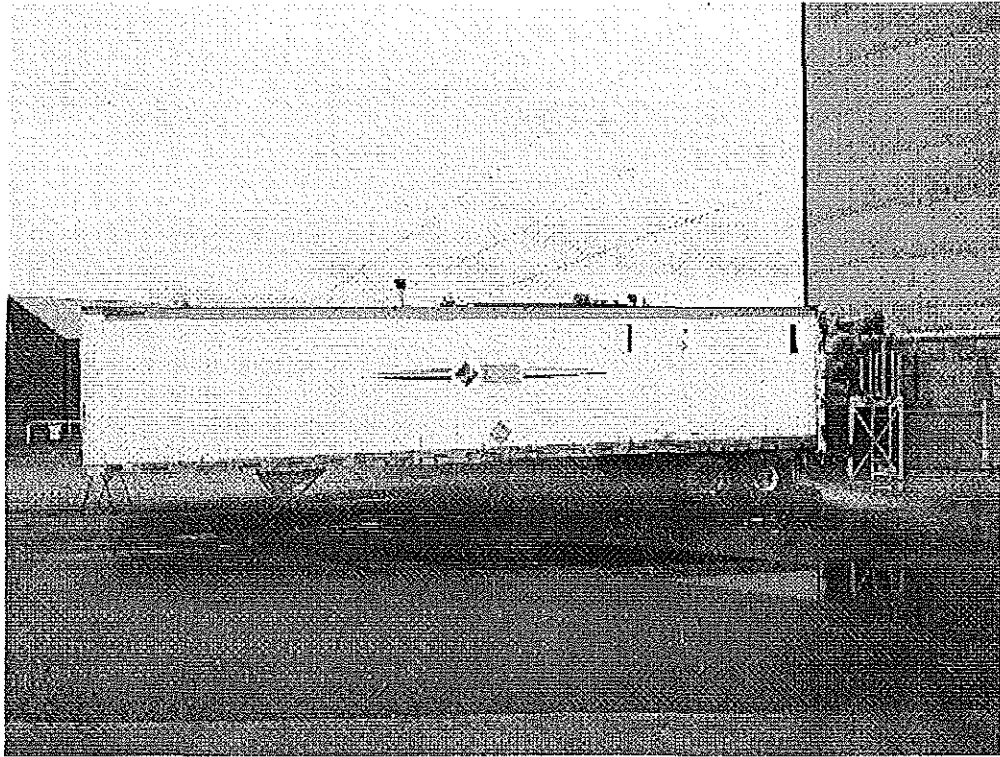
Once the storage silos have filled, waste is sent to two semi trailers via a two duct system. This system was not in operation at the time of my inspection. I noticed a pile of sawdust (~1 yd³) below the duct system where the ducts enter the trailers. I requested of Mr. Misale that he ensure the tightness of the seal where the duct enters the trailers prior to the next use, to which he agreed.

Image 4(8/20/2014) : Semi trailer collection system

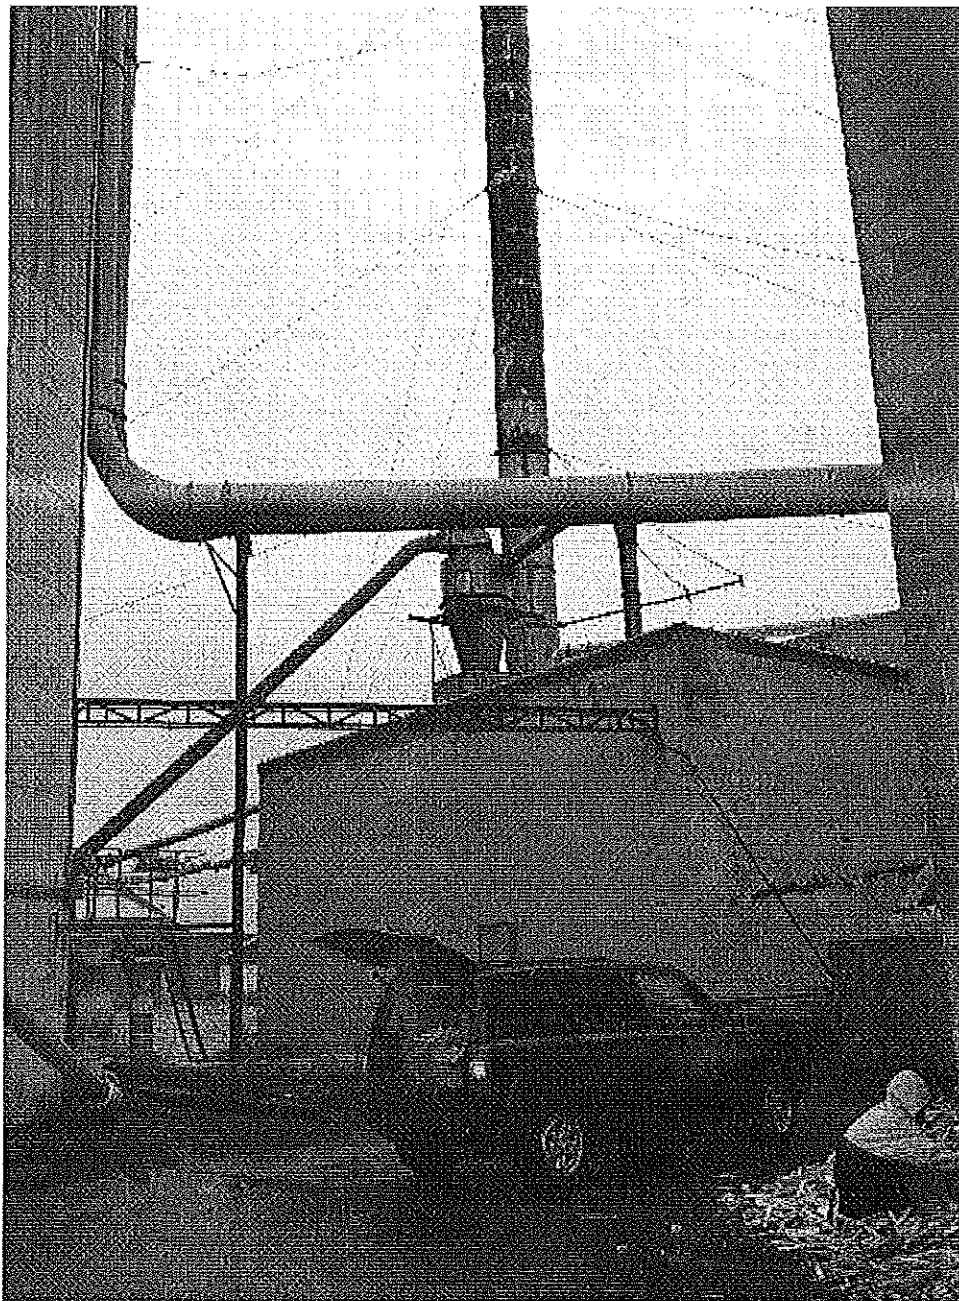
Image 5(8/20/2014) : Boiler building with cyclone visible on top.

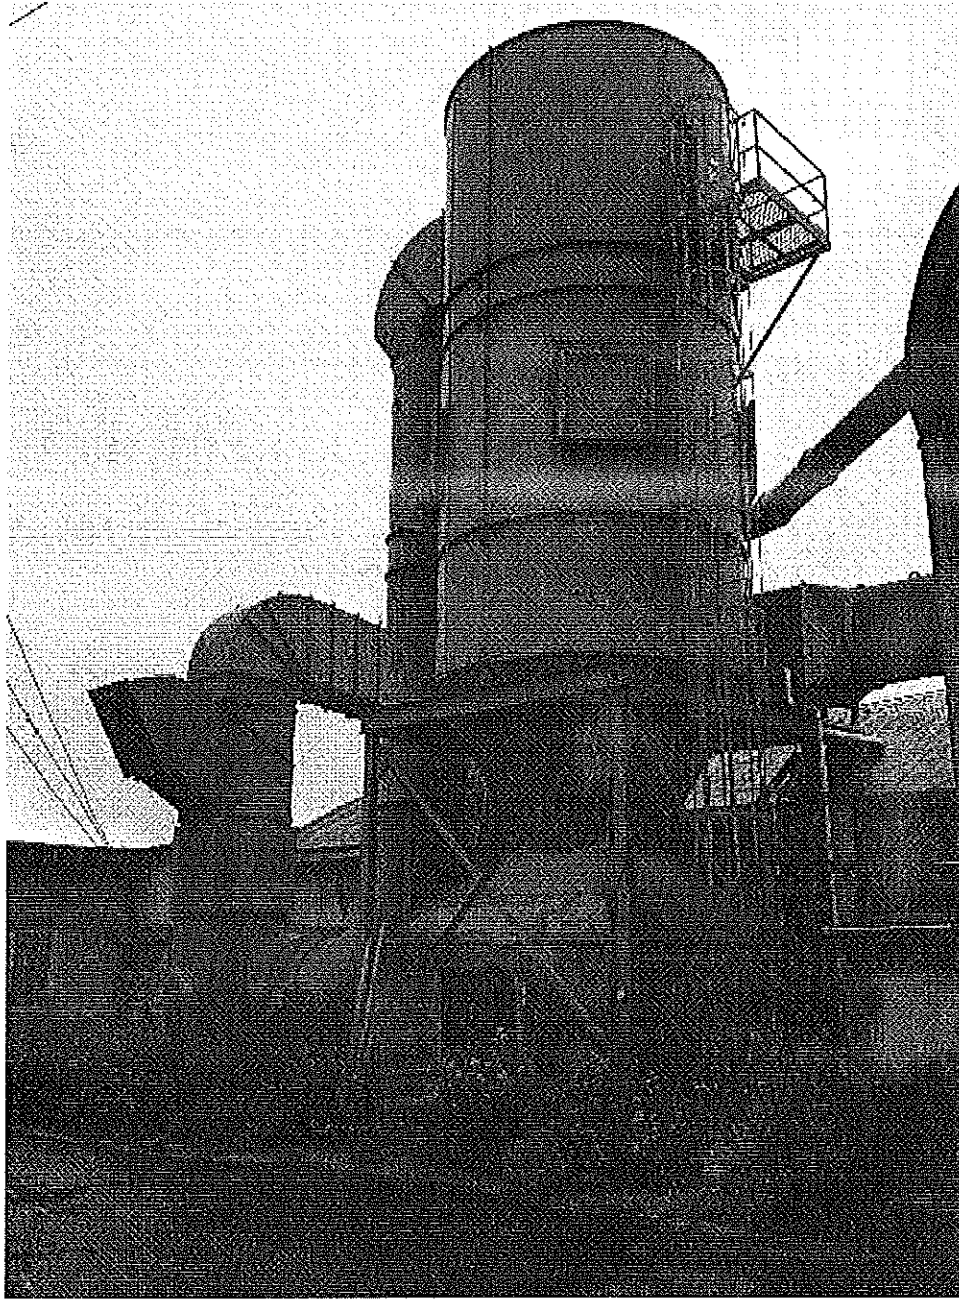
The mill operates a pneumatic waste handling system for wood waste utilizing extensive ductwork throughout the facility, fed to a baghouse to collect the fines, while the remaining wood waste is conveyed to a cyclone on top of two storage silos via a closed loop conveying system. Large pieces of wood waste are separated out in the cyclone and ground in a hog for use as fuel in the boiler. The ductwork has a spark detection system which enables a fire suppression system. All 456 bags in the baghouse were changed in October of 2013. The system was in use and no visible emissions or fugitive dust were observed.

Image 6(8/20/2014) : Baghouse

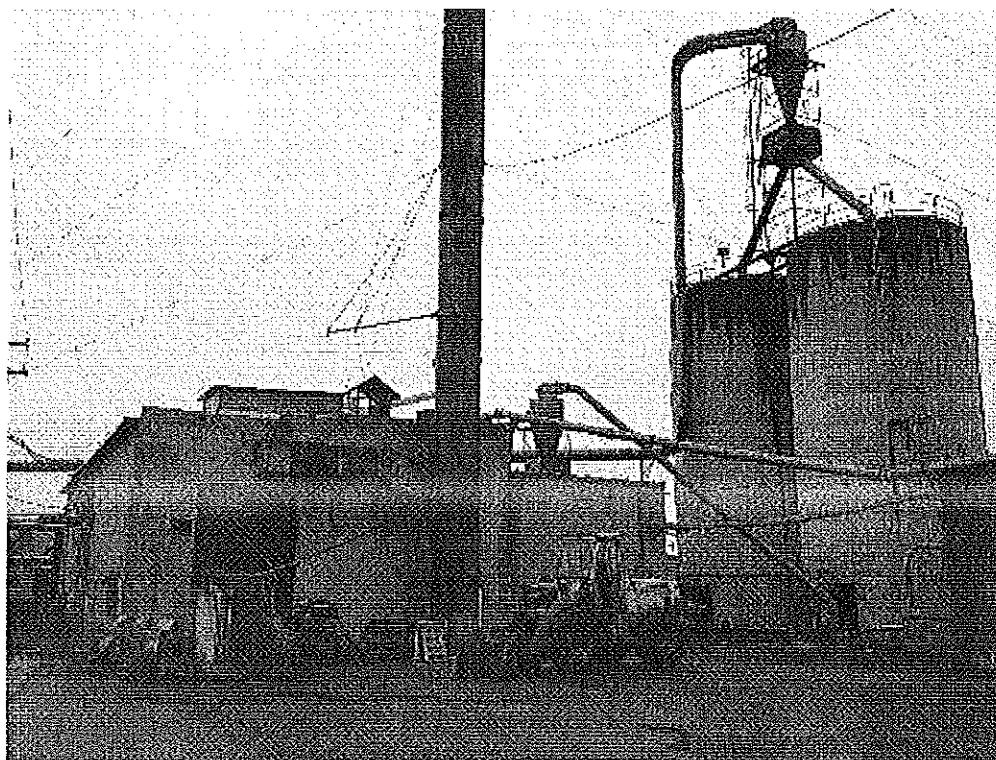
Image 7(8/20/2014) : Boiler building & stack with storage silos. Note cyclone on top of storage silos.

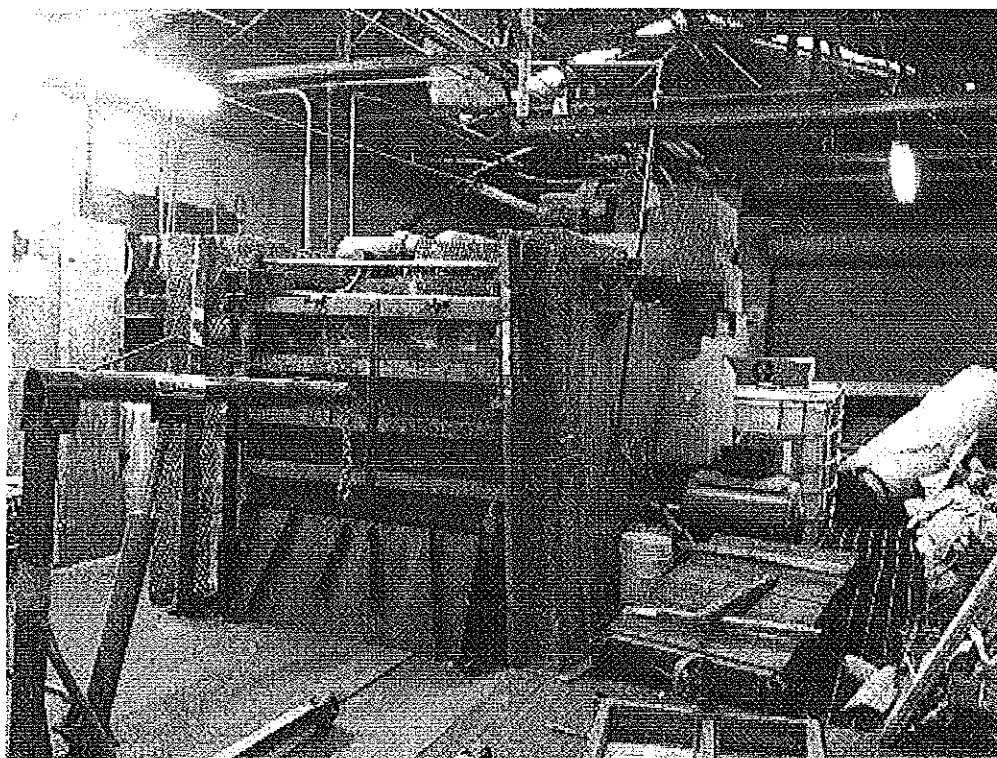
Image 8(8/20/2014) : Dip tank
