**Subject: Response to July 16, 2018 Violation Notice**

*Three Rivers Gray Iron*

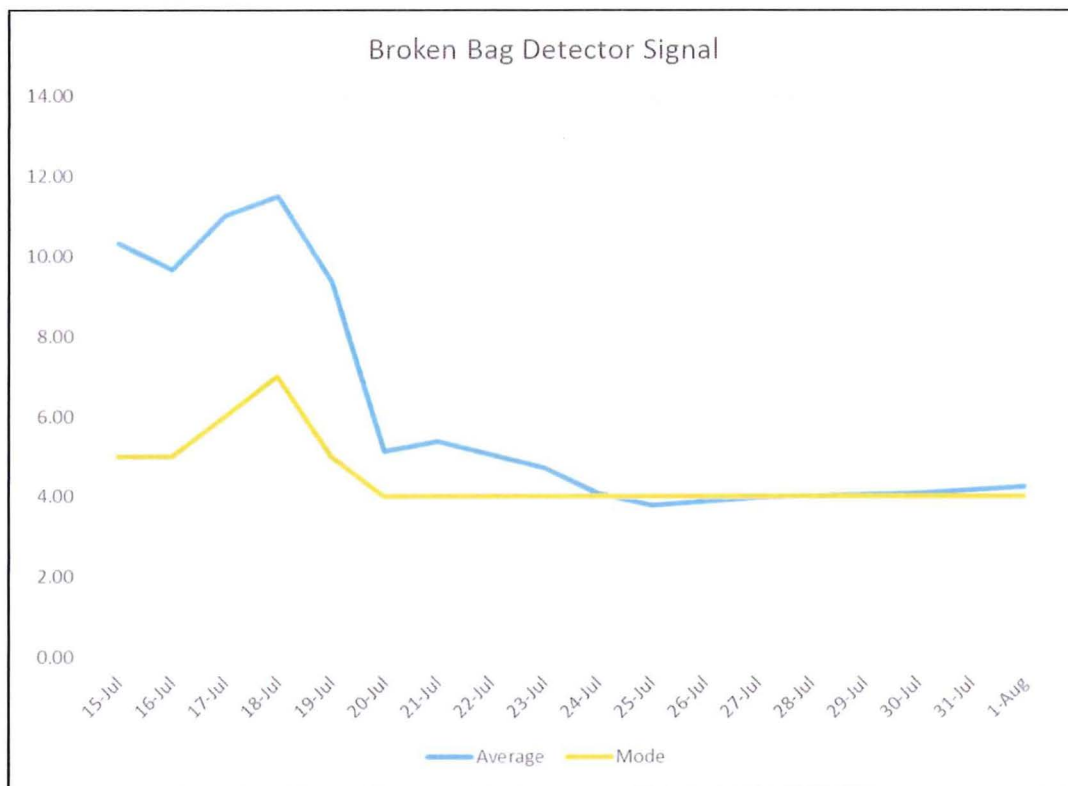
- Causes and Duration:
  - On three of the inspections, a total of 17 bad ventures were found, which we believe was a major contributor to the blown bags
  - On the 7/14/18 inspection, Waltz-Holst was able to find a hole in the baghouse, which was allowing water in during rain events. We believe that this was also a contributing factor due to the internal corrosion it was causing.
- The violation is not believed to be ongoing as the apparent sources of the malfunctions have been addressed.
  - The readings from the new Bag Leak Detection System (noted below) appear to show that the problems have been resolved. The following graph shows the downward trend and eventual smoothing of the signal.

- Summary of actions taken and/or to be taken and associated dates:
  - Please see the previous sections.
- Steps being taken to prevent a recurrence:
  - Continue to conduct daily visible emission readings
  - Continue to monitor and record differential pressure of the baghouse
  - Installation of a Bag Leak Detection System on the stack associated with the N Fuller.
    - We have recently determined the appropriate setpoints for the BLDS alarm. The BLDS has been installed for a period of time long enough to establish a good baseline with which to set the alarm.
