DEPARTMENT OF ENVIRONMENTAL QUALITY
AIR QUALITY DIVISION
ACTIVITY REPORT: On-site Inspection

FACILITY: Beacon Park Finishing LLC		SRN / ID: B3000
LOCATION: 15765 STURGEON, ROSEVILLE		DISTRICT: Warren
CITY: ROSEVILLE		COUNTY: MACOMB
CONTACT: Popat Patel , Environmental Manager/Chemist		ACTIVITY DATE: 03/08/2022
STAFF: Adam Bogнар	COMPLIANCE STATUS: Non Compliance	SOURCE CLASS: MINOR
SUBJECT: Scheduled Inspection		
RESOLVED COMPLAINTS:

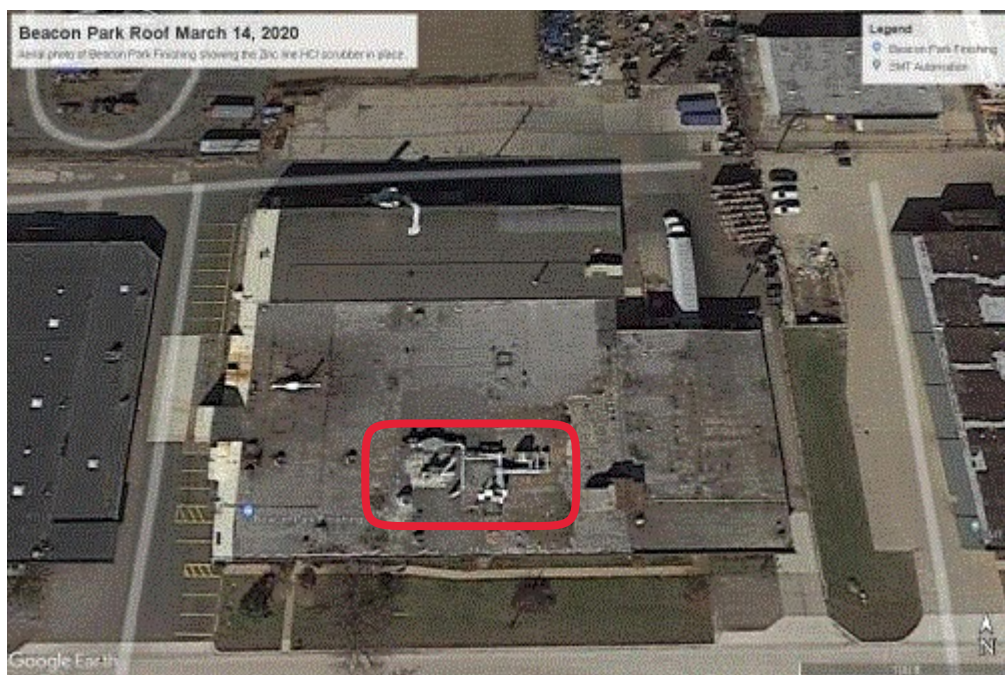
Image 1(March 14, 2020) : Shows Control B installed on March 14, 2020

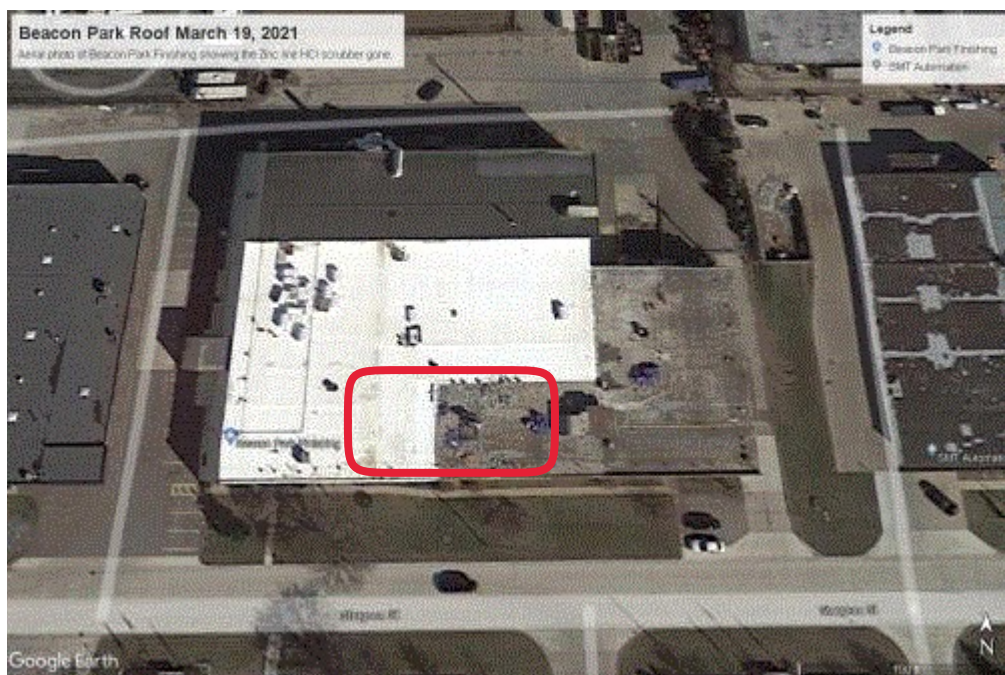
Mr. Patel explained that Control B was not installed during this inspection. In order to fix the roof, Control B had to be removed. Google Earth Pro aerial photos of the facility roof indicate the scrubber was on the roof on March 14, 2020 and gone on March 19, 2021 (Attachments 3 & 4). Google Earth Pro does not have any pictures of the facility between those two dates. Based on this data, the scrubber was removed sometime between March 2020 and March 2021. The facility is

having trouble getting someone to re-install the scrubber unit. Currently, the single 30-40% HCl tank is exhausted to the general in-plant environment.

Image 2(March 19, 2021) : Shows Control B gone on March 19, 2021
