DEPARTMENT OF ENVIRONMENTAL QUALITY  
AIR QUALITY DIVISION  
**ACTIVITY REPORT: On-site Inspection**

B300067806

<b>FACILITY:</b> Beacon Park Finishing LLC		<b>SRN / ID:</b> B3000
<b>LOCATION:</b> 15765 STURGEON, ROSEVILLE		<b>DISTRICT:</b> Warren
<b>CITY:</b> ROSEVILLE		<b>COUNTY:</b> MACOMB
<b>CONTACT:</b> Garrett Kanehann , Owner/CEO		<b>ACTIVITY DATE:</b> 06/21/2023
<b>STAFF:</b> Adam Bogнар	<b>COMPLIANCE STATUS:</b> Non Compliance	<b>SOURCE CLASS:</b> MINOR
<b>SUBJECT:</b> Self-initiated inspection		
<b>RESOLVED COMPLAINTS:</b>

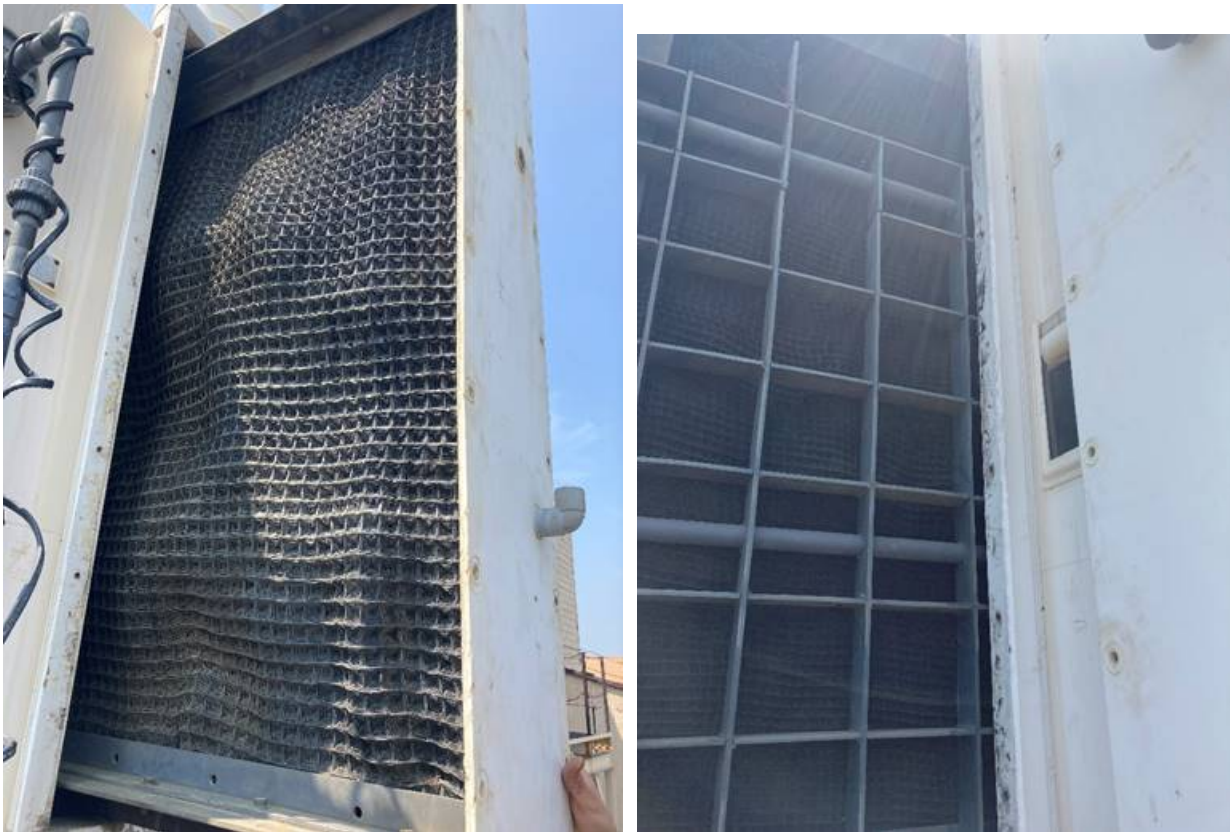
I asked Justin to demonstrate that the composite mesh pads had been cleaned and reinstalled on Control D. Justin and I donned safety goggles and a cloth mask to check the filters on the Control D. Justin took me up on a scissor lift to observe these filters. The filters were already unbolted. Justin stated that he didn't want to bolt the filters back up yet because they are not operating the plating tanks, and he expected that AQD would want to see the filters. Justin removed the stage 1 and stage 2 filter cartridges, revealing the composite mesh pad filters. I observed that the stage 1 filter had been re-installed, and the stage 2 filter had been cleaned. I could tell the stage 2 filter had been cleaned because it was essentially free from dust.

During my last inspection on April 12, 2023, the stage 2 filter was completely covered in a thick dust cake. I took pictures of the stage 1 filter on the date of this inspection. These photos are included in this report below. The picture on the left is the front of the stage 1 filter and the picture on the right is the backside of the stage 1 filter.

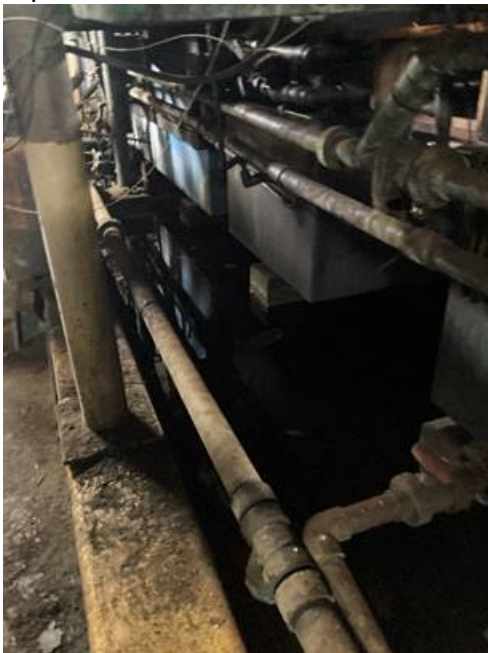
During the inspection I observed that none of the processes at Beacon Park Finishing were operating. Ramon stated that he believes four people were working in the plant on this date (Ramon, Justin, Popat, and one other person). I observed that the dikes underneath the chrome plating tanks were still filled with fluid. I took a photograph of the dikes, which is included in this report below.
