**DEPARTMENT OF ENVIRONMENTAL QUALITY
AIR QUALITY DIVISION
ACTIVITY REPORT: Scheduled Inspection**

FACILITY: CADILLAC ASPHALT, LLC, Ann Arbor		SRN / ID: B4265
LOCATION: 857 S WAGNER RD, ANN ARBOR		DISTRICT: Jackson
CITY: ANN ARBOR		COUNTY: WASHTENAW
CONTACT: Susanne Hanf, Environmental Engineer		ACTIVITY DATE: 06/06/2019
STAFF: Mike Kovalchick	COMPLIANCE STATUS: Compliance	SOURCE CLASS: SM OPT OUT
SUBJECT: Inspection of an asphalt plant.		
RESOLVED COMPLAINTS:

Minor Source: Opt-out Source for HAPS, CO, SO2 and NOx. Full Compliance Evaluation (FCE)

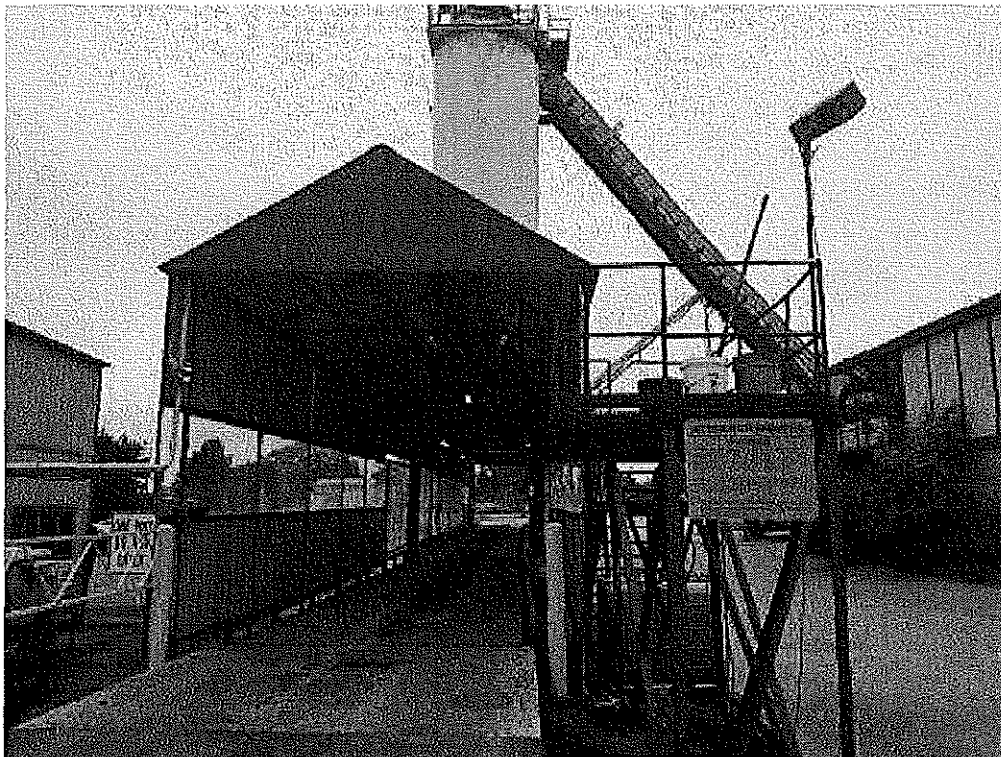
Next, we headed to the loadout area to observe truck loadout operations. The area was enclosed, and no emissions were noted during a truck load out. I observed that the HMA storage silos and loadout operations were connected to an emission capture system. These areas are under vacuum where steam, odors and other constituents potentially off-gassing from the final product were sent through a unit equipped with a series of filters. The fan was operating. The permit allows for the entrance and exit of the loadout operation to be open. It appears that this unit satisfies the requirement in EUSILOS to control truck loadout emissions.

Image 2(Asphalt Loading) : Asphalt loading.

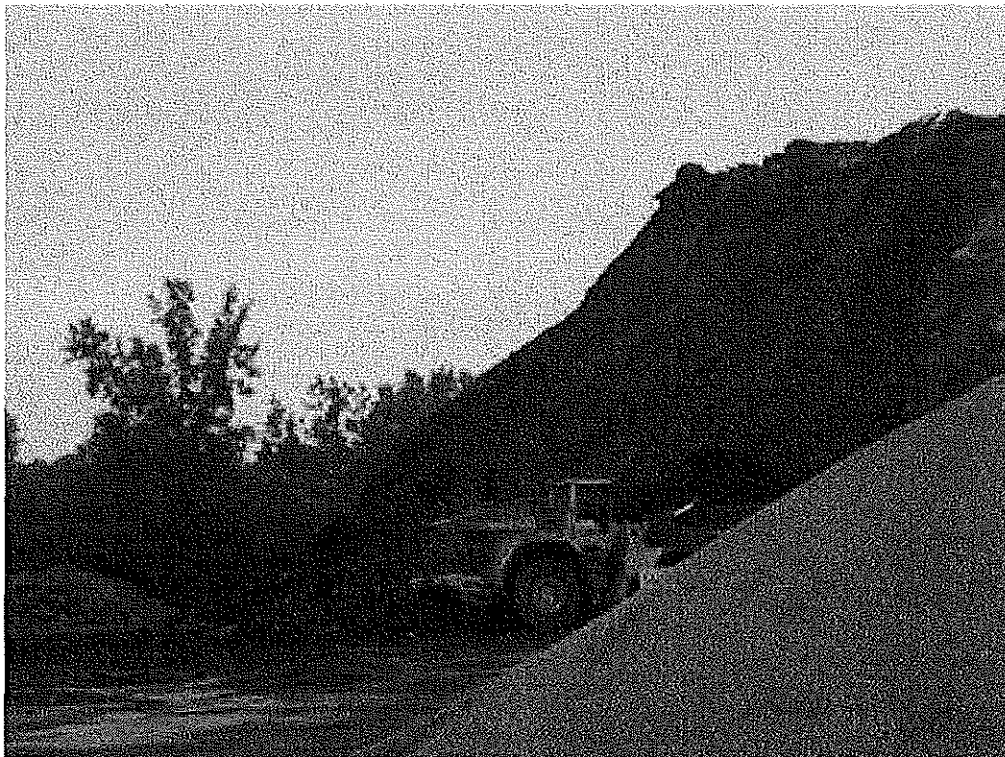
JW showed me the RAP pile. It was by far the largest RAP pile I had seen. JW speculated that the top of the pile is actually the highest elevation in Ann Arbor and nick named it Mt. RAPMORE. We circled the pile and I noted that it encroached on a wet land on one side. There appeared to be a berm in place to prevent storm water from the pile entering the wetland. (A quick literature search shows that typically very little leachates off a RAP pile although some minor amounts of lead have been documented in acidic conditions at other facilities.)

Image 4(RAP Pile) : Large RAP pile estimated to contain 500,000 tons.

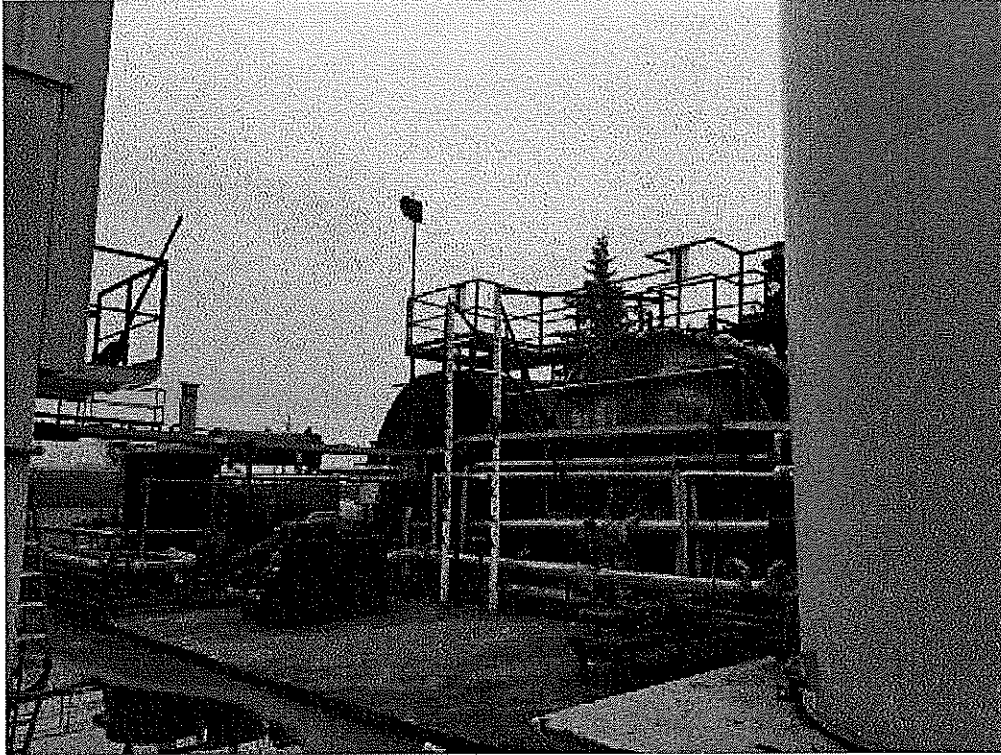
Image 5(Asphalt Cement Tanks) : Asphalt Cement Tanks

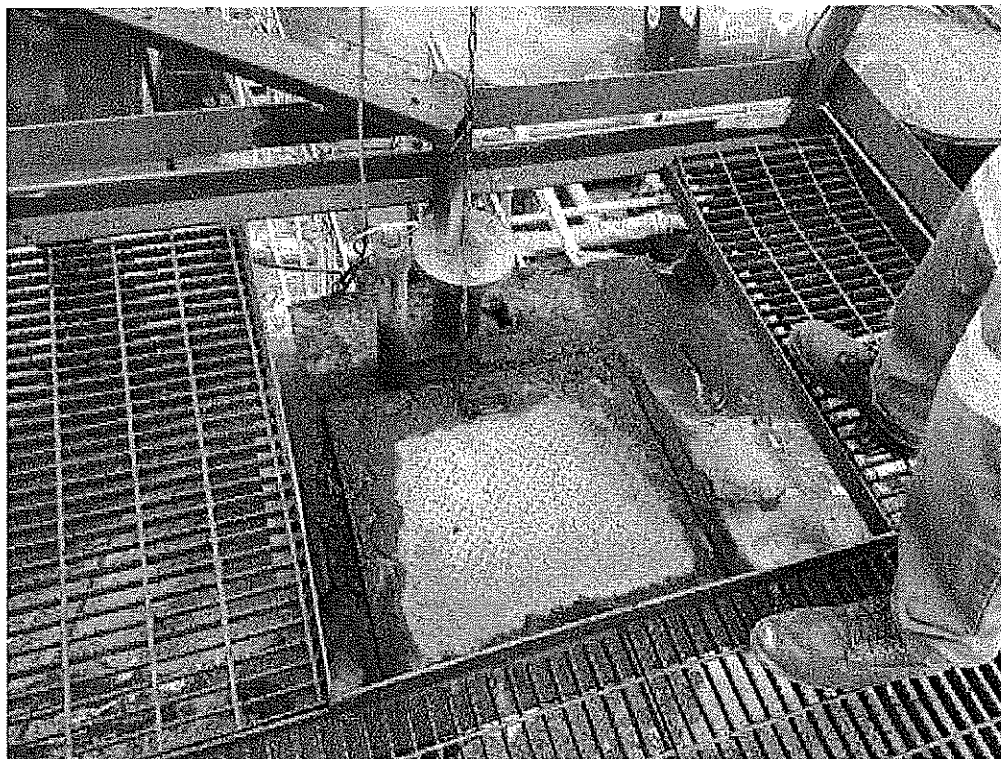
From there we moved to the material feed conveyors and drum dryers. As we passed by, I also observed the bag house. It wasn't examined closer since it wasn't operating. No visible emissions were seen coming from the mixing of raw materials and we continued on to the liquid asphalt cement tanks. I observed the vapor condensation unit installed at the top of the tanks, which are required by their permit under EUACTANKS. I noted that for each of the 2 tanks, there is a hatch at the top of the tank. JW explained that they used the hatches previously to check liquid levels in the tanks. Now they have level indicators on the side of the tanks, so the hatches are no longer used. Unfortunately, both hatches were heavily corroded and leaking vapor/steam and creating odors. (See attached photos.)

Image 6(Tank Hatch 1) : Asphalt cement tank showing leaking hatch.

I held a brief post-inspection meeting with JW. I indicated to him that although not specifically spelled out in their permit, the 2 hatches on the asphalt cement storage tanks would need to be repaired as emissions from the hatches are generating odors and bypassing the vapor control system. JW indicated that he would have it fixed as soon as possible.

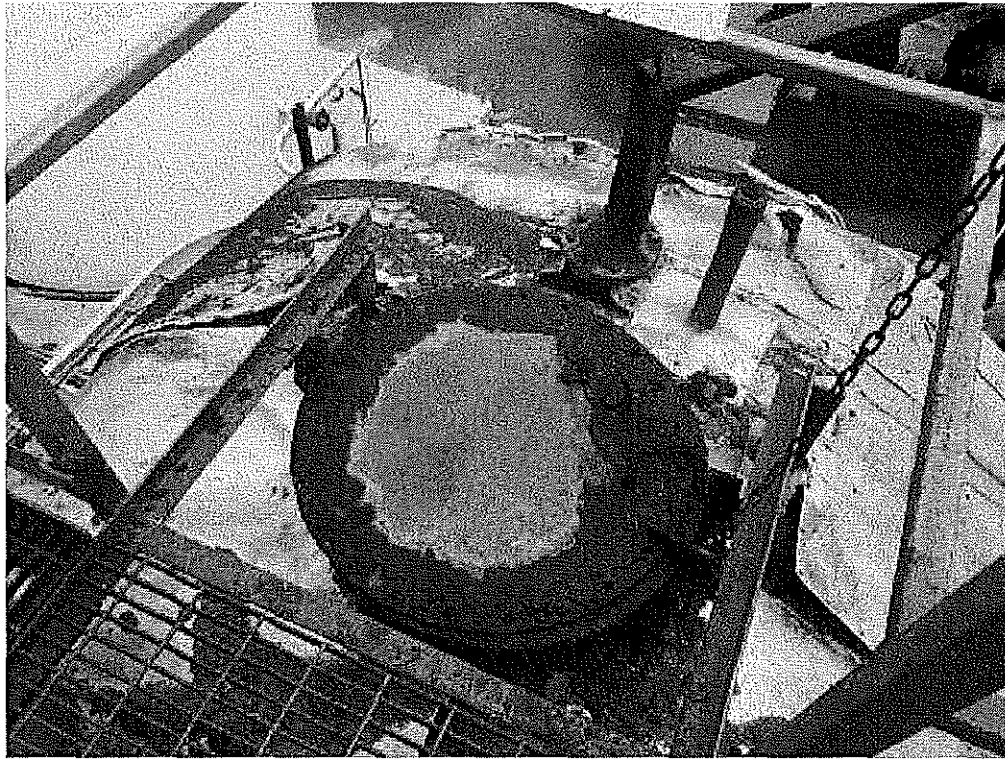
Image 7(Tank 2 Hatch) : Another leaking hatch on an asphalt cement tank.

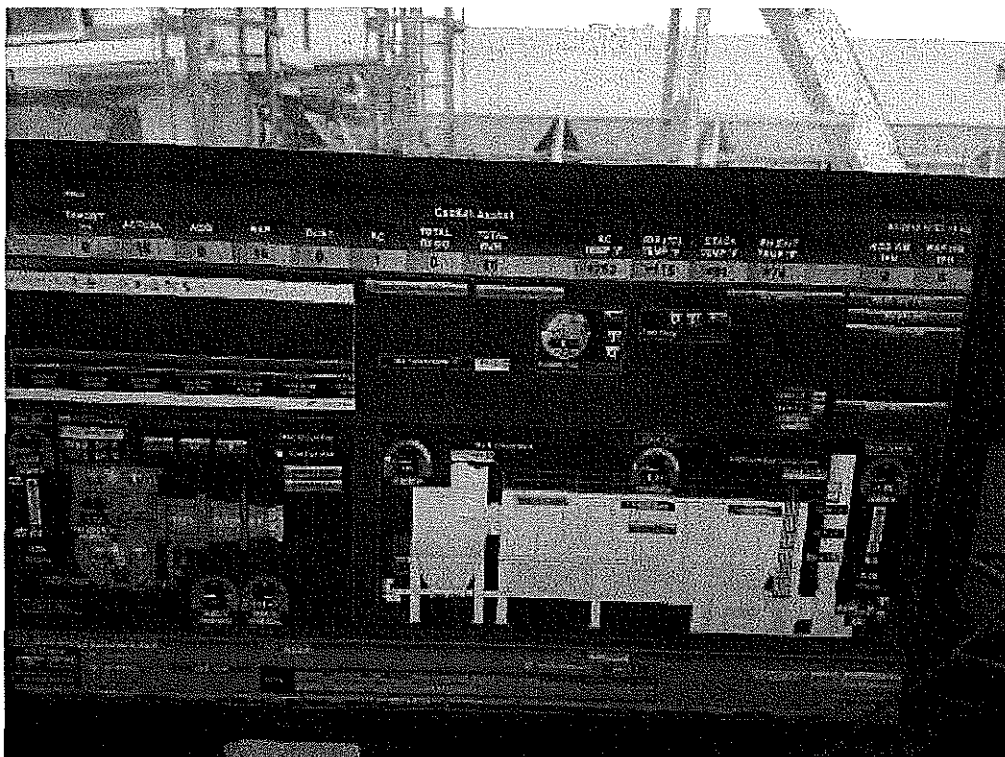
Image 8(Control Screen) : Control screen showing operating parameters.

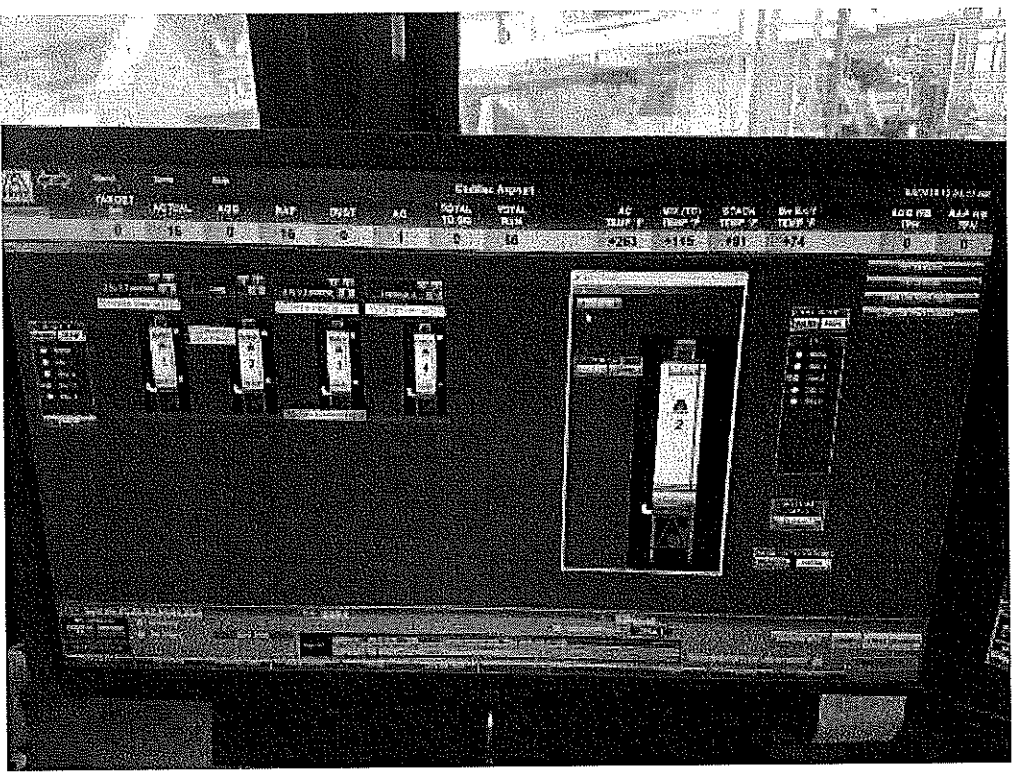
Image 9(Control Screen 2) : Screen shot from control room.

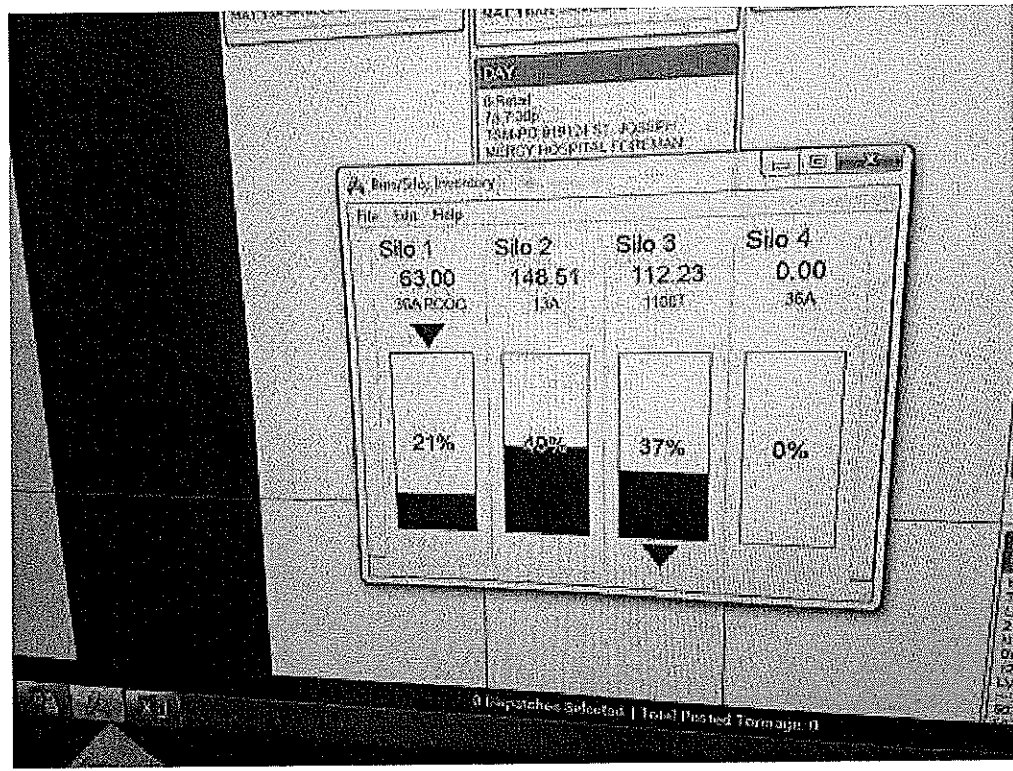
From there we headed to the control tower. See attached screen pics of the control screens. It showed that product was present in the 3 silos. A 4th smaller silo was empty. This silo is used to hold any waste asphalt product that might be generated.

Image 10(Control Room) : Screen shot showing levels of asphalt in the storage silos.
