DEPARTMENT OF ENVIRONMENTAL QUALITY
AIR QUALITY DIVISION
ACTIVITY REPORT: Scheduled Inspection

FACILITY: Twin City Concrete		SRN / ID: B5232
LOCATION: 609 South Carpenter Avenue, KINGSFORD		DISTRICT: Upper Peninsula
CITY: KINGSFORD		COUNTY: DICKINSON
CONTACT: Bob Broullire , Operator		ACTIVITY DATE: 05/04/2017
STAFF: Joe Scanlan	COMPLIANCE STATUS: Compliance	SOURCE CLASS: MINOR
SUBJECT: Unannounced inspection to determine compliance with PTI# 289-75.		
RESOLVED COMPLAINTS:

INSPECTION DATE: 5/04/2017**DEQ STAFF:** Joseph Scanlan**FACILITY:** Midwest Redi-Mix**FACILITY OWNER:** Twin City Concrete, Inc.

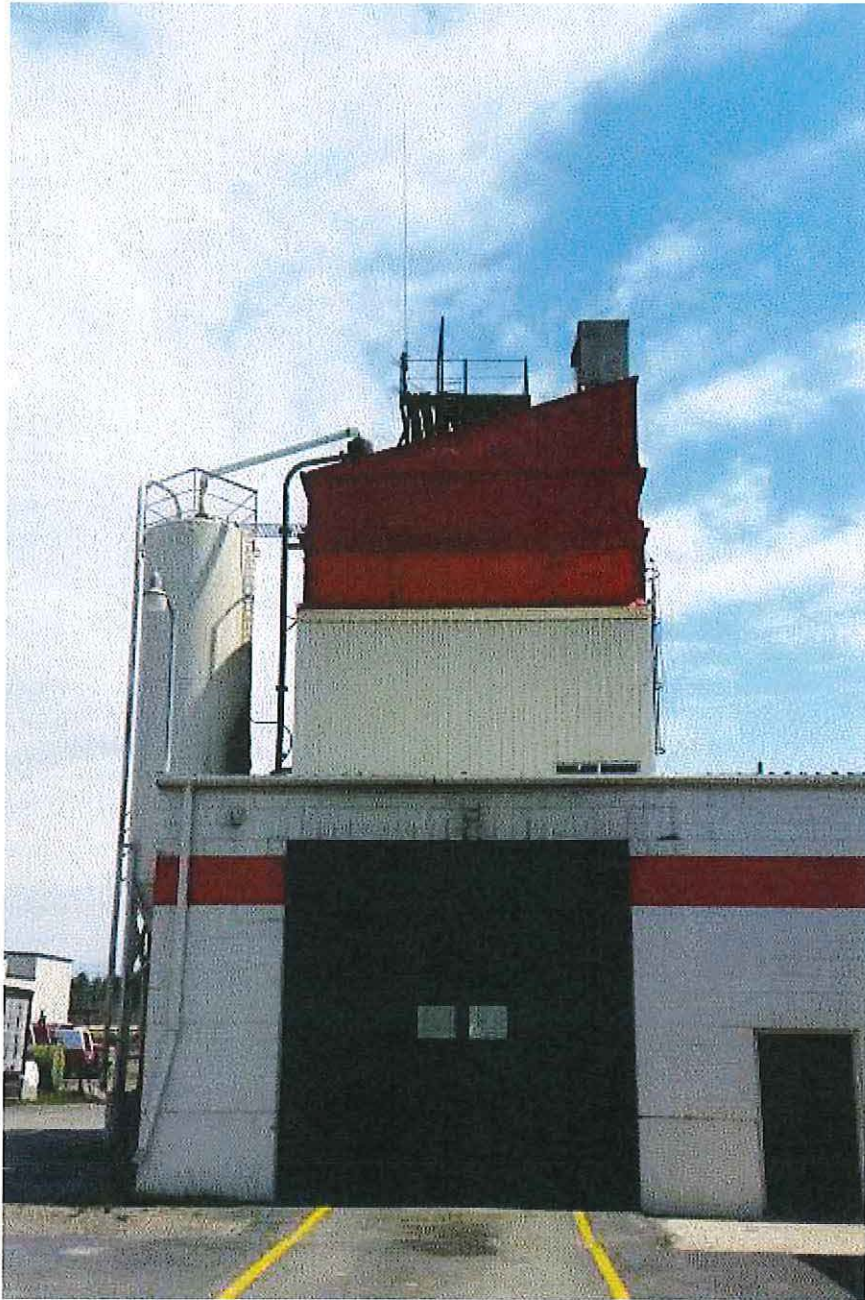
Image 1(MWRM1) : 36-IS Dusty Dustless shaker-style silo filter vent, naturally-vented, positioned on top of load-out area.
