**DEPARTMENT OF ENVIRONMENTAL QUALITY  
AIR QUALITY DIVISION  
ACTIVITY REPORT: Scheduled Inspection**

FACILITY: WILLBEE TRANSIT MIX CO		SRN / ID: B6077
LOCATION: 2323 BROOKLYN RD, JACKSON		DISTRICT: Jackson
CITY: JACKSON		COUNTY: JACKSON
CONTACT:		ACTIVITY DATE: 03/02/2017
STAFF: Mike Kovalchick	COMPLIANCE STATUS: Compliance	SOURCE CLASS:
SUBJECT: Inspection. Incinerator was shutdown and sold in 2012. No longer any activity at this facility that requires a permit or otherwise needs to be inspected again.		
RESOLVED COMPLAINTS:

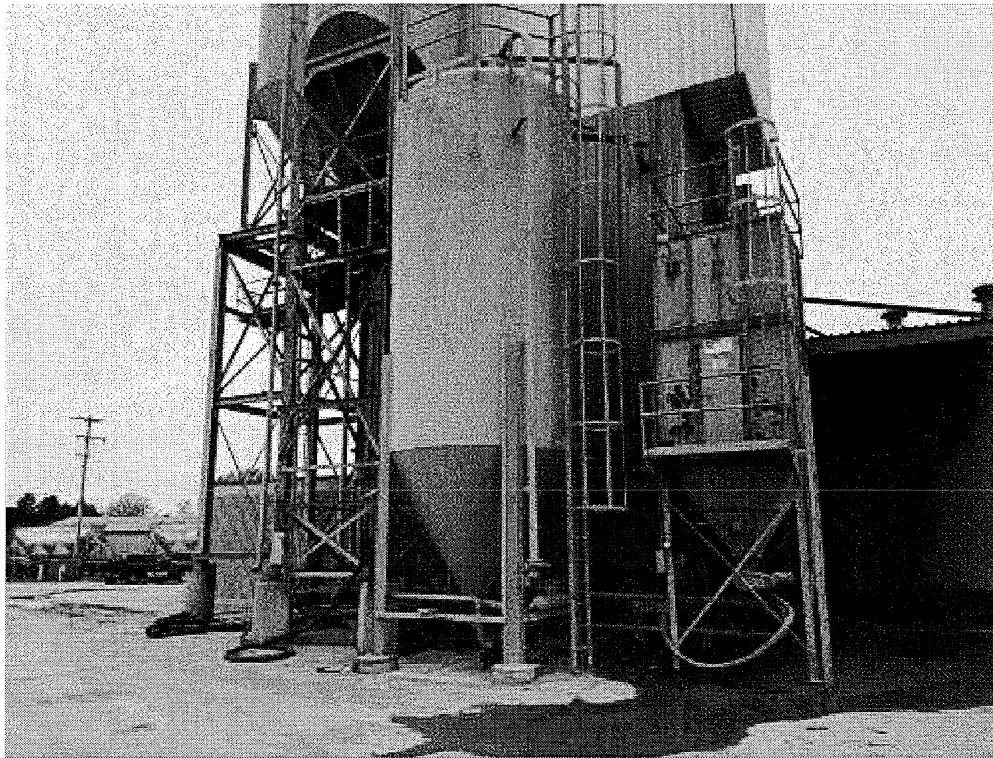
They have a permit # 745-77 for a dust collector for the cement storage facility. The dust collector was not operating when I arrived as there was no truck loading going on. The permit doesn't have substantive conditions other than a requirement for doing fugitive dust measures for the area around the cement loading.

**Image 1(Dust collector)** : Dust collector on right with a storage bin on left.

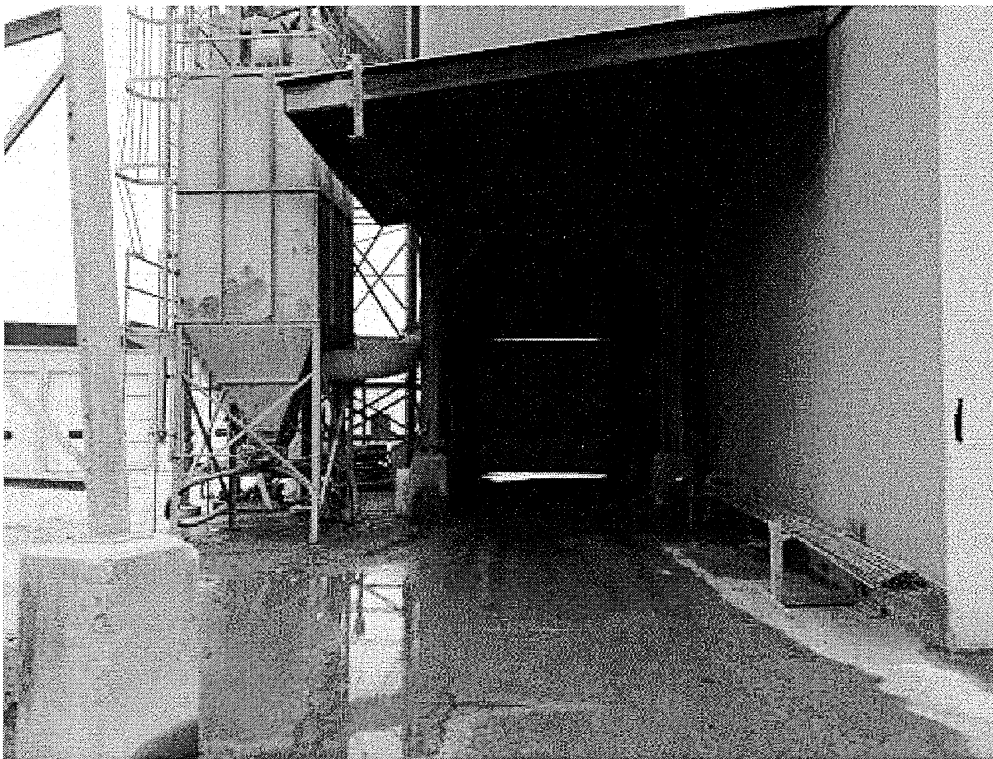
The dust collector is automatically turned on when they are loading cement trucks to catch fugitive cement dust. A large hood/exhaust fan is located directly above where the trucks are loaded in the loading bay. (The cement is loaded into the truck form above as well.) All cement dust that is captured by the dust collector is returned to the cement storage silo. I asked about their fugitive dust control program that is required by the permit. He said that they brush the yard lot approximately twice a month or when it rains. He said that basically everything is cemented over so there never is any track out problem. He indicated that about 200 trucks per day go through the facility. He said that the bags in the dust collector were changed out about 6 months ago and they generally change them every 2 years or so. The dust collector itself appeared to be in good shape. (See attached photos.) It appeared that there was an exhaust stack at the very top of the collector which wasn't easily accessible or easy to see. There appeared to be some minor about of dust fallout on the collector in the vicinity of the exhaust stack but it wasn't clear where it had come from other than probably the trucks themselves when they exit the loading area.

**Image 2(Loading bay)** : Loading bay with dust collector on left.
