DEPARTMENT OF ENVIRONMENTAL QUALITY
AIR QUALITY DIVISION
ACTIVITY REPORT: On-site Inspection

B905059601

FACILITY: BUCKEYE TERMINALS LLC -DETROIT TAYLOR TERMINAL		SRN / ID: B9050
LOCATION: 8000 BEECH DALY RD S, TAYLOR		DISTRICT: Detroit
CITY: TAYLOR		COUNTY: WAYNE
CONTACT: Paul Ransom , Operation Manager		ACTIVITY DATE: 06/01/2021
STAFF: C. Nazaret Sandoval	COMPLIANCE STATUS: Compliance	SOURCE CLASS: SM OPT OUT
SUBJECT: Unscheduled Inspection		
RESOLVED COMPLAINTS:

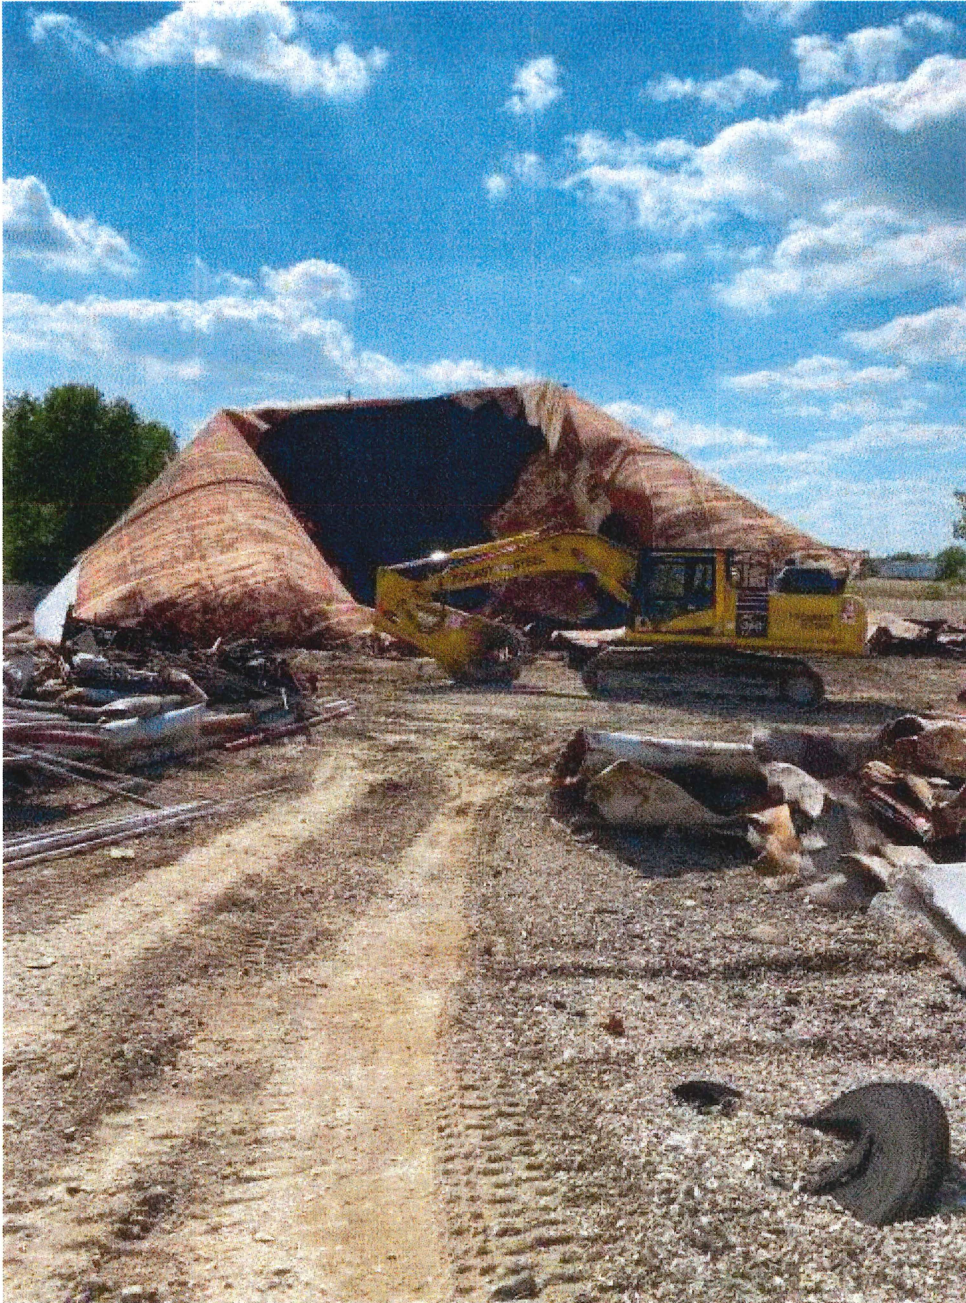
When the terminal was in operation there were seven storage tanks. During the inspection I observed that only one of the seven tanks has been demolished. At the farthest west end of the facility there was rubbish metal from the shell of the tank and from all the appurtenances and connecting pipes. The dismantled tank was one of the two tanks with the highest-capacity storage. The rest of the storage tanks were still standing, but they were all disconnected and the cathodic protection to all tanks has been removed. Mr. Zeestraten indicated that Buckeye expected to complete the demolition work by 7/4/2021.

Image 1(Tank Shell) : Image of a tank shell after being dismantled. View from the east side of the property.

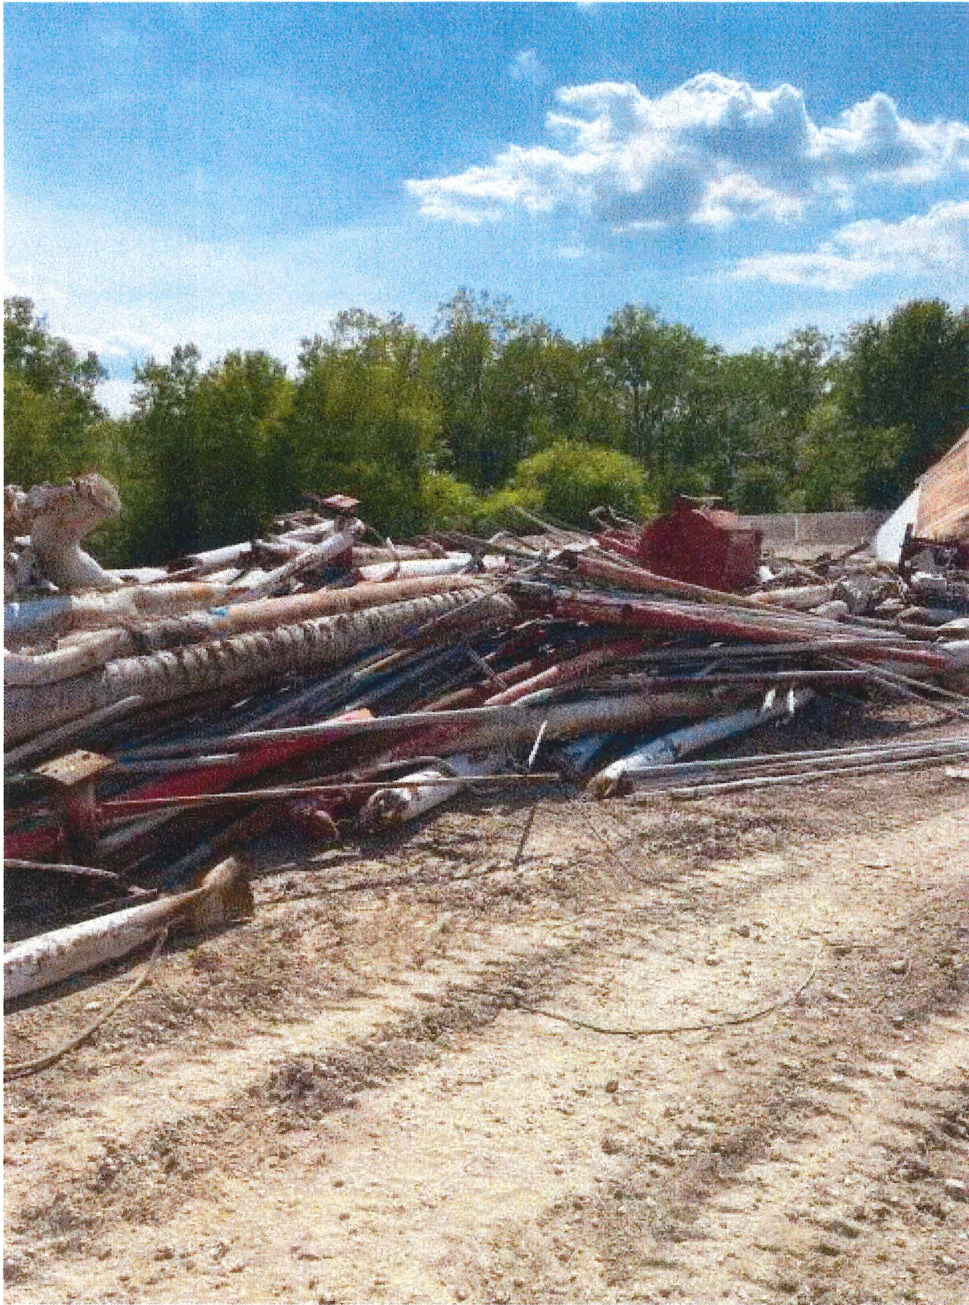
Image 2(Piping) : Remains of the tank piping system after wrecking activity

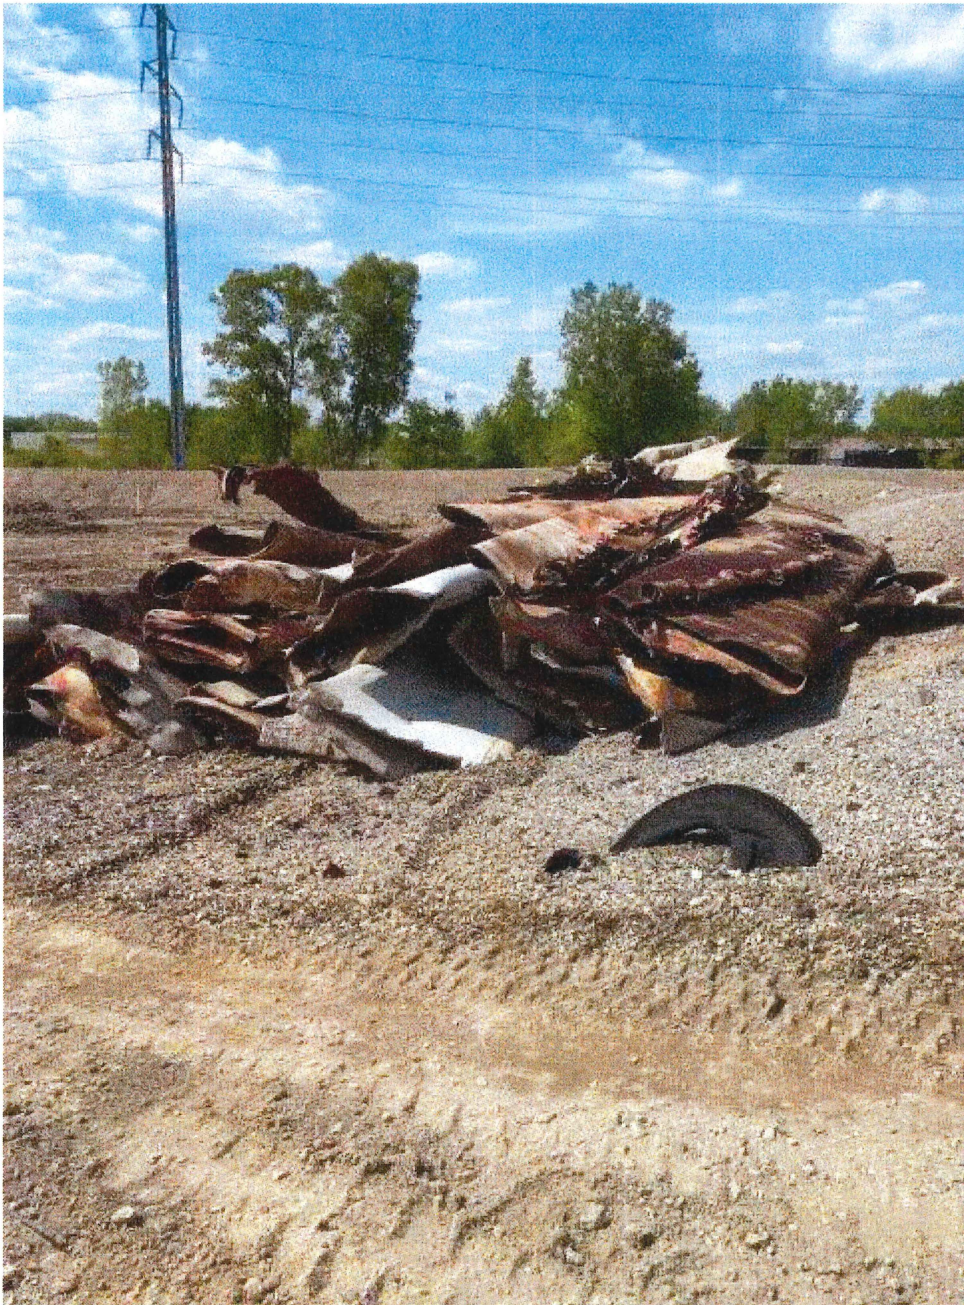
Image 3(Metal) : Metal sheets from dismantled tank

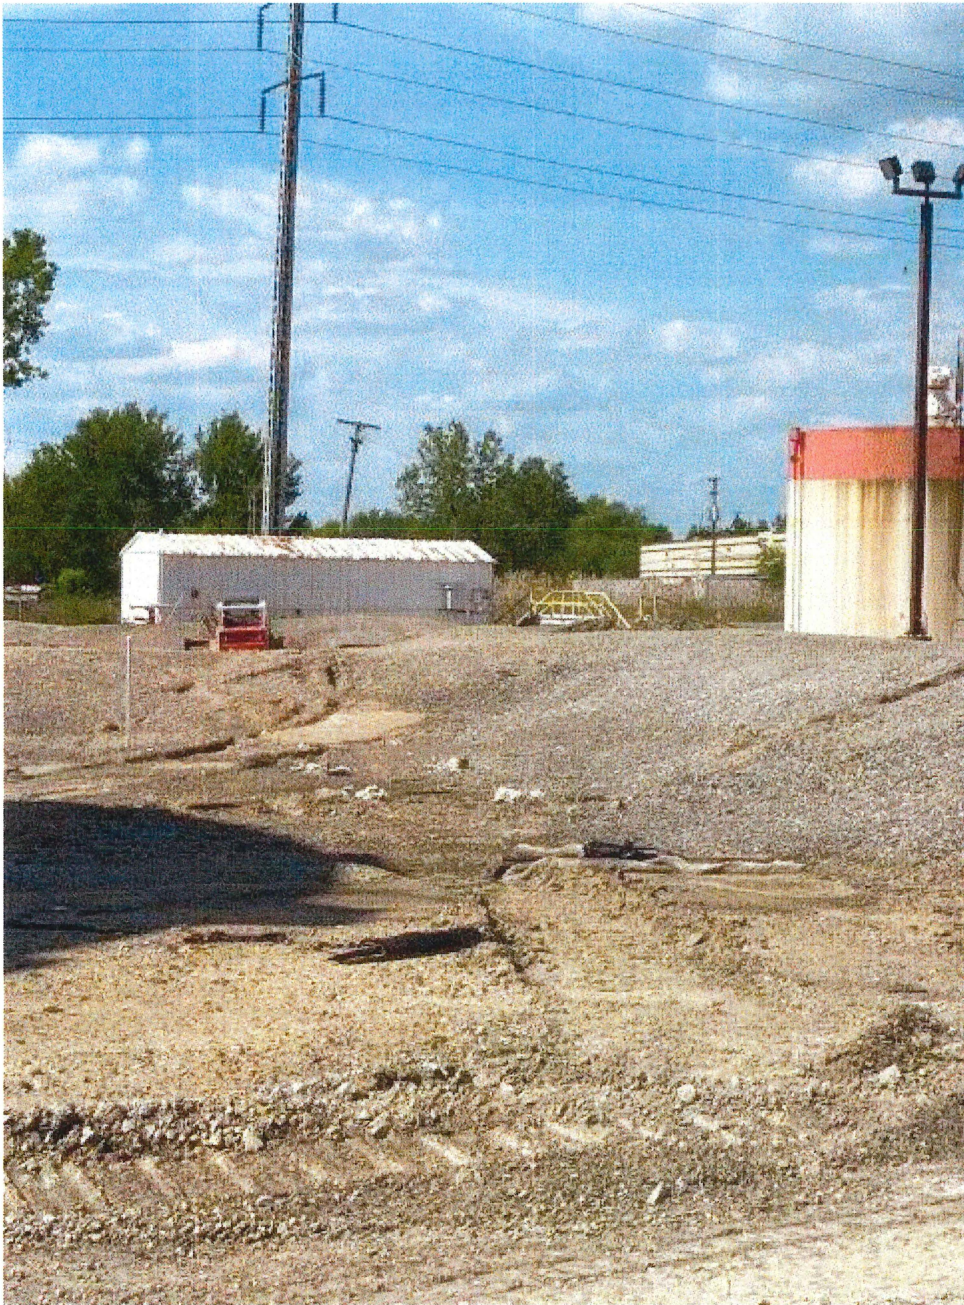
The office building and the loading rack have been demolished years ago. There is only one standing building located at the north side of the property, west of Beech Daly Rd. and close to the railroad track. The one-floor building is used for storage of electrical gear. In the building, Mr. Zeestraten pointed out to the electrical circuits that were used to power the terminal system operations and the cathodic protection of the storage tanks. All those

Image 4(Electrical Building) : One-floor Standing Building housing the Electrical Controls and Switches

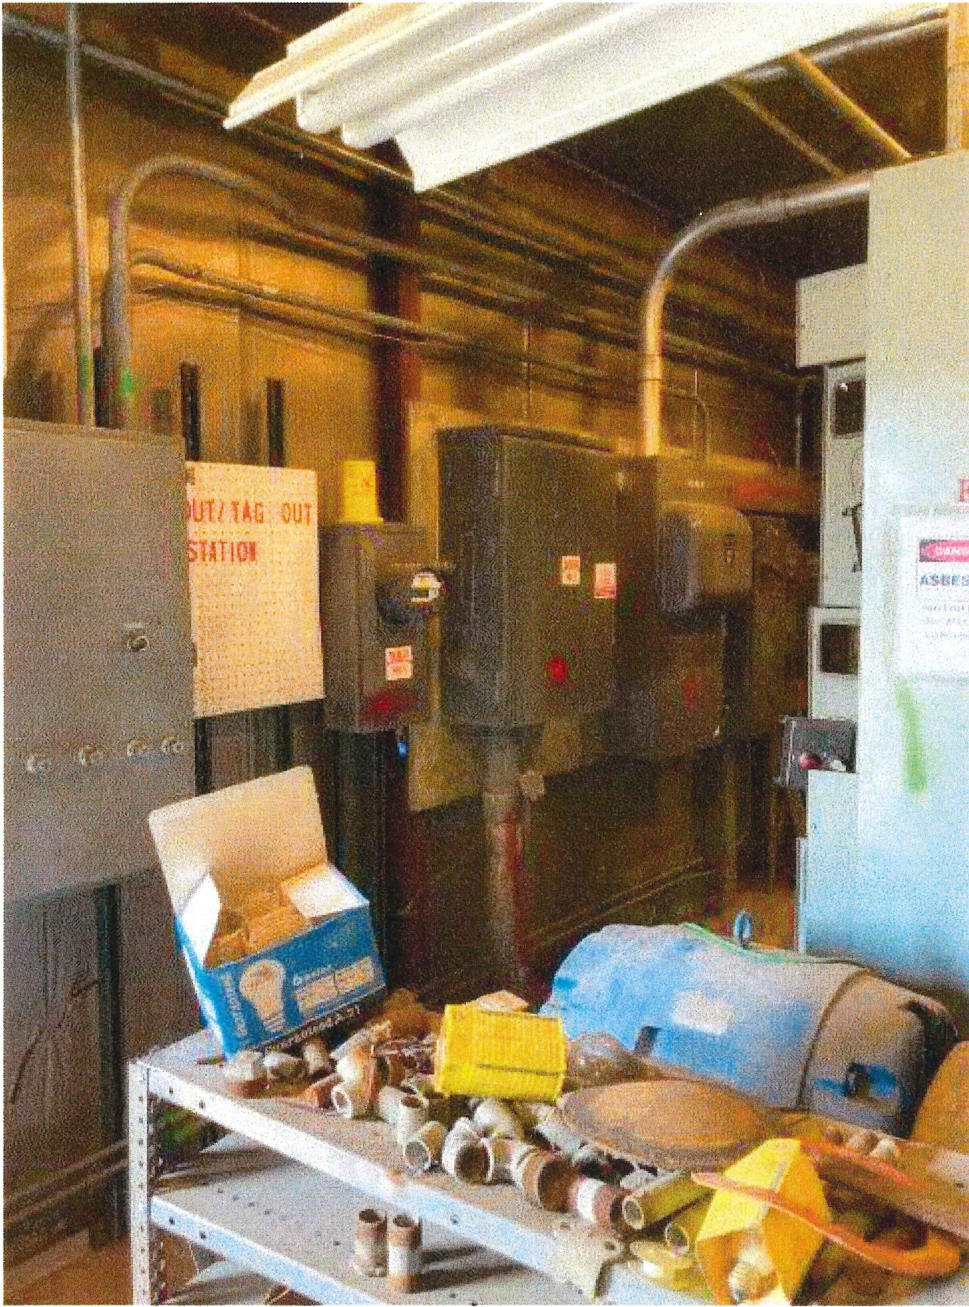
Image 5(Electrical Building) : Inside the building - North Wall

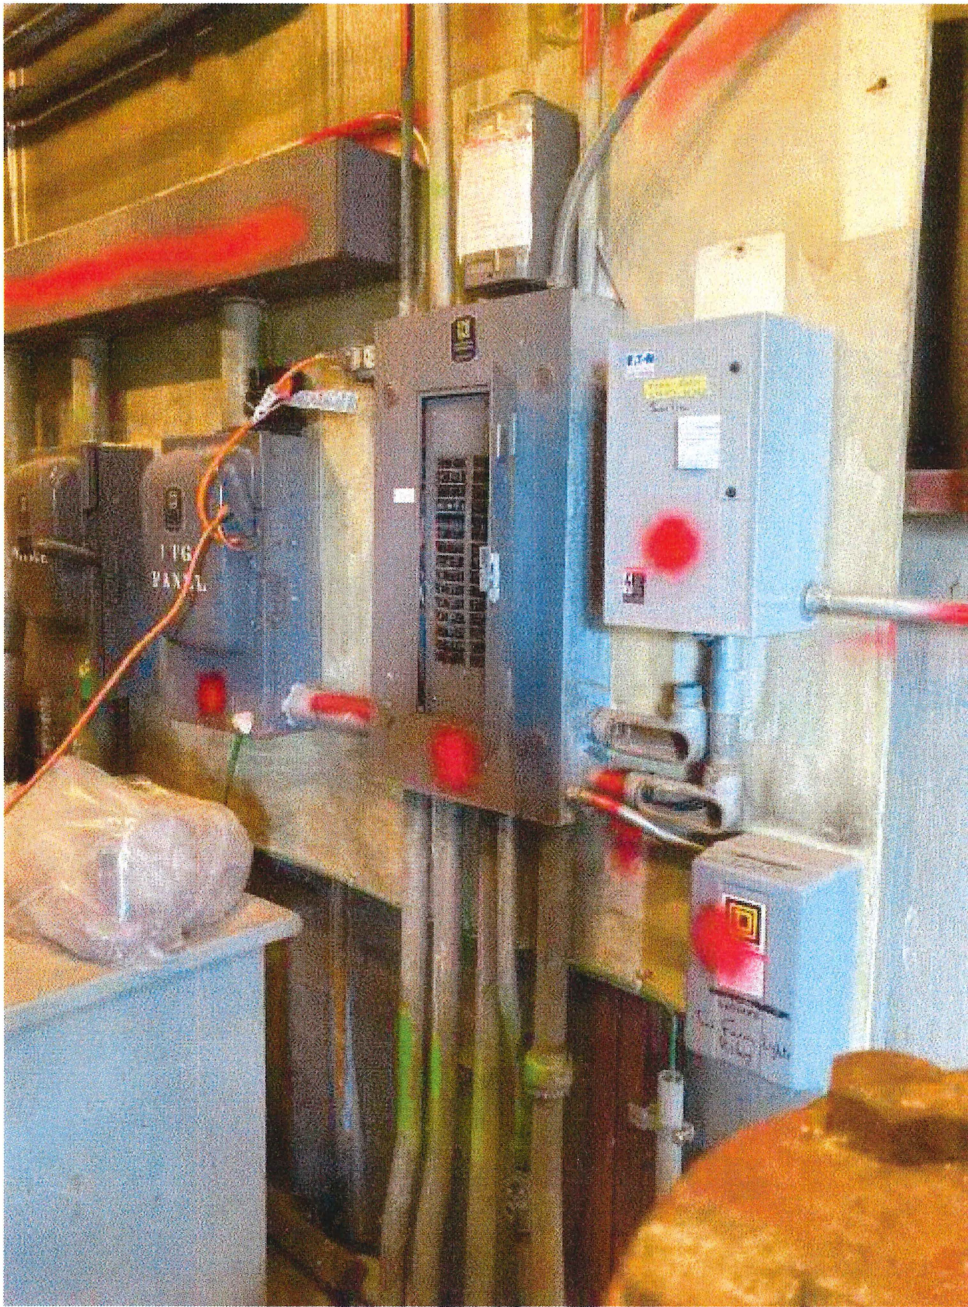
Image 6(Electrical Building) : Inside Building - South Wall

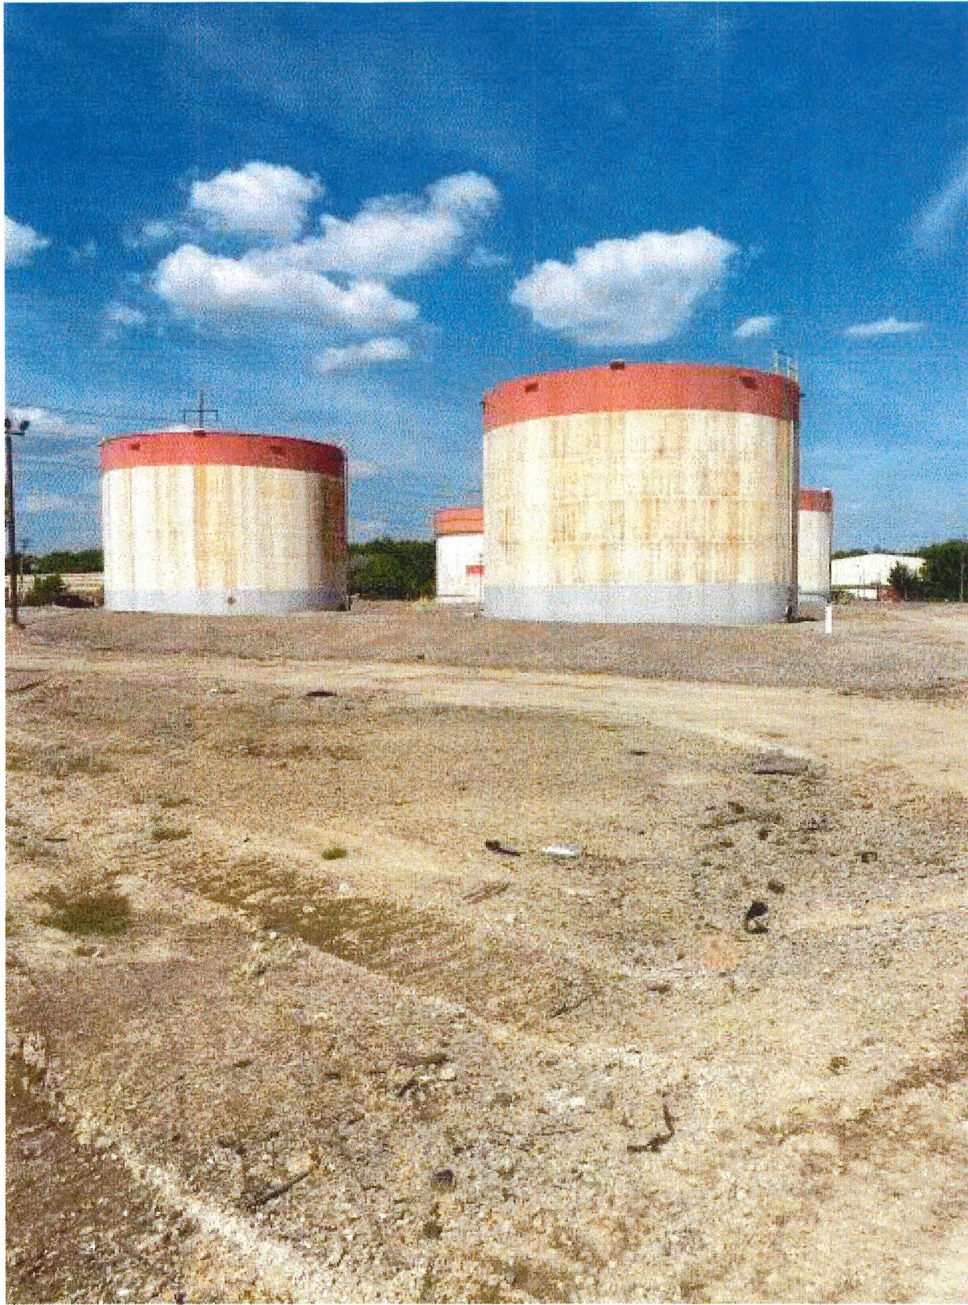
Image 7(Tanks) : Standing Storage Tanks
