DEPARTMENT OF ENVIRONMENTAL QUALITY
AIR QUALITY DIVISION
ACTIVITY REPORT: Self Initiated Inspection

FACILITY: MOYLE CONCRETE - ONTONAGON		SRN / ID: N0784
LOCATION: 49953 GREENLAND RD, ONTONAGON		DISTRICT: Upper Peninsula
CITY: ONTONAGON		COUNTY: ONTONAGON
CONTACT: JON LABYAK , PLANT MANAGER		ACTIVITY DATE: 11/06/2015
STAFF: Joe Scanlan	COMPLIANCE STATUS: Compliance	SOURCE CLASS: MINOR
SUBJECT: Unannounced inspection of concrete batch plant to determine compliance with PTI# 247-84.		
RESOLVED COMPLAINTS:

FACILITY: *Ontonagon Concrete Batch Plant—Moyle Concrete, Inc.*

INSPECTION DATE: 11/6/2015

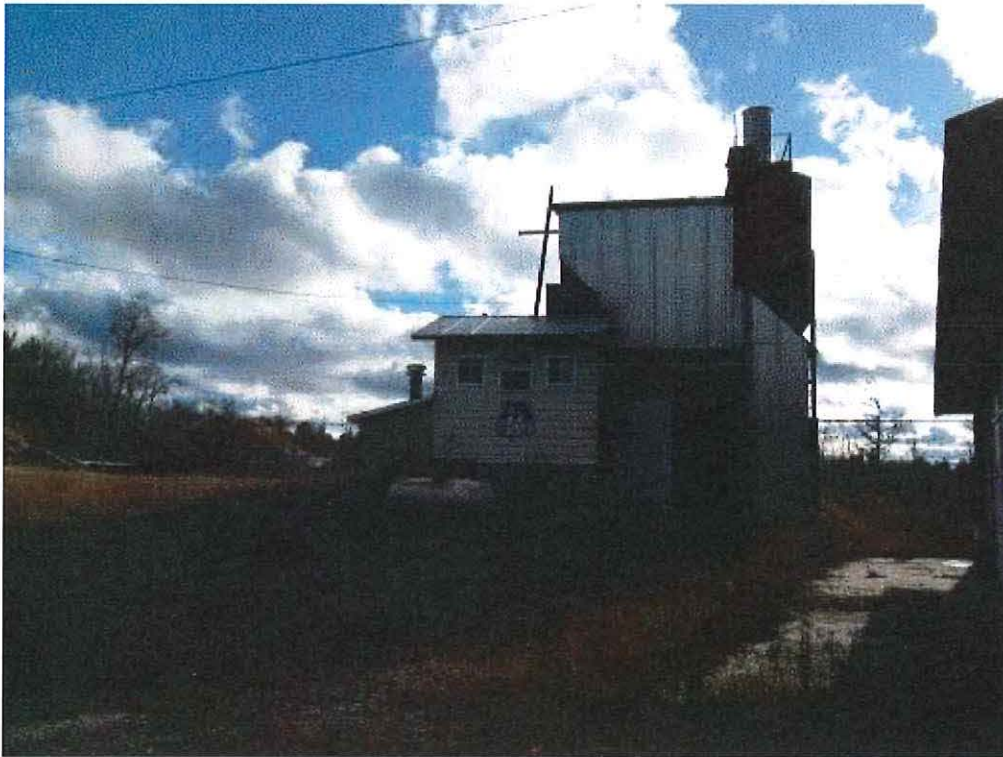
Image 1(MC1) : Front of facility from M-38 (Greenland Road). Offices are in the building frame right.

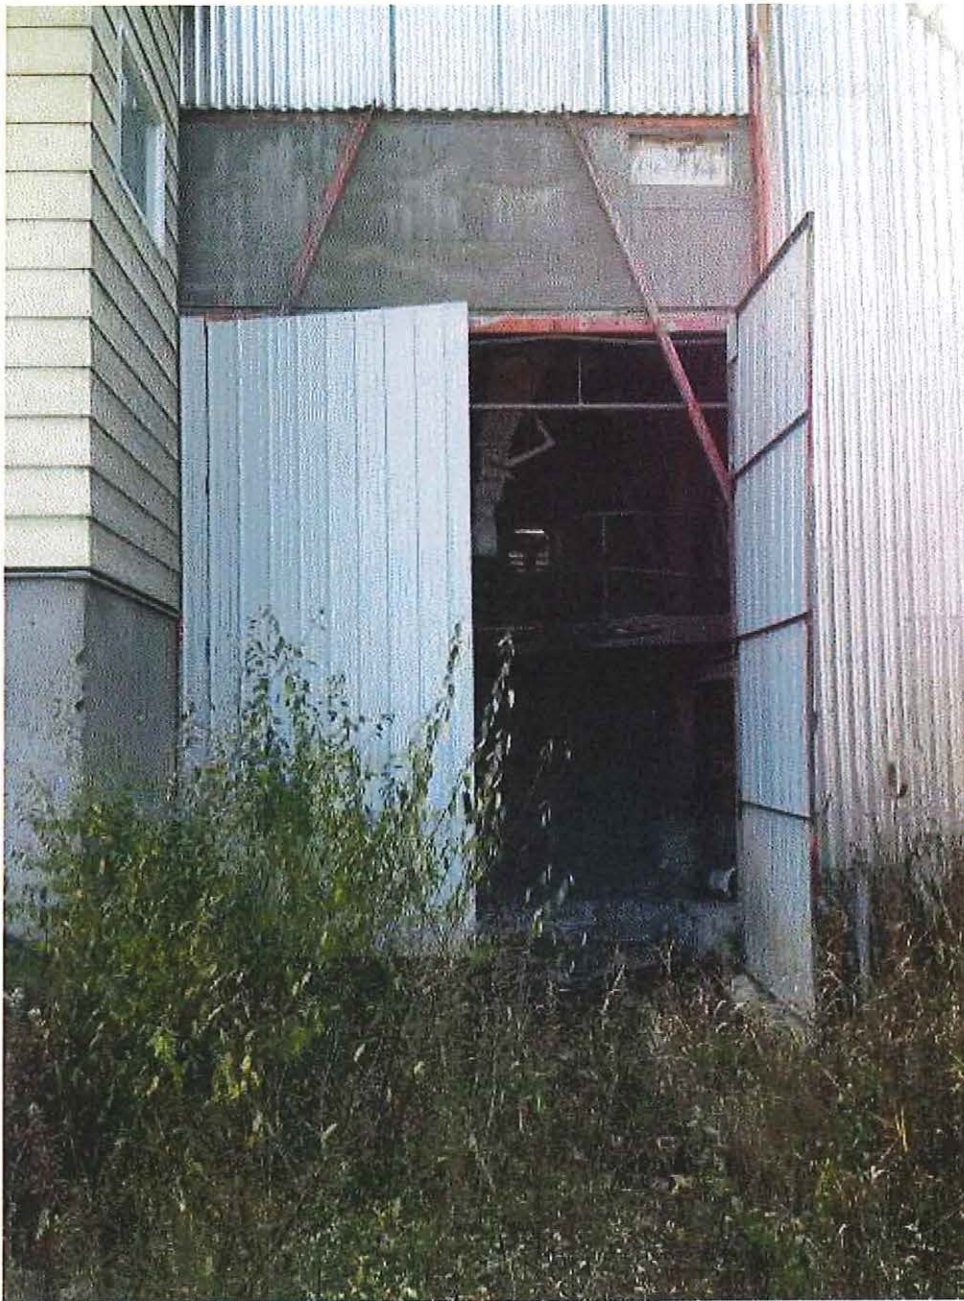
Image 2(MC2) : Enclosed load-out area, with doors open

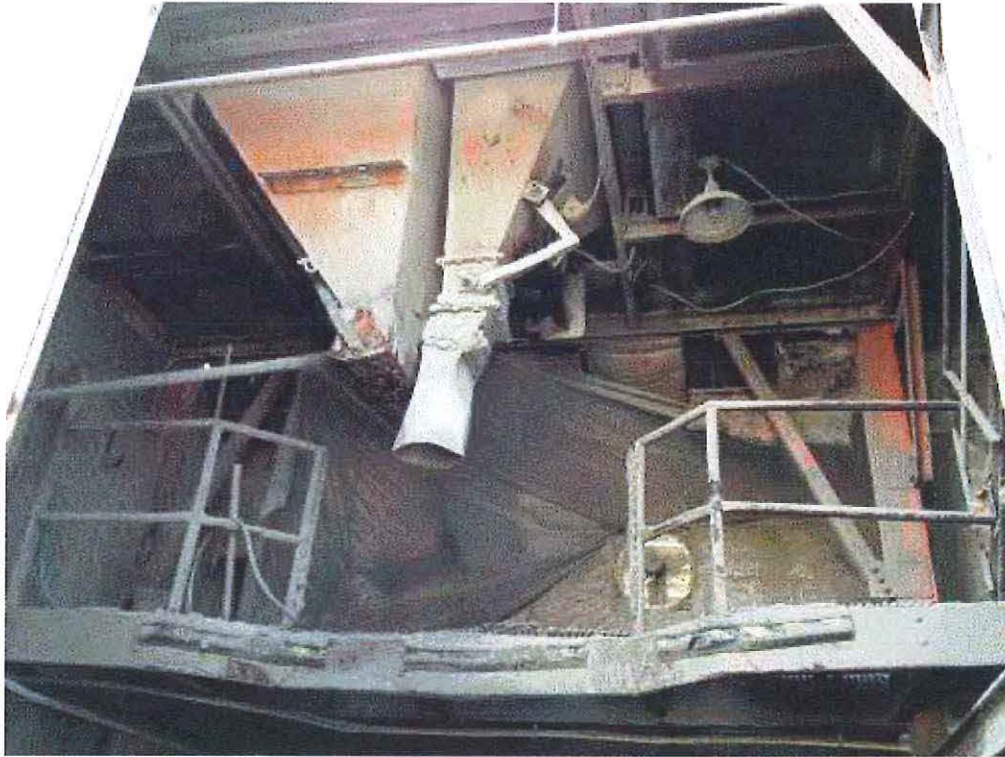
Image 3(MC3) : Load-out bins and chute

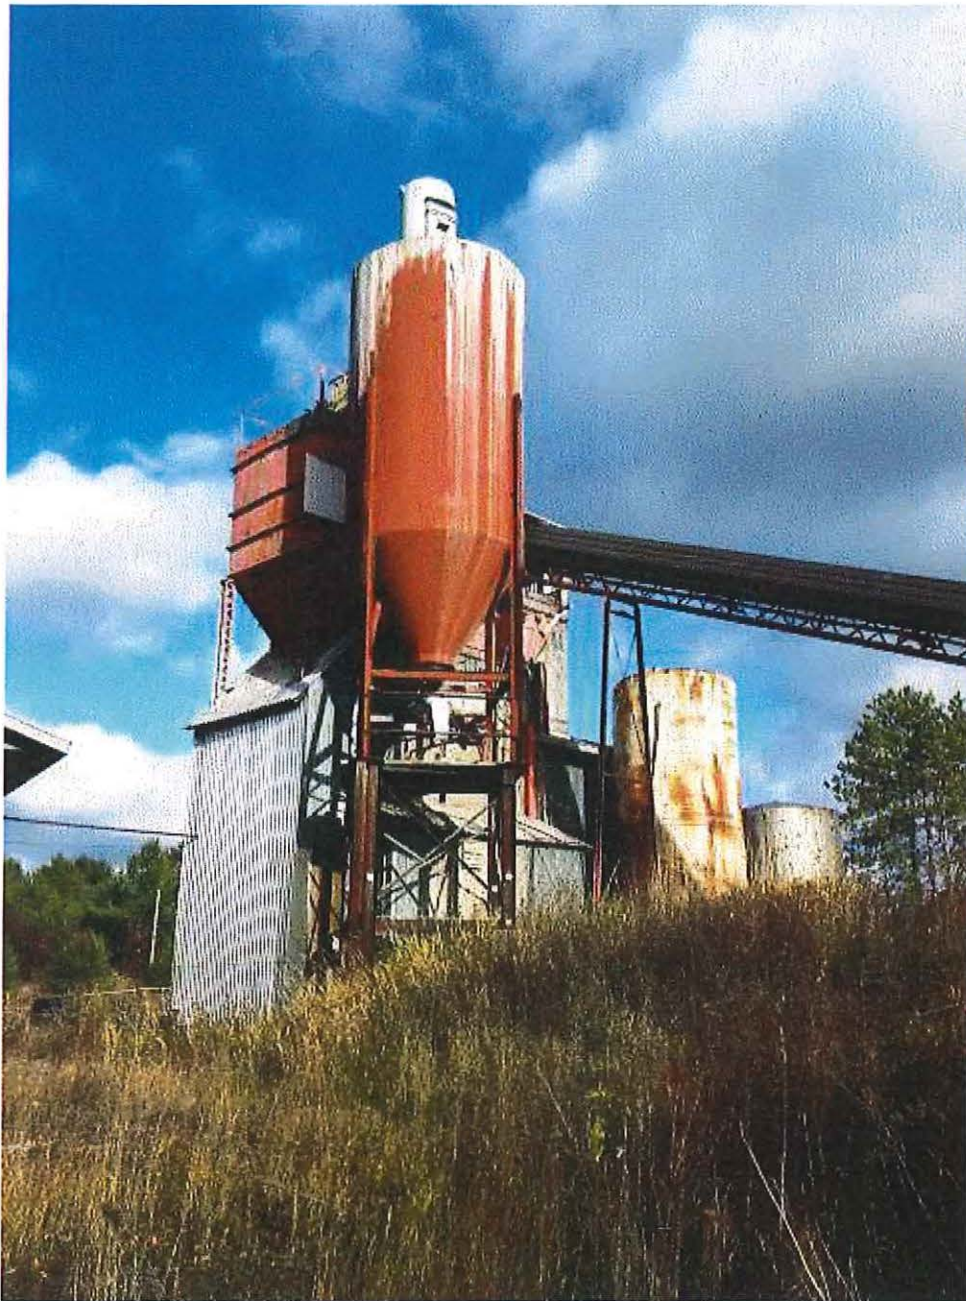
This facility is vacant and it is apparent that it has not operated in quite some time. The driveway is gated and the parking/walking area around the facility is overgrown with vegetation. The facility does appear operable and turn-key ready.

Image 4(MC4) : Overgrown vegetation at site--no activity apparent

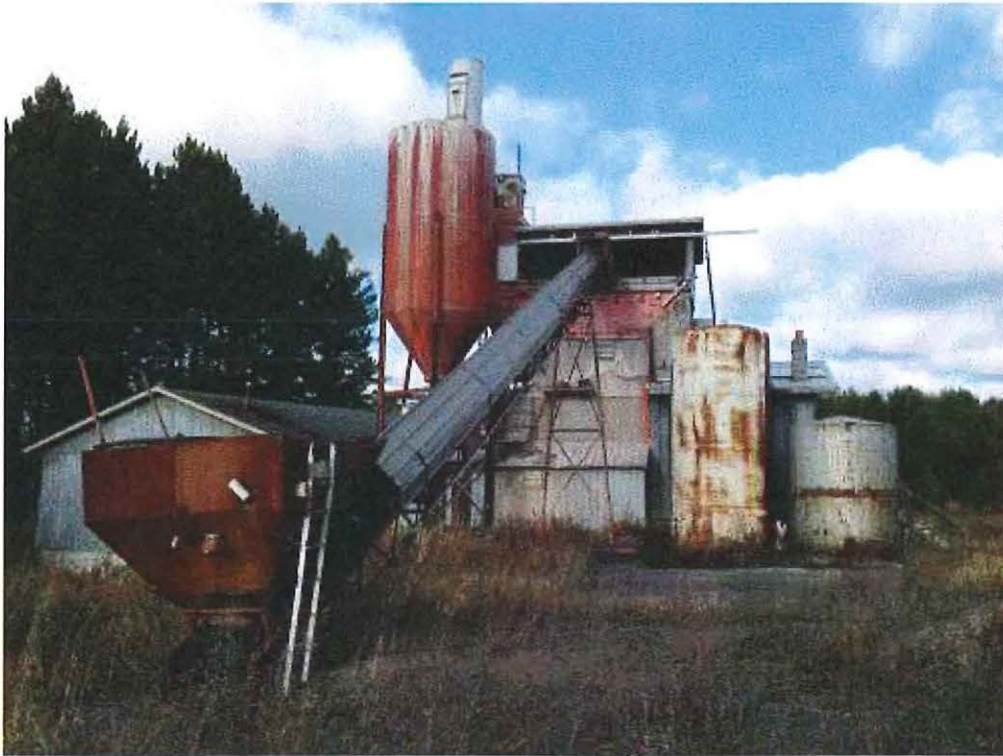
Image 5(MC5) : Overgrown vegetation at site--no activity apparent

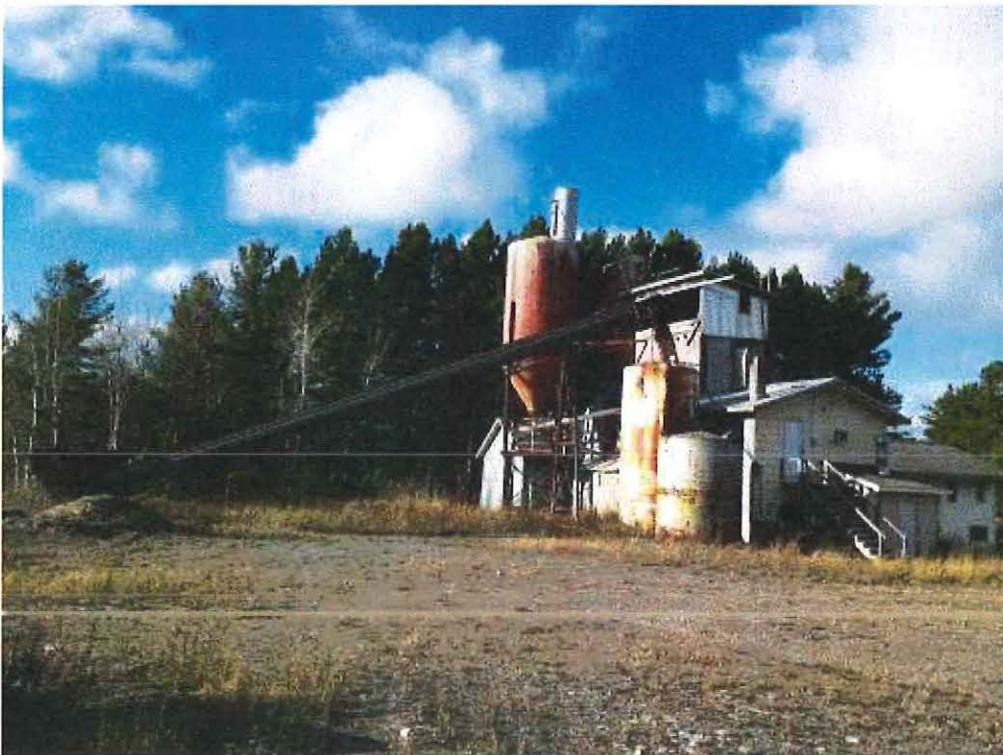
Image 6(MC6) : Overgrown vegetation at site--no activity apparent
