**DEPARTMENT OF ENVIRONMENTAL QUALITY  
AIR QUALITY DIVISION  
ACTIVITY REPORT: Self Initiated Inspection**

N078645169

FACILITY: HMI Hardwoods, LLC		SRN / ID: N0786
LOCATION: 430 Division Street, CLINTON		DISTRICT: Jackson
CITY: CLINTON		COUNTY: LENAWEE
CONTACT: Ronald Steele , Maintenance Manager		ACTIVITY DATE: 07/10/2018
STAFF: Mike Kovalchick	COMPLIANCE STATUS: Non Compliance	SOURCE CLASS: MINOR
SUBJECT: Potential T5 source of CO from excess emissions from wood fired boiler.		
RESOLVED COMPLAINTS:

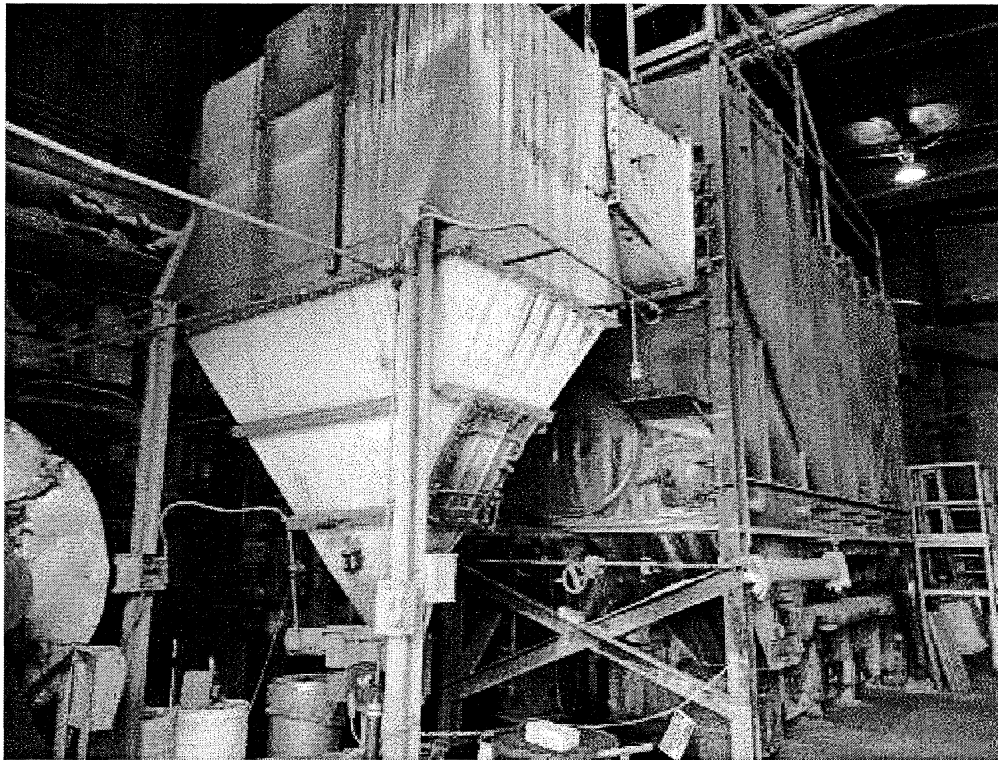
The wood fired boiler was equipped with a multi-clone control device. See attached photo. All of the ash is conveyed through a closed auger to a three-sided shed. From the shed it is put into a roll off dumpster and kept wet until it is picked up. See attached photo. The ash is nonhazardous and is disposed offsite. I noted some spillage of the ash on the ground but was contained within the 3-sided shed.

**Image 3(Wood boiler)** : Wood boiler with multi-clone collector in the front.

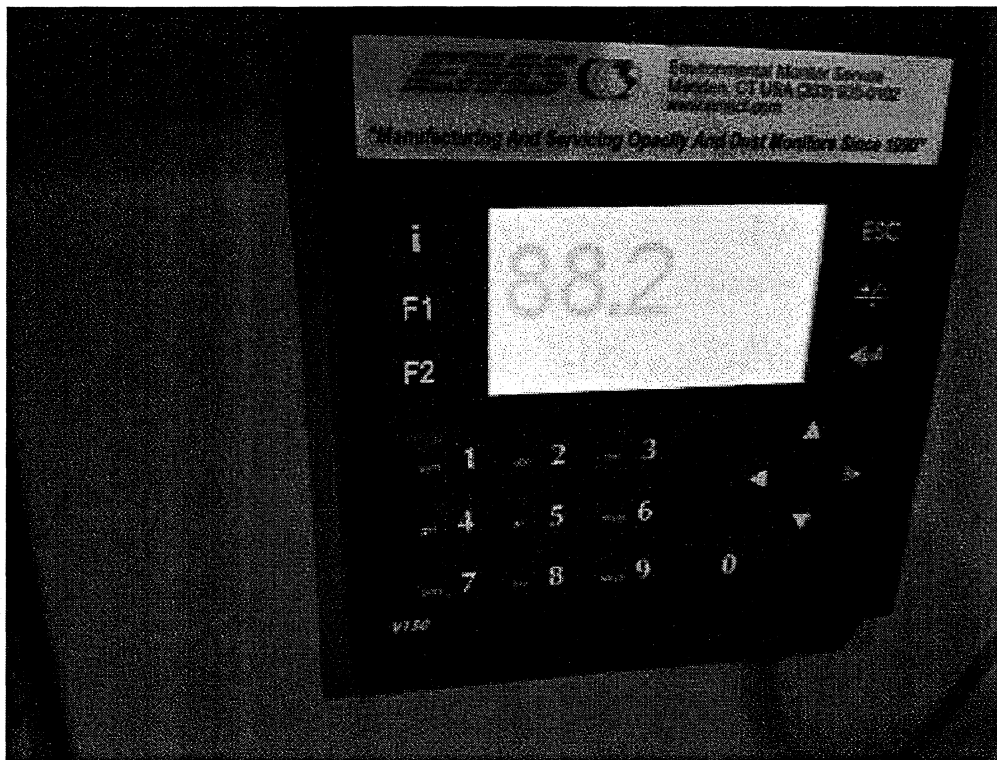
The operator showed me the opacity monitor display. It was reading 88%. The operator said that lenses was dirty and that it was operating correctly earlier in the day. He showed me paper chart recordings of the opacity for 2018 of which I requested a copy. It wasn't clear when the opacity monitor was last calibrated although apparently the lenses are cleaned once a week. (Note: Upon further review, the paper charts didn't actually have opacity recorded on them.)

Since the Company is currently not maintaining opacity records, compliance status with this condition can't be determined. Based on discussions with the boiler operator and the fact that the wood fired boiler is only controlled with a multi-clone collector, excess opacity is suspected.

**Image 4(Opacity Monitor) :** Opacity Monitor showing incorrect reading.

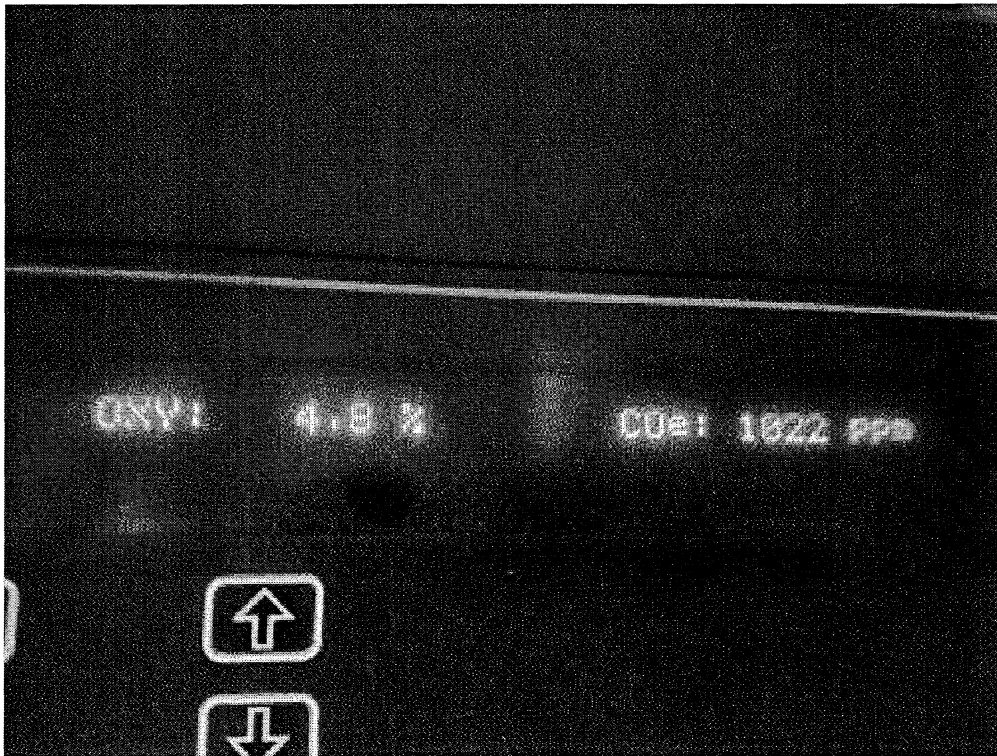
The operator showed me another digital display for percent oxygen and carbon monoxide emissions in ppm. See attached photo. CO showed 1022 ppm and percent oxygen was at 4.8%. He indicated that the CO reading was typical. The operator indicated that he generally ignores opacity and CO readings and instead relies on percent oxygen as a gauge to adjust fuel feed. If oxygen goes up, he increases the amount of fuel added. Due to the variety of types of wood that is feed into the boiler, the percent moisture content and whether it is green wood or not creates lots of fluctuations. The operator outlined a number of situations that created visible smoke.

Carbon monoxide emissions can be estimated. The Company maintains a CO monitor on the boiler exhaust. It showed a reading of 1020 ppm during the inspection. The boiler operator indicated that reading represented typical operation.

This works out to 1.5 pounds CO per minute or 90 pounds per hour. In the month of June, the boiler operated 672 hours. This comes to 30 tons per month or 363 tons per year assuming uniformity to the boiler load. (Boiler is used more in the Winter.) Estimated emissions far exceed permitted levels and suggests the facility should be considered a Major Source or even a PSD major source for CO. A CO stack test will be required to further define compliance. A CO stack test has not been previously conducted on this boiler. (Note: Historically, the Company

**Image 5(Oxygen/CO monitor) :** Oxygen/CO monitor.

A Violation Notice (VN) will be sent to the Company outlining the violations. They will have 21 days to respond with a compliance plan. Furthermore, a CO stack test will be required along with a opacity demonstration for the wood fired boiler.

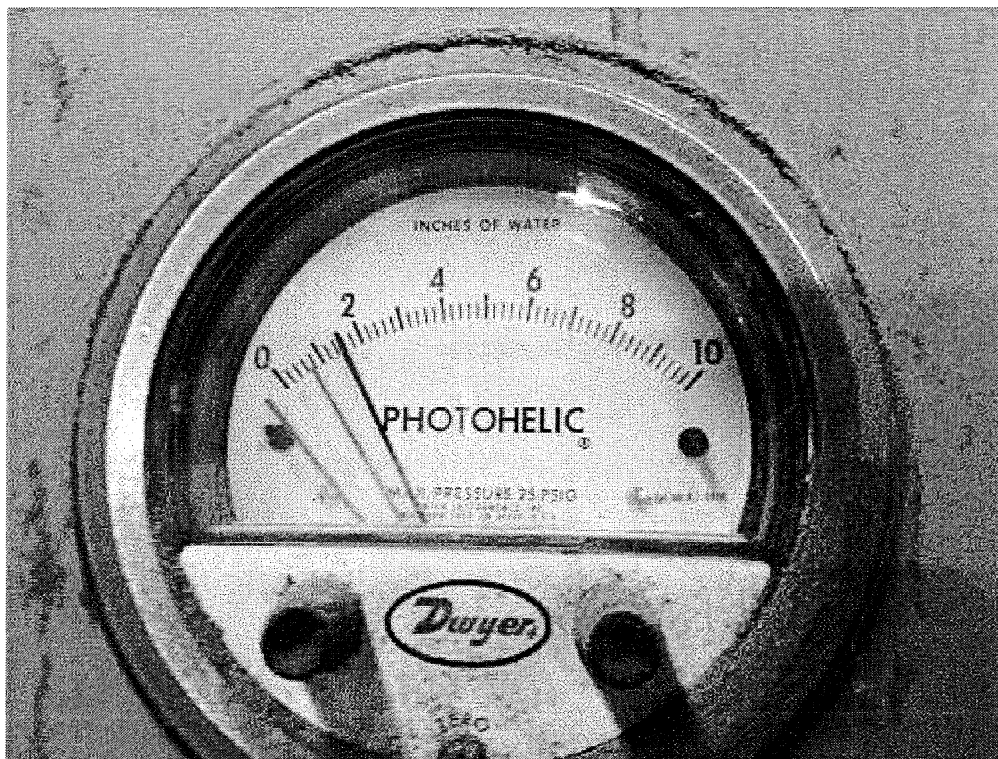
Both of the baghouses exhaust horizontally. See attached photo. Collected dust from both collectors was spilling out on to the ground and visible emissions were noted while dust was being dropped into a truck. The Murphy Rogers collector had a pressure drop gauge located on it although it wasn't clear what the proper operating range was. See attached photo. RS noted that the bags in that baghouse had been replaced only a month ago. The other baghouse was not examined.

**Image 7(Pressure drop) :** Pressure drop gauge for bag house for fuel handling system.

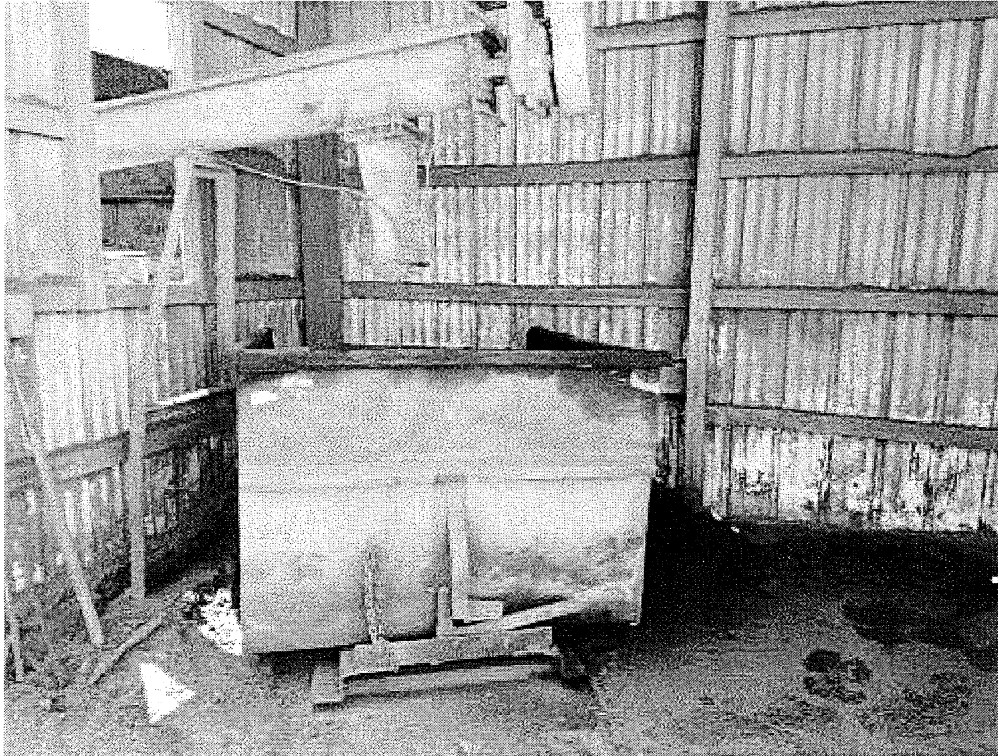
**Image 8(Ash collection)** : Ash collection from multi-clone collector.

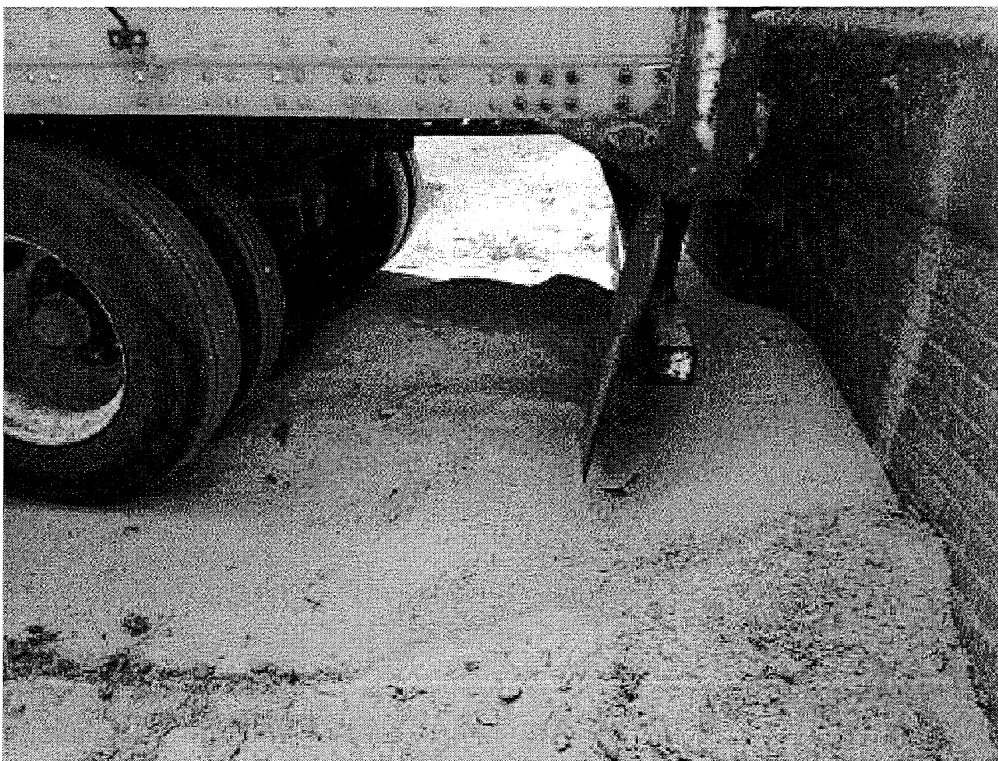
Opacity was noted for the fuel (saw dust/wood) handling system while the collected air contaminants were being loaded into a truck. Saw dust also had spilled out on the ground and surrounding areas. (See attached photos.) This is a violation of the PTI and also Rule 370; the collection and disposal of air contaminants shall be performed in a manner so as to minimize the introduction of contaminants to the outer air.

PTI Condition # 15 and Rule 370. Improper handling of collected air contaminants resulting in opacity and accumulation on the ground.

**Image 9(Dust on ground)** : Dust on ground.

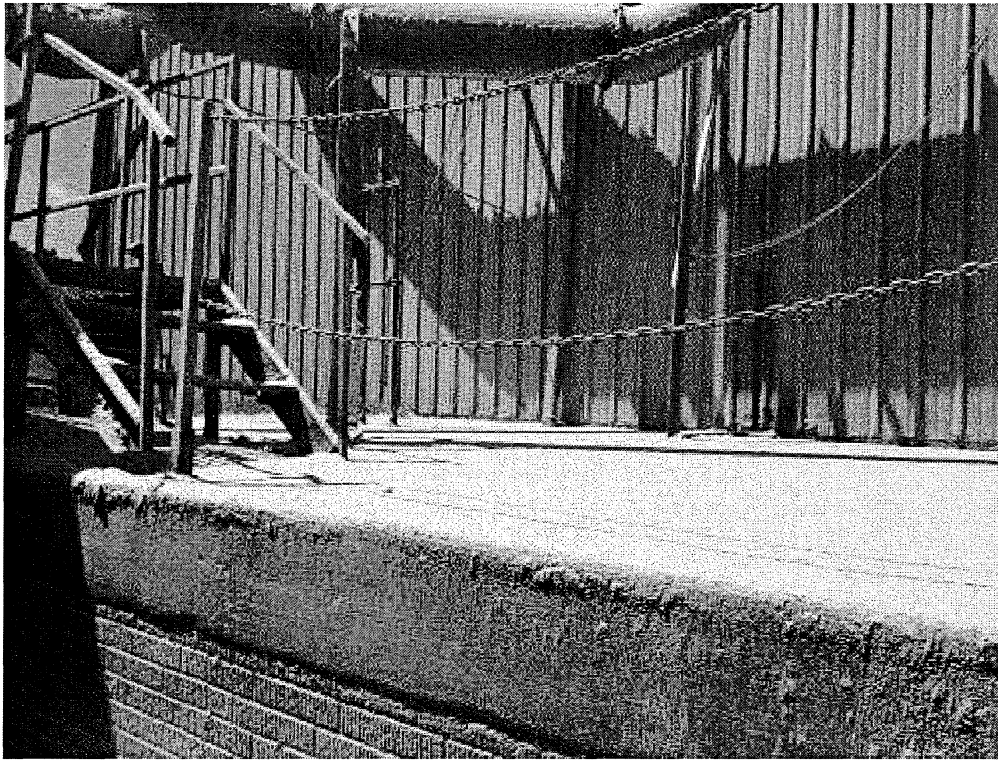
Image 10(Dust on ground) : Dust on ground near fuel handling baghouse

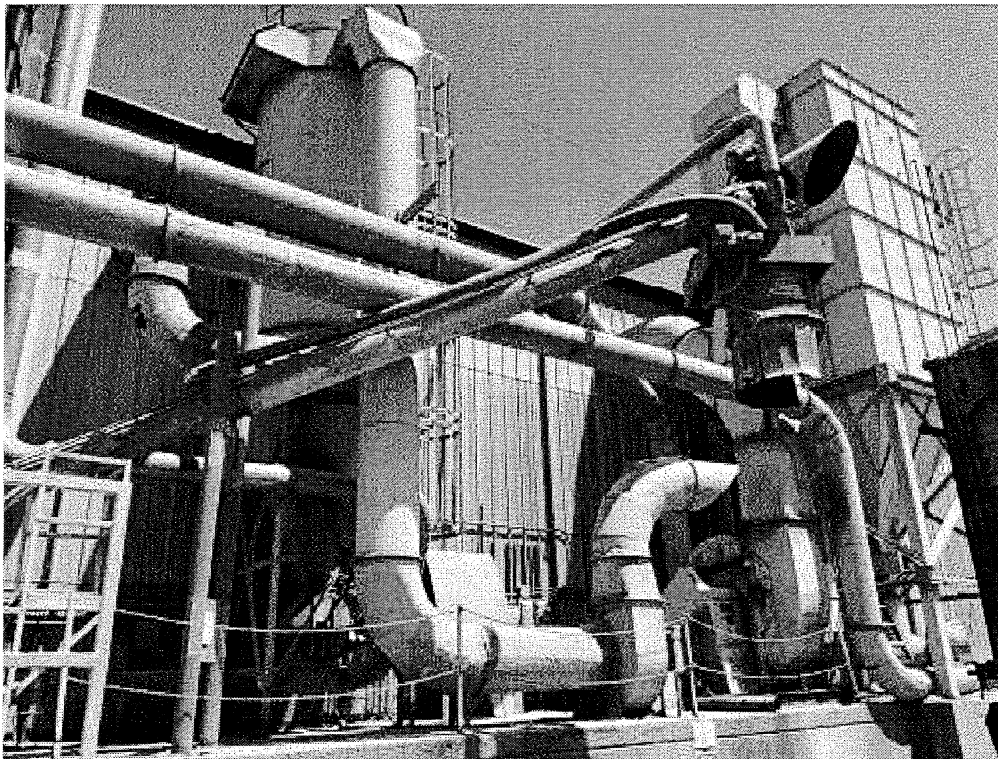
**Image 11(Bag houses)** : 2 bag houses. Exhaust is horizontal.

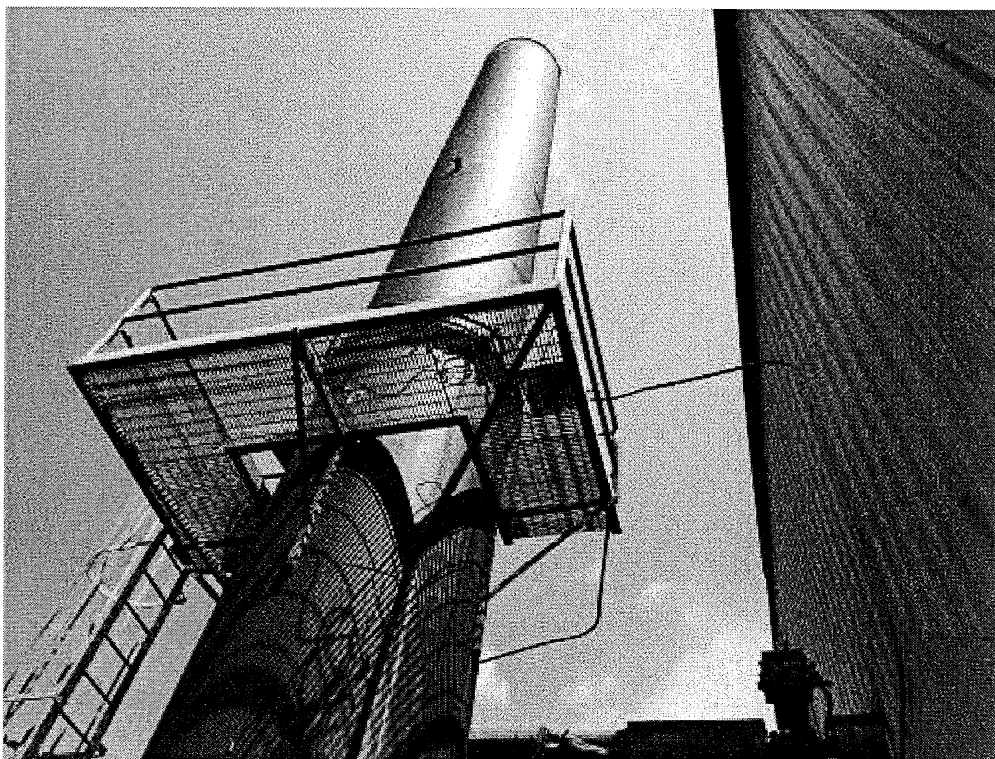
While walking back to the office, I observed the wood boiler exhaust stack. The permit requires the exhaust stack from the boiler to have a maximum diameter of 69 inches at an exit point not less than 65 feet above ground level and exhaust vertically upwards. The dimensions of the stack were confirmed as part of conducting the stack test in 1986 and appeared to that high visually. Opacity of the exhaust smoke was observed to be between 5 to 10%.

**Image 12(Boiler exhaust)** : Boiler exhaust stack
