**DEPARTMENT OF ENVIRONMENTAL QUALITY
AIR QUALITY DIVISION
ACTIVITY REPORT: Scheduled Inspection**

FACILITY: The Andersons Webberville Operation		SRN / ID: N0863
LOCATION: 2690 STOCKBRIDGE RD, WEBBERVILLE		DISTRICT: Lansing
CITY: WEBBERVILLE		COUNTY: INGHAM
CONTACT: Mike Rumsey , Area Operations Manager		ACTIVITY DATE: 08/21/2019
STAFF: Michelle Luplow	COMPLIANCE STATUS: Compliance	SOURCE CLASS: MINOR
SUBJECT: scheduled, unannounced inspection of The Andersons under PTI's 758-90A and 704-84A		
RESOLVED COMPLAINTS:

Purpose

Conduct an unannounced, scheduled inspection to determine compliance with The Andersons Permit to Install (PTI) Nos. 758-90A and 704-84A. This facility was last inspected in April 2012.

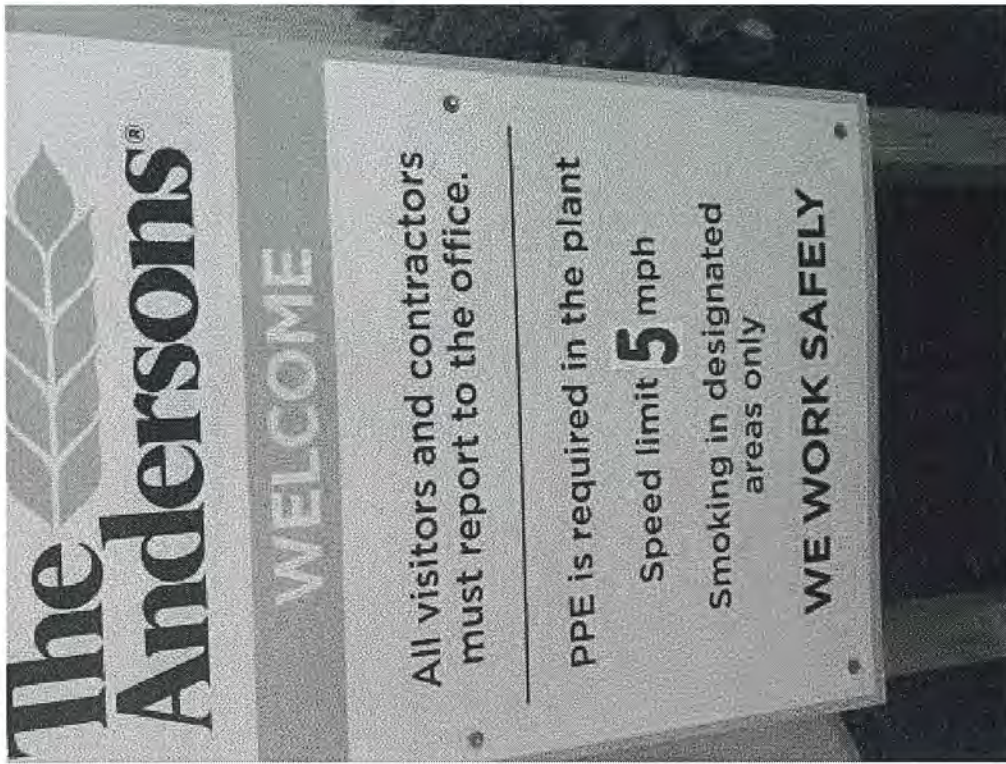
Upon entering the site, I saw a speed limit sign posted for 12 mph. I made M. Rumsey aware of this requirement and he explained that corporate had sent these signs out to their facilities to regulate truck speed. I gave the option of requesting a modification to the permit, or modifying the speed limit signs throughout the sign from 12 mph to 8 mph. M. Rumsey said he word order number stickers to change the posted speed limit from 12 mph to 8 mph. In follow-up he sent me a photo of one of the updated speed limit signs – The Andersons has changed their speed limit sign from 12 mph to 5 mph, to match the 5 mph truck speed requirement on the truck scale (see attached photo).

Image 1(Speed Limit) : Changed speed limit from 12 mph to 5 mph
