DEPARTMENT OF ENVIRONMENTAL QUALITY  
AIR QUALITY DIVISION  
ACTIVITY REPORT: Scheduled Inspection

N089554697

<b>FACILITY:</b> LACKS INDUSTRIES INC		<b>SRN / ID:</b> N0895
<b>LOCATION:</b> 4260 AIRLANE SE, KENTWOOD		<b>DISTRICT:</b> Grand Rapids
<b>CITY:</b> KENTWOOD		<b>COUNTY:</b> KENT
<b>CONTACT:</b> Jim Morrissey , General Manager		<b>ACTIVITY DATE:</b> 08/18/2020
<b>STAFF:</b> April Lazzaro	<b>COMPLIANCE STATUS:</b> Non Compliance	<b>SOURCE CLASS:</b> MAJOR
<b>SUBJECT:</b> Announced, scheduled inspection.		
<b>RESOLVED COMPLAINTS:</b>

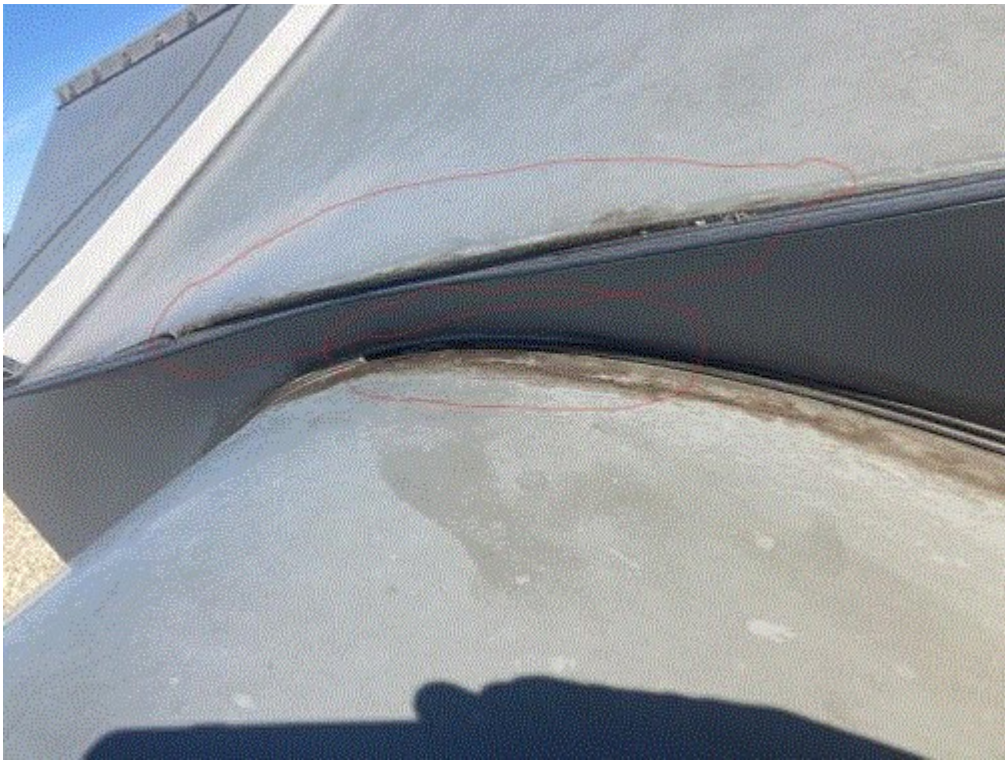
I continued to listen for sounds that are cues of air leaks in the ductwork. I paused at the ductwork inlet to the scrubber as I noted a noise there. I pointed it out to Lacks representatives who thought the sound came from the scrubber observation port that consists of a somewhat loose plexiglass cover. I stated that I wasn't convinced that the observation port was the cause of the noise I heard, so I asked that Lacks get a ladder so we can look up on top of the unit where the ductwork attaches to the scrubber body. Mr. Greiner from maintenance climbed up the ladder first and reported that there was, in fact, a problem and air infiltration occurring. I climbed the ladder as well and found that the top of the scrubber where the walls connect had separated. The seams were worn and there was some minor staining indicative of chromic acid. There was also separation of the ductwork into the body of the scrubber itself. These two breaches in the structure of the control device were substantial in nature. See attached photos of the two structural failures of the composite mesh pad scrubber. Lacks representatives insisted that the structural failures were not present the week before during their inspections of the unit. Based on the visual presentation of the seam and ductwork breach it would appear they had been that way for some time.

I had concerns regarding the viability of the stack test because the leakages were in between the two stack test probes. During previous testing on the Airline South equipment a similar air leak was observed, and testing was deemed invalid at that time. I contacted the supervisor of the Technical Programs Unit, Karen Kajiya-Mills, to discuss what I had just observed. Ms. Kajiya-Mills confirmed that the current, ongoing test is invalid.

**Due to the disrepair of the scrubber, and the fact that Lacks has identified that the scrubber is the method of compliance with the chrome NEHSAP, this is a violation of MI-ROP-N0895-2018a, Special Condition III.3, Rule 910 and 40 CFR 63.342(f). A Violation Notice will be issued.**

**Image 1(Chrome plate)** : Areas where two seams have separated, allowing for air infiltration on the inlet side of the hexavalent chrome plating scrubber.

**The Violation Notice will also include the requirement that Lacks modify the existing O&M Plan to increase the frequency of inspections of the scrubber from quarterly to monthly. In addition to the increased frequency, Lacks will need to modify the plan to include a checklist that identifies individual components of the scrubber for inspection. The modified plan shall also include the requirement for generating visual documentation of each component of the unit, using photographic means. Using this method with support two things: 1- that the inspections are conducted thoroughly and completely and 2- it will provide evidence of the timeframe of any structural issues that may appear over time. The modified plan should also include a training module for all Lacks staff that are conducting the inspections of the control equipment. All documentation generated during the monthly O&M inspections shall be maintained on file for a minimum of five years and made available upon request. The changes to this plan are being required by the AQD (Administrator) as allowed in 40 CFR 63.342(f) because the current plan has failed to provide for the proper operation of the affected source in a manner consistent with good air pollution control practices. If the scrubber and ductwork is replaced at some point, the requirements of the plan can be revisited.**

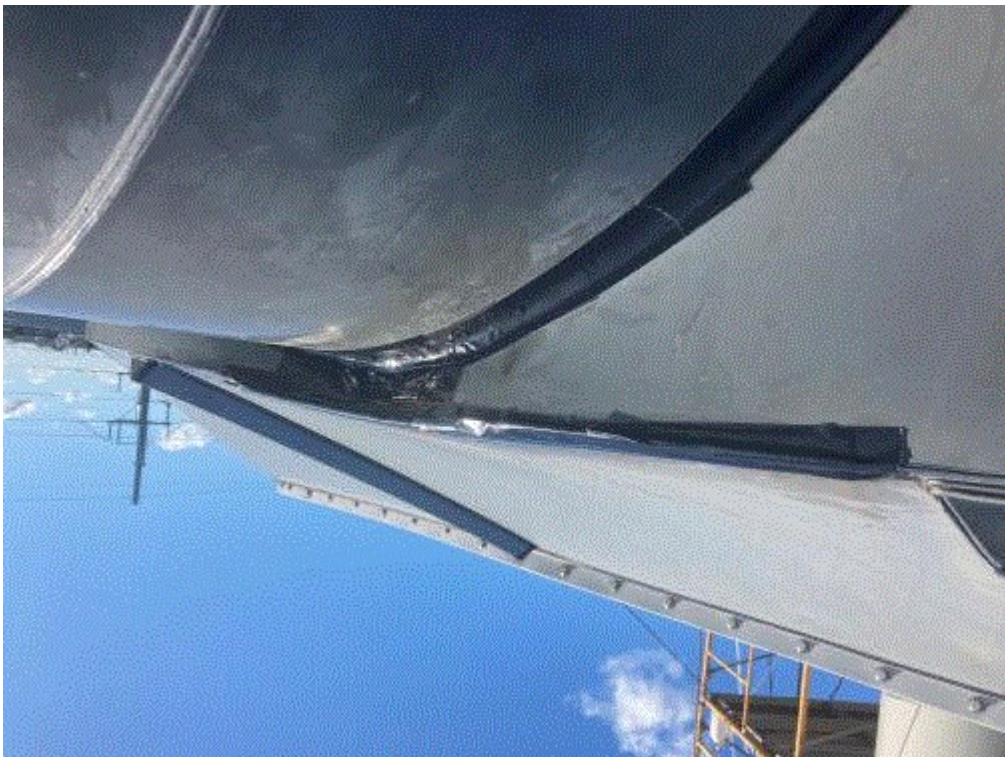
**Image 2(Chrome plate)** : Temporary repair of scrubber.

Due to the severity of the ductwork failure, it was not able to be permanently repaired with the scrubber on because the air flow was prohibiting the sealing of the rubber strips. A compromise was reached with Lacks whereby they were able to seal the ductwork and scrubber body temporarily with duct tape. (see attached photo) I inspected the seal of the tape after it was applied and found that it was sound; and it was acceptable to re-start the testing. I asked for Lacks to provide me with an update and information to confirm that the repair was conducted during the upcoming weekend downtime. I received documentation on September 3, 2020 that included photos demonstrating that the repair to the scrubber had been made.

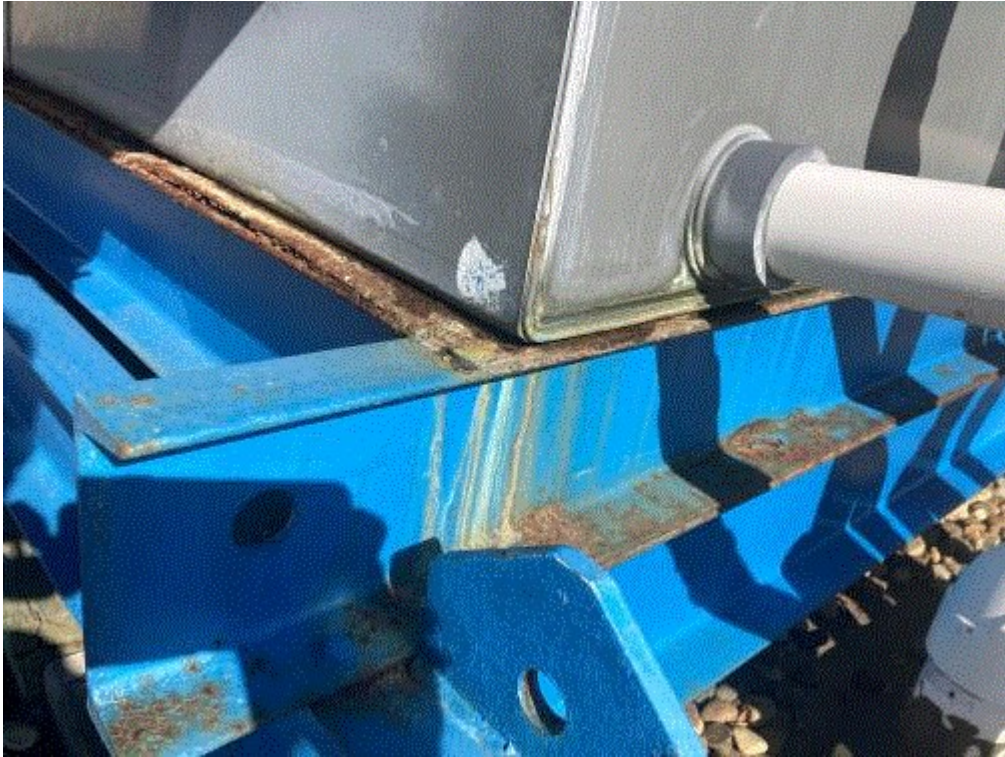
**After arrival at the facility and a brief meeting, we went to the roof to inspect the control device for EUPN-12. Stack testing for hexavalent chromium emissions from the EUPN-12 was taking place during the inspection. Run #1 of the testing had started at approximately 8:30 AM. As we approached the three-stage composite mesh pad scrubber the patches and repairs that have taken place over time were visible due to the black rubber strips that have been installed to eliminate leaks in the ductwork. (see attached photos) Standing water was observed in the bottom of each of the three stages. I inspected the scrubber exterior, using visual and auditory (sound) cues as I did so. I identified an active liquid leak from the scrubber stage one bleed off pipe that was green in nature. The leak was not new, as evidenced by the corrosion of the steel framework that was observed (see attached photos). I discussed this with Lacks representatives who indicated that the green color was likely mold. I stated that moldy water does not corrode steel framework and that due to the fact that it is coming from stage one is comprised of water containing the chromic acid from the plating solution.**

**Image 3(Chrome plate)** : Liquid leak from stage 1 of scrubber, causing deterioration of structural support.

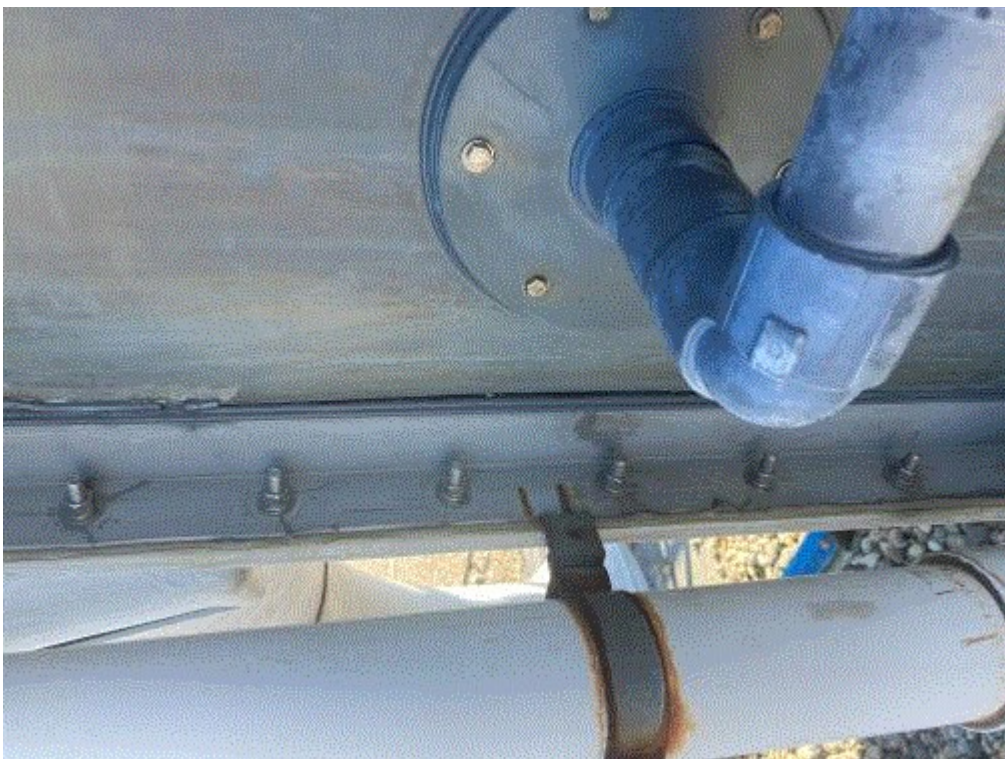
**The inspection of the chrome etch scrubber continued, using visual and auditory cues which identified a split in the seam at the front of the scrubber body, and air infiltration was occurring. (see attached photo) This breach of the seam was approximately 5' off the ground and was easily visible and heard through auditory inspection.**

**As with the chrome scrubber, Lacks representatives insisted that the structural failure of the chrome etch scrubber was not present the week before during their inspections of the unit. Based on the visual presentation of the seam and ductwork breach it would appear it had been that way for some time.**

**This is a violation of MI-ROP-N0895-2018a, Special Condition III.1 and Rule 910 which include the requirement to use, install, and operate a control device in a satisfactory manner. A Violation Notice will be issued.**

**Image 4(Chrome etch)** : Seam separation at stage 1 of chrome etch scrubber allowing for air infiltration.

requirement that Lacks modify the existing O&M/Malfunction Abatement Plan to increase the frequency of inspections of the scrubber from quarterly to monthly. In addition to the increased frequency, Lacks will need to modify the plan to include a checklist that identifies individual components of the scrubber for inspection. The modified plan shall also include the requirement for generating visual documentation of each component of the unit, using photographic means. Using this method with support two things: 1- that the inspections are conducted thoroughly and completely and 2- it will provide evidence of the timeframe of any structural issues that may appear over time. The modified plan should also include a training module for all Lacks staff that are conducting the inspections of the control equipment. All documentation generated during the monthly O&M/Malfunction Abatement Plan inspections shall be maintained on file for a minimum of five years and made available upon request.

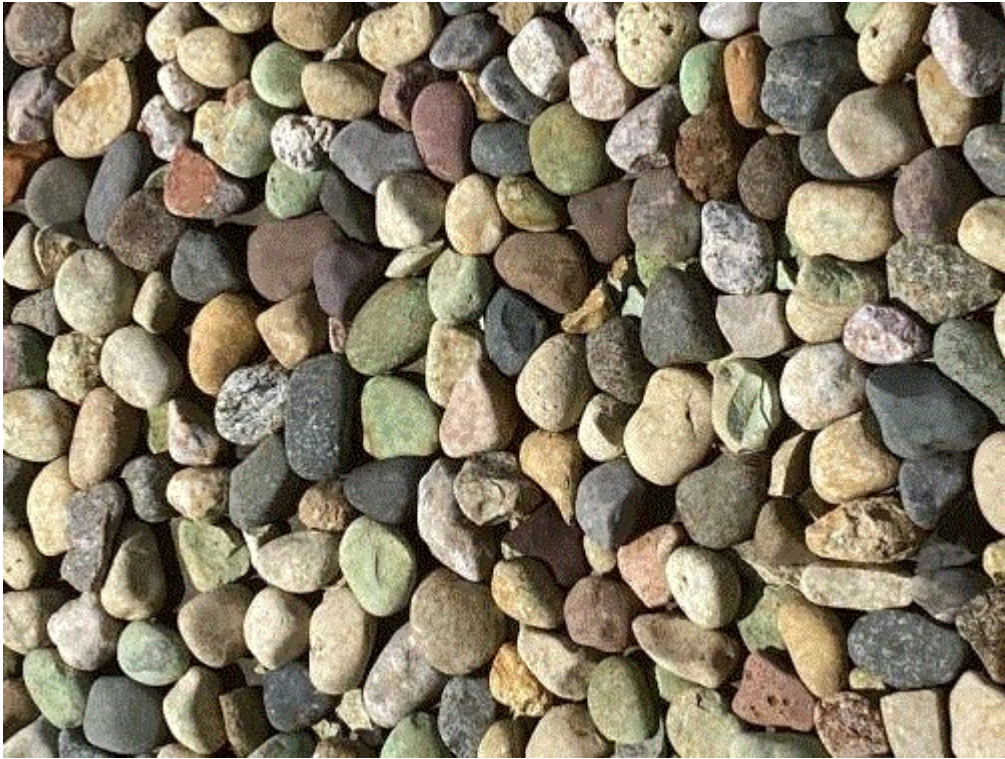
All other control devices in FGN-1 were visually inspected while on the roof. No additional issues with the devices were identified during the visual inspection. There were two items of note. New paint was identified on one of the scrubbers on the east side of the roof. This should be closely monitored during future inspections. Also, it is noted that the rubber roof is covered with stones. These stones vary in color, but quite a few of them are shades of white. As we approached the EU-PN6 scrubber which controls the electroless copper plating tanks, I noted something different about the stones. The white stones surrounding this unit were green in color (see attached photo). I picked up a few of the white stones to find that the undersides of them were still white, with some visible "dripping" of green down the sides. I pointed this out to Ms. Baweja. At the time of the inspection there were no green emissions noted. I later discussed this phenomenon with Mr. Greiner. He indicated that there is a green powder that they put in the tanks on the weekend, and perhaps there was an issue with that sometime in the past. This issue was to be internally investigated. In the Violation Notice, AQD will request that Lacks report on the findings of this investigation.

**Image 5(Electroless copper)** : Green stained rocks near electroless copper scrubber.
