DEPARTMENT OF ENVIRONMENTAL QUALITY  
AIR QUALITY DIVISION  
ACTIVITY REPORT: On-site Inspection

N089558291

<b>FACILITY:</b> LACKS INDUSTRIES INC		<b>SRN / ID:</b> N0895
<b>LOCATION:</b> 4260 AIRLANE SE, KENTWOOD		<b>DISTRICT:</b> Grand Rapids
<b>CITY:</b> KENTWOOD		<b>COUNTY:</b> KENT
<b>CONTACT:</b> Karen Baweja , Supervisor of Air Quality		<b>ACTIVITY DATE:</b> 05/27/2021
<b>STAFF:</b> April Lazzaro	<b>COMPLIANCE STATUS:</b> Compliance	<b>SOURCE CLASS:</b> MAJOR
<b>SUBJECT:</b> Partial Compliance Evaluation of Airplane North Plater.		
<b>RESOLVED COMPLAINTS:</b>

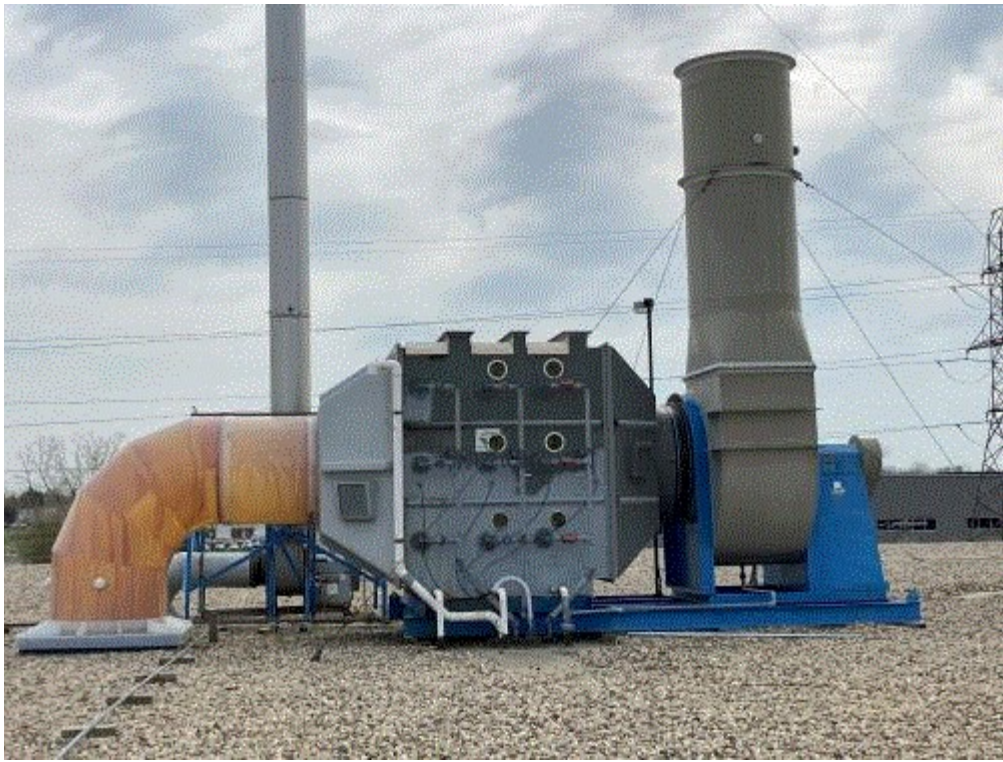
**EUPN-10 consists of three chrome etch tanks, one etch regeneration unit and one evaporator/reclaim unit controlled by a composite mesh pad scrubber. Repairs to this scrubber are ongoing and occur bi-weekly due to the age of the unit. There was visible staining on the exterior of the scrubber and a horizontal support vein was not properly connected to the scrubber body. However, there were no active leaks identified. Lacks has plans to conduct significant maintenance to the unit during the July 2021 plant shutdown. I suggested that Lacks clean up the unit so it looked better, and that they would have an easier time identifying any new issues early. Lacks informed me that they were unable to clean the old stains but plan to paint the unit during the July 2021 maintenance work.**

**Image 1(EUPN-10)** : Chrome etch scrubber.

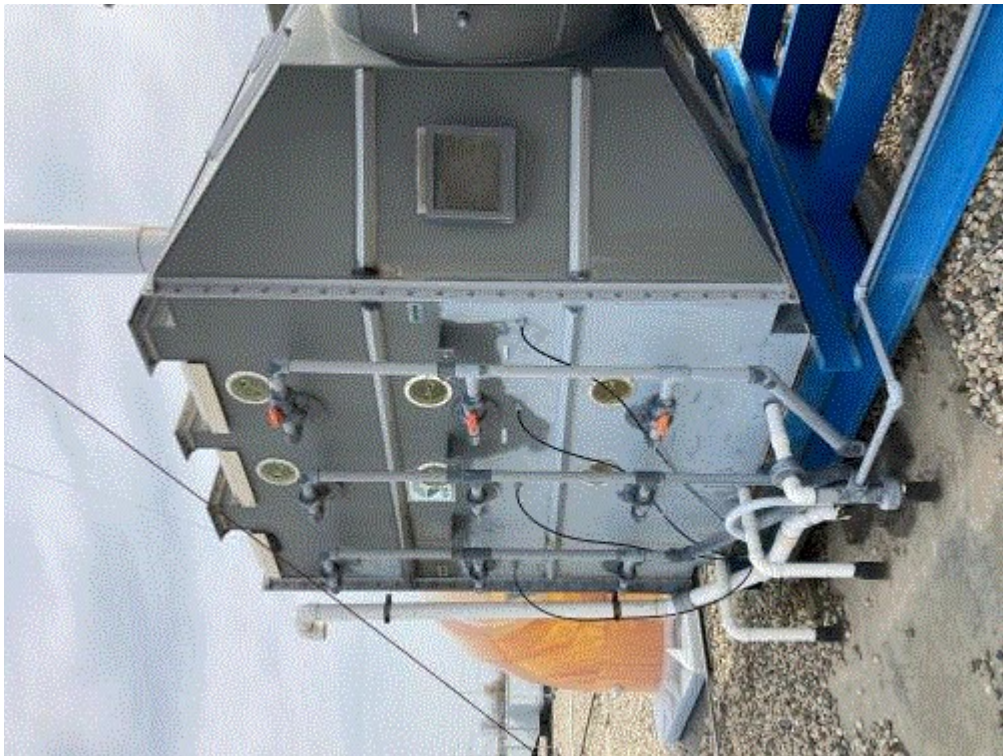
**Image 2(EUPN-10)** : Chrome etch scrubber.

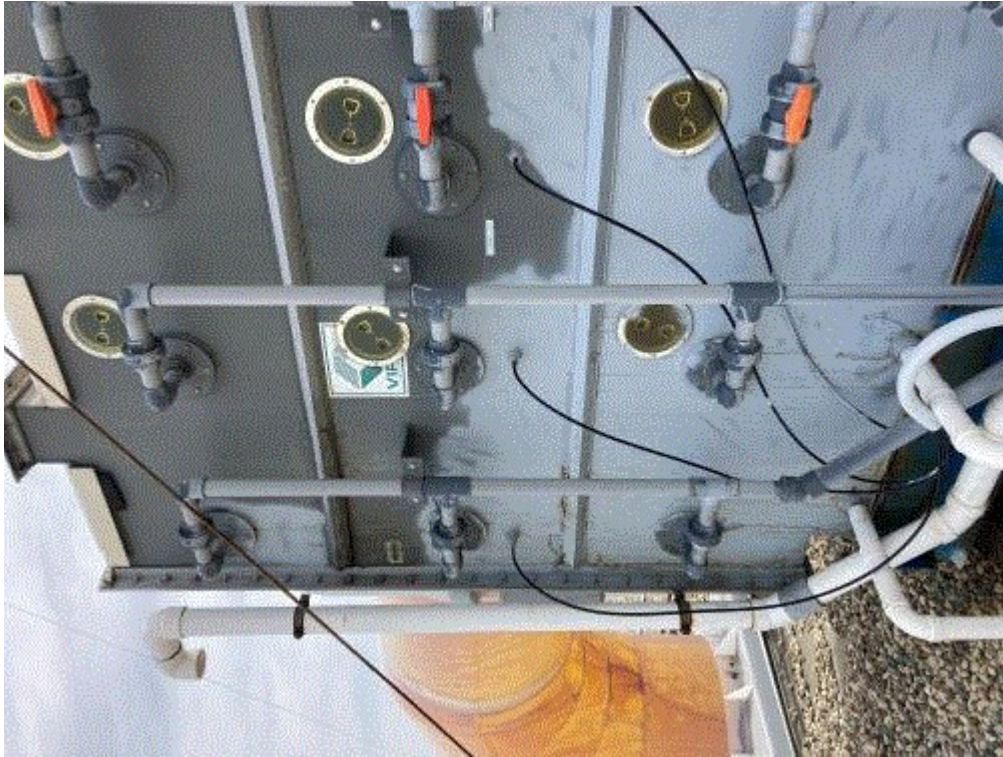
**Image 3(EUPN-10)** : Chrome etch scrubber.

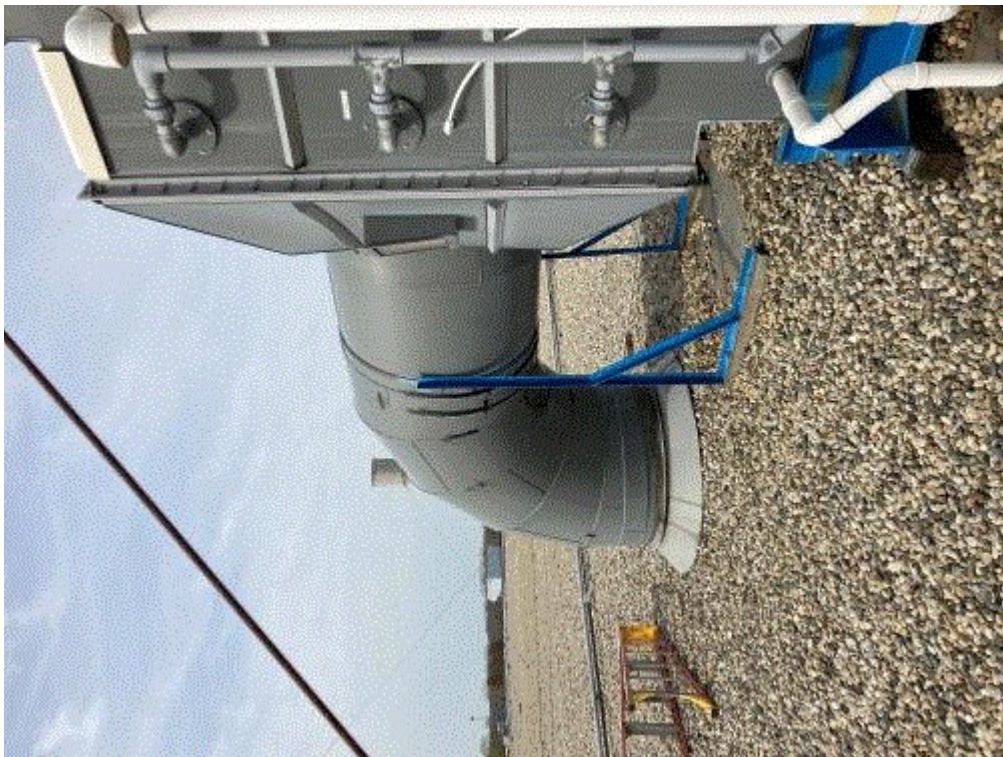
**EUPN-12 consists of three chrome plate tanks and one purification tank and one evaporator/reclaim unit controlled by a composite mesh pad scrubber. The repairs to the ductwork and scrubber body that were conducted after the 2020 compliance inspection appear to have been maintained and were still in place. I did not observe any issues in the repaired areas, nor did I identify new issues with this scrubber.**

**Image 4(EUPN-12)** : Chrome plate scrubber.

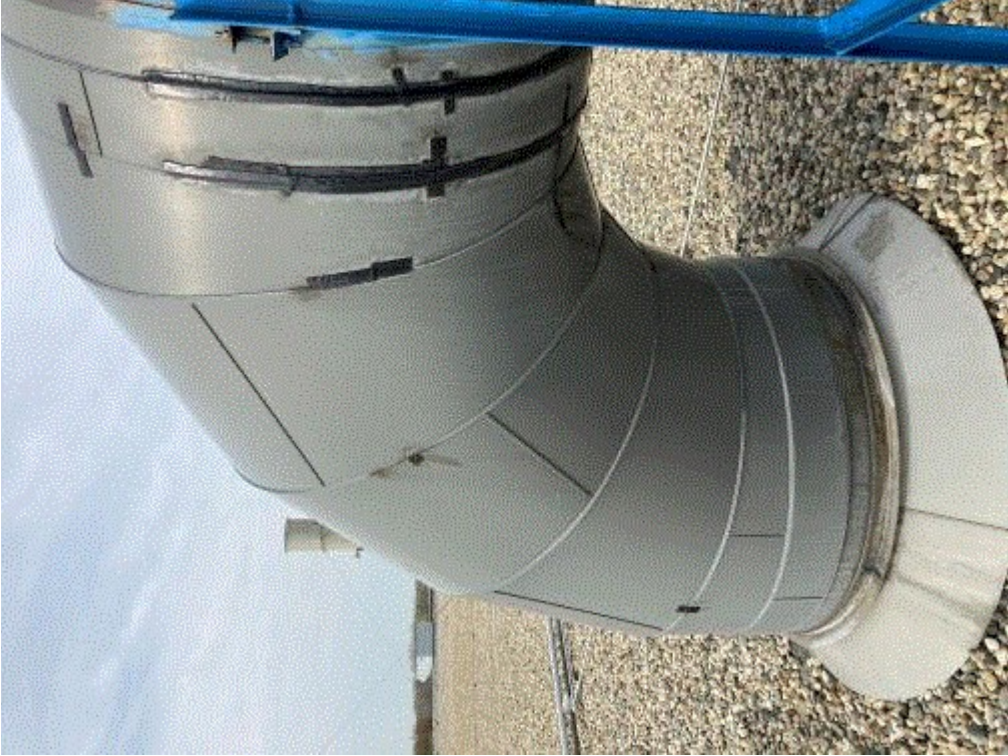
**Image 5(EUPN-12)** : Chrome plate scrubber inlet ductwork.

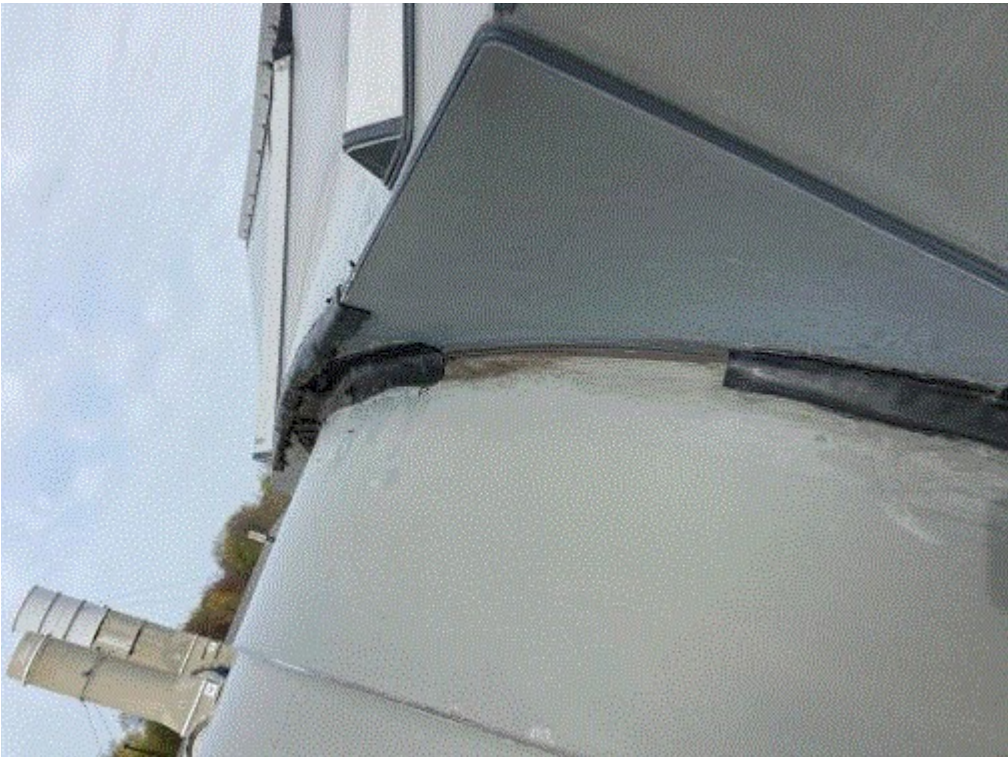
**Image 6(EUPN-12)** : Chrome plate scrubber top inlet.

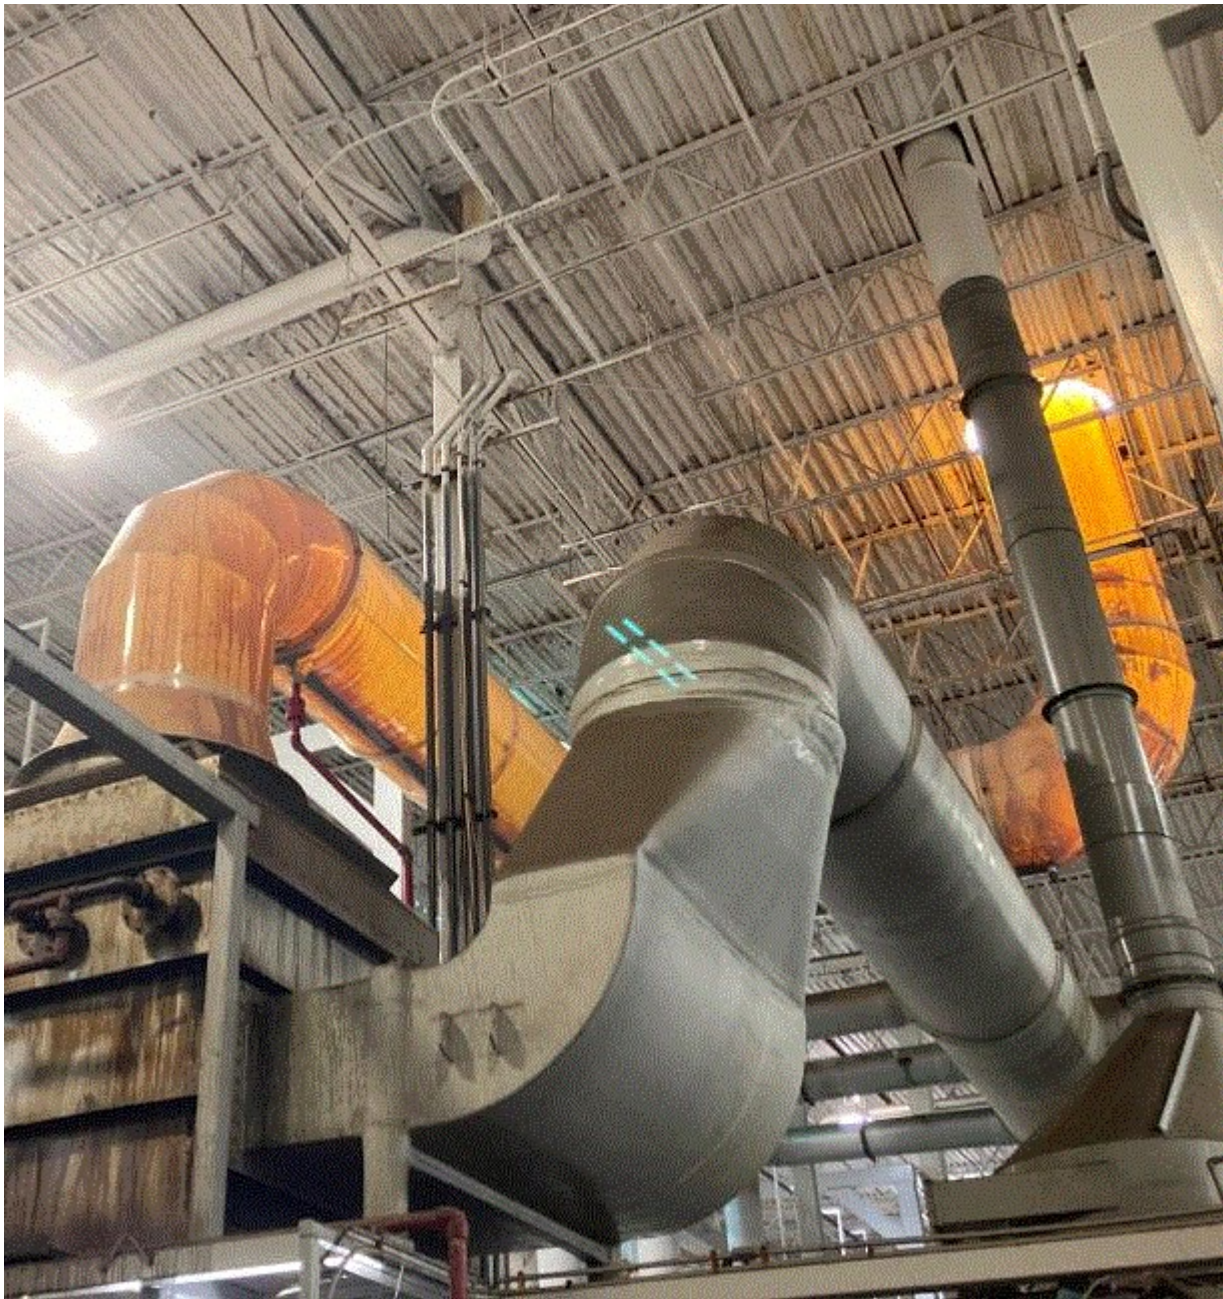
**This emission unit also has new ductwork from the evaporator/reclaim unit up to the scrubber. It is made of a transparent material called Kynar which is chemical resistant.**

**Image 7(EUPN-10) :** Photo provided by Lacks of the Kynar ductwork from the evaporator to the roof and scrubber inlet.
