**DEPARTMENT OF ENVIRONMENTAL QUALITY
AIR QUALITY DIVISION
ACTIVITY REPORT: Scheduled Inspection**

FACILITY: TRI-COUNTY CREMATION SERVICE		SRN / ID: N1374
LOCATION: 1100 E MICHIGAN, YPSILANTI		DISTRICT: Jackson
CITY: YPSILANTI		COUNTY: WASHTENAW
CONTACT: Bill Hudson , General Manager		ACTIVITY DATE: 10/25/2018
STAFF: Mike Kovalchick	COMPLIANCE STATUS: Non Compliance	SOURCE CLASS: MINOR
SUBJECT: Inspection and complaint investigation for black smoke.		
RESOLVED COMPLAINTS:

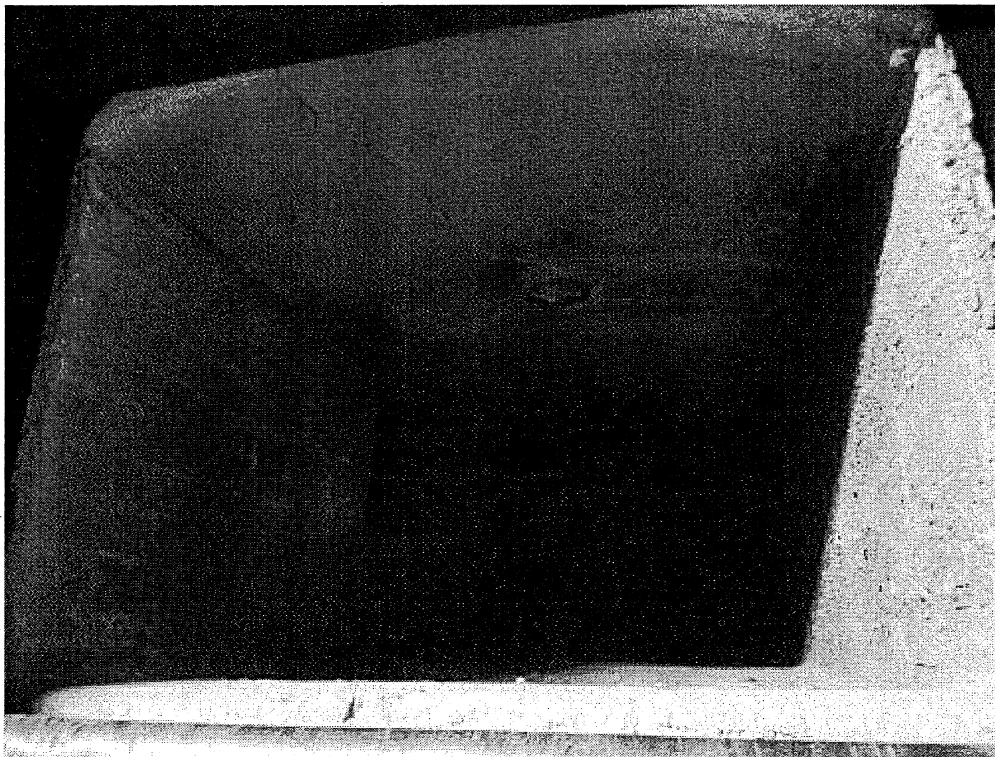
The unit is equipped with chart recorders for opacity and afterburner temperature. The control panel showed that the temperature was still about 450 degrees F. due to left-over heat from the previous day. The inside of the unit appeared to be clean and in good shape although some minor cracking of the firebrick was visible. (See attached photo.) The opacity monitor lens could be seen adjacent to the stack above the unit but below the roof.

Image 3(Crematorium unit) : Crematorium unit-inside.

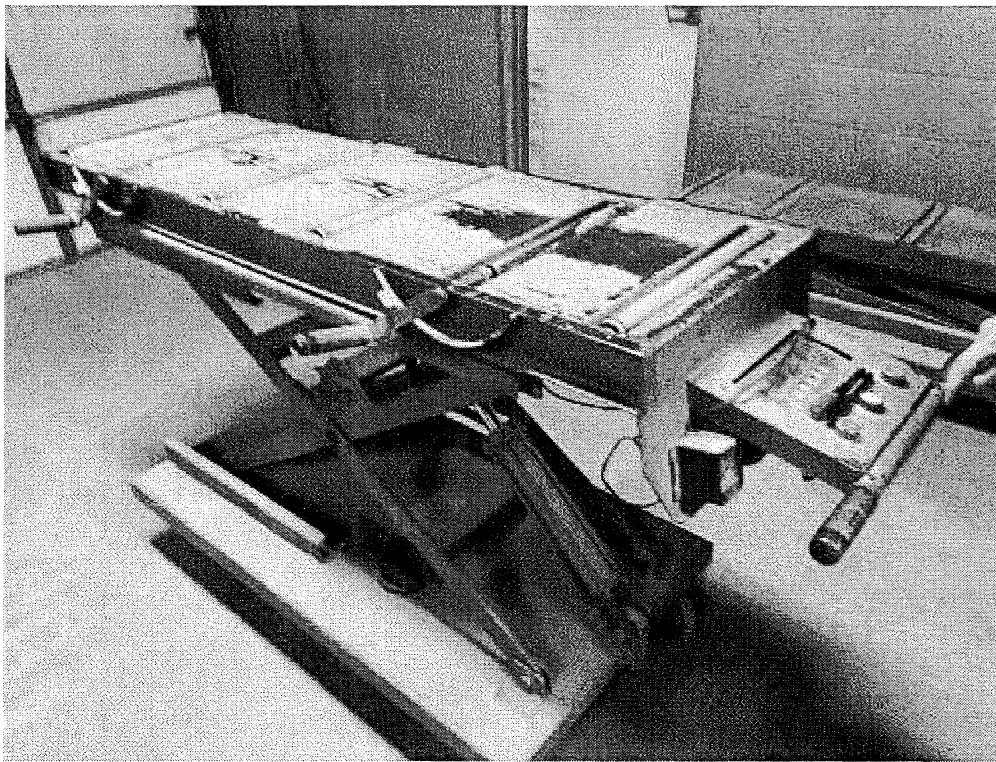
Image 4(Weight scale) : Weight scale

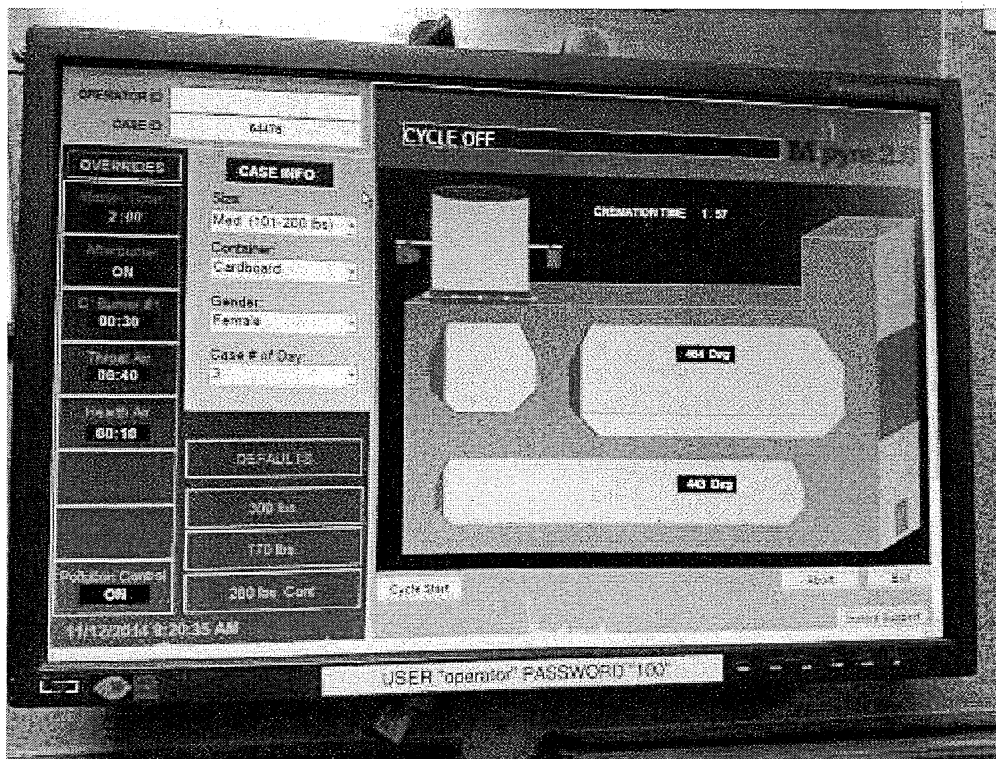
Image 5(Control panel view) : Control panel view

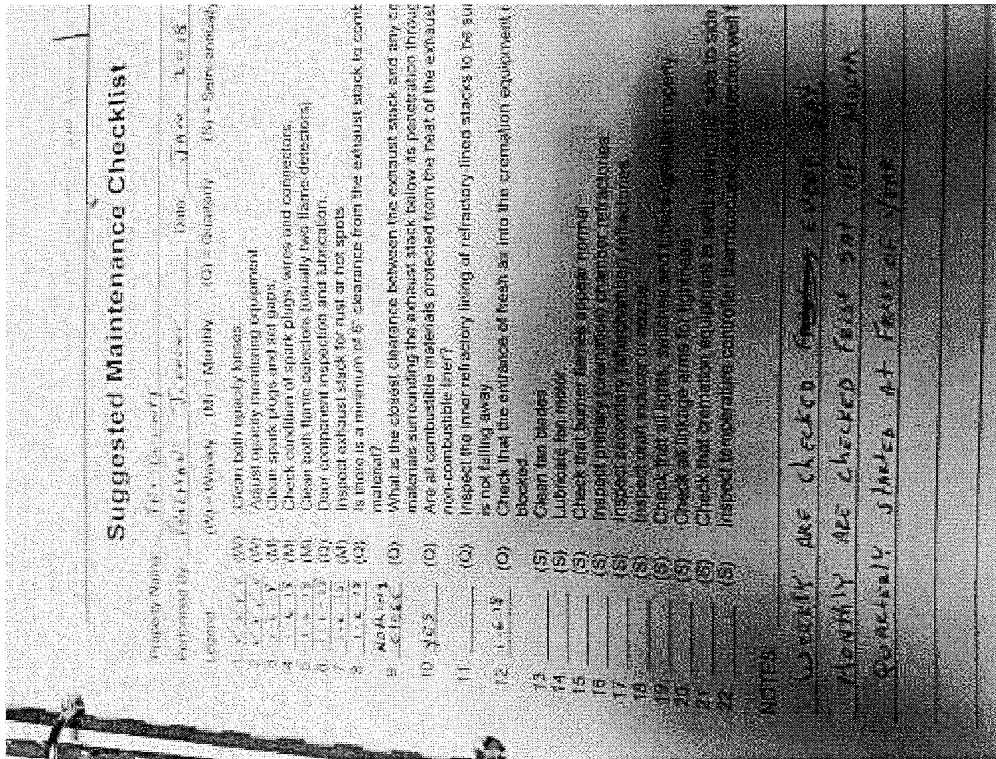
See photos of maintenance logs. Based on the log and discussions with the operator, the required quarterly inspections to check and service all equipment associated with the crematory isn't being done. Matthews International has not been out since August 2017. The operator is only able to service/inspect some of the components.

Image 6(Maintenance log) : Maintenance log

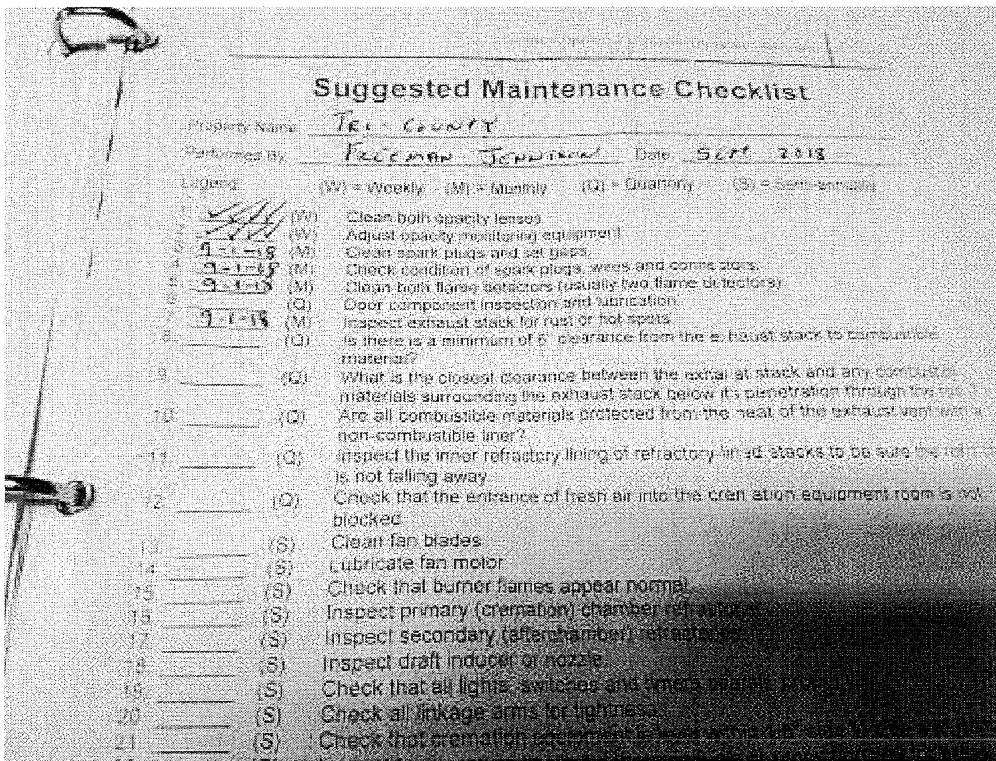
Image 7(Maintenance Log) : Maintenance Log for September

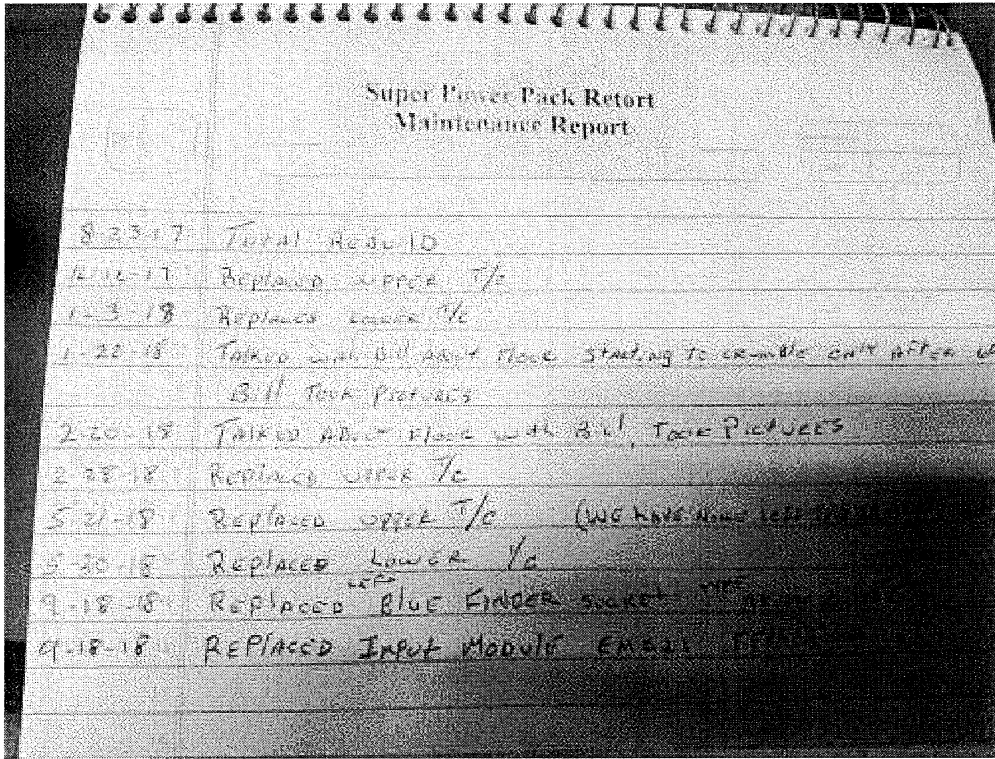
The permittee must make inspections, at least quarterly, to check and to service, as necessary, all equipment associated with EU-CREMATORY2/3. (Quarterly inspections have not been done since the crematory was rebuilt in August 2017.)

Image 8(Maintenance Report) : Maintenance Report since unit was rebuilt.
