DEPARTMENT OF ENVIRONMENTAL QUALITY  
AIR QUALITY DIVISION  
ACTIVITY REPORT: Scheduled Inspection

FACILITY: Michigan Automotive Compressor Inc.		SRN / ID: N1966
LOCATION: 2400 N. DEARING RD, PARMA		DISTRICT: Jackson
CITY: PARMA		COUNTY: JACKSON
CONTACT: Jill Yoxheimer , Senior Environmental Engineer		ACTIVITY DATE: 06/01/2017
STAFF: Mike Kovalchick	COMPLIANCE STATUS: Non Compliance	SOURCE CLASS: MAJOR
SUBJECT: Compliance inspection. The Company is out of compliance with the BOILER MACT		
RESOLVED COMPLAINTS:

### Major Source-Full Compliance Evaluation

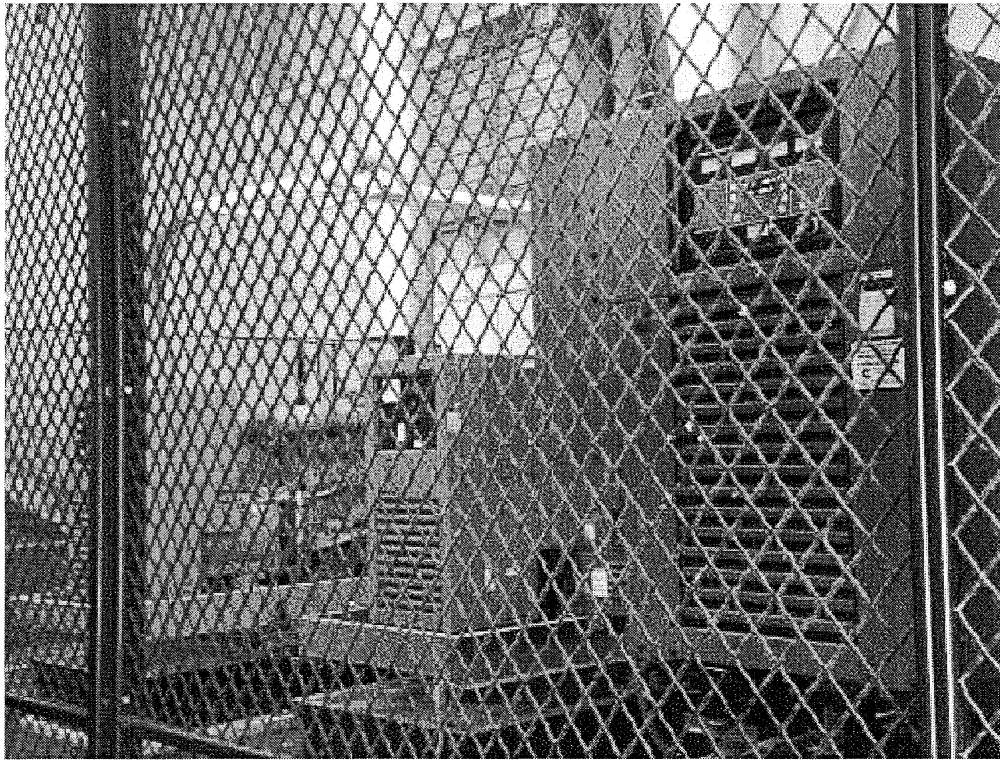
We first stopped to look at the emergency generators. 3 of the 4 emergency generators were together. AS didn't know where the 4<sup>th</sup> one was located in the building but later confirmed that it is still being used. The generators appeared to be in excellent condition. (See photo.)

**Image 2(Emergency generators)** : Some of the emergency generators

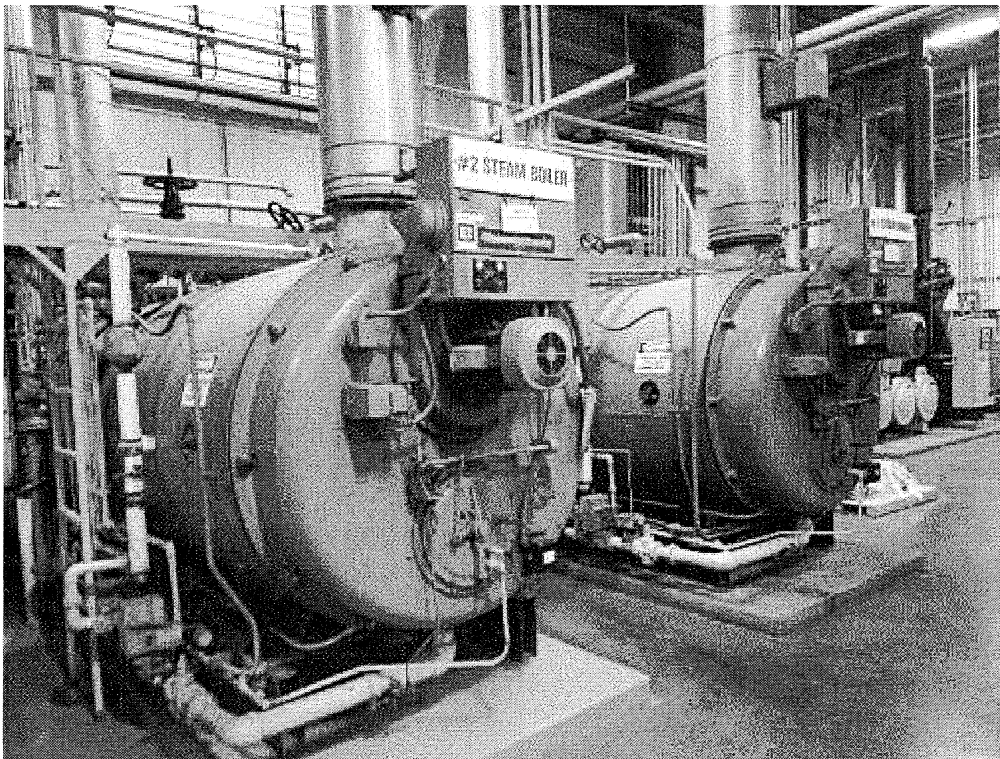
Of the 4 large boilers, EUFAC-BOILER1 and EUFAC-BOILER2 were operating. EUFAC-BOILER3 was on standby. EUFAC-BOILER4 is shut down for good. It was discovered that 8 boiler tubes needed to be replaced and the expensive was determined too expensive.

Next, we visited the powerhouses with the natural gas fired boilers were located. 2 of them were operating (#1 & #2), one was on standby(#3) with the 4<sup>th</sup> one inoperable. The active boilers all appeared to be well maintained. (See photo.)

**Image 3(Boilers)** : Boilers (from right to left 1, 2, 3)

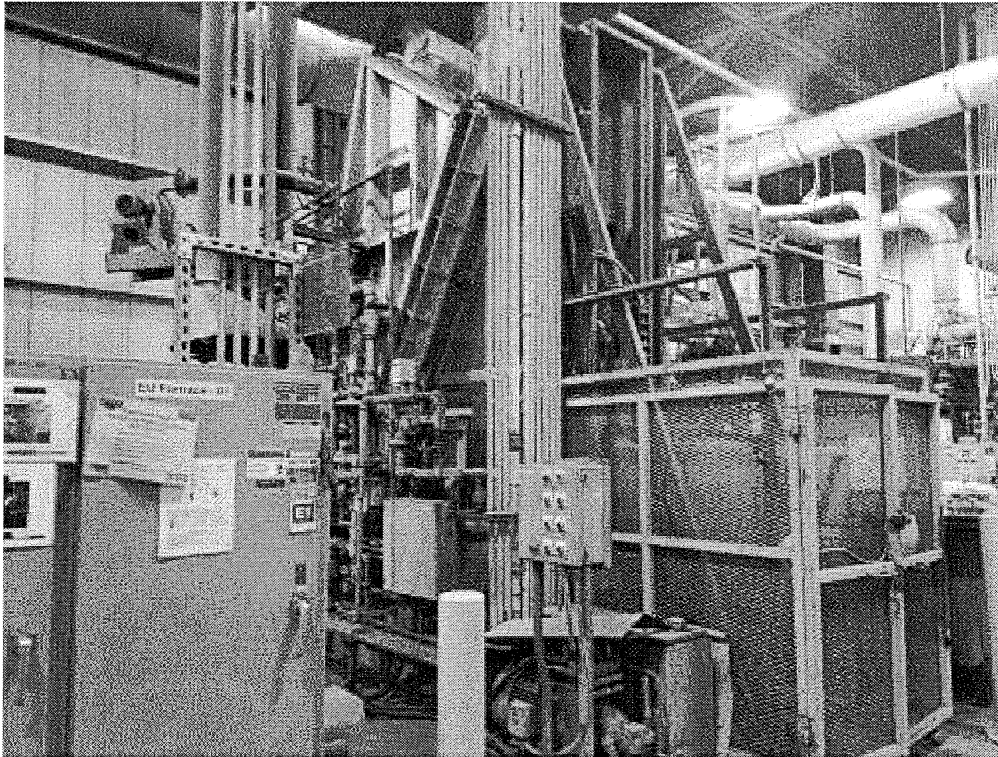
EUFURNACE1(DC-0012) is permanently shut down. (See photo.)

**Image 4(DC-0012)** : Shutdown Furnace DC-0012

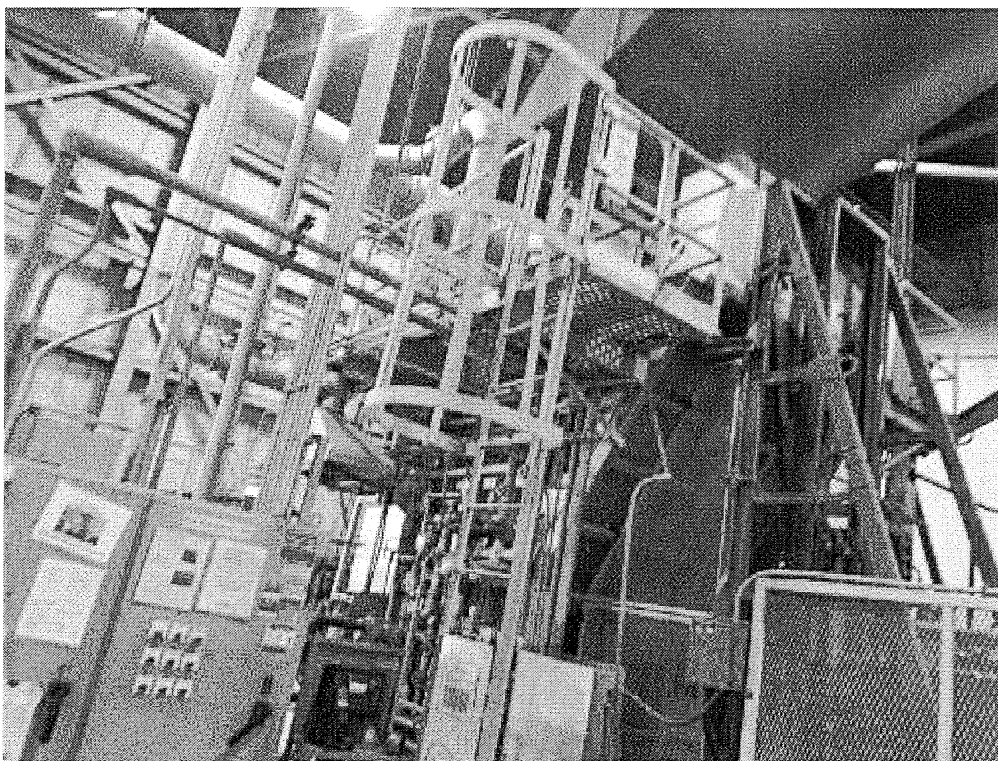
EUFURNACE3A(DC-0013) was operating showing a temperature of 1322 degrees F. No smoke was seen. (See photo.) Fluxing or pouring was not observed.

**Image 5(DC-0013)** : Furnace DC-0013

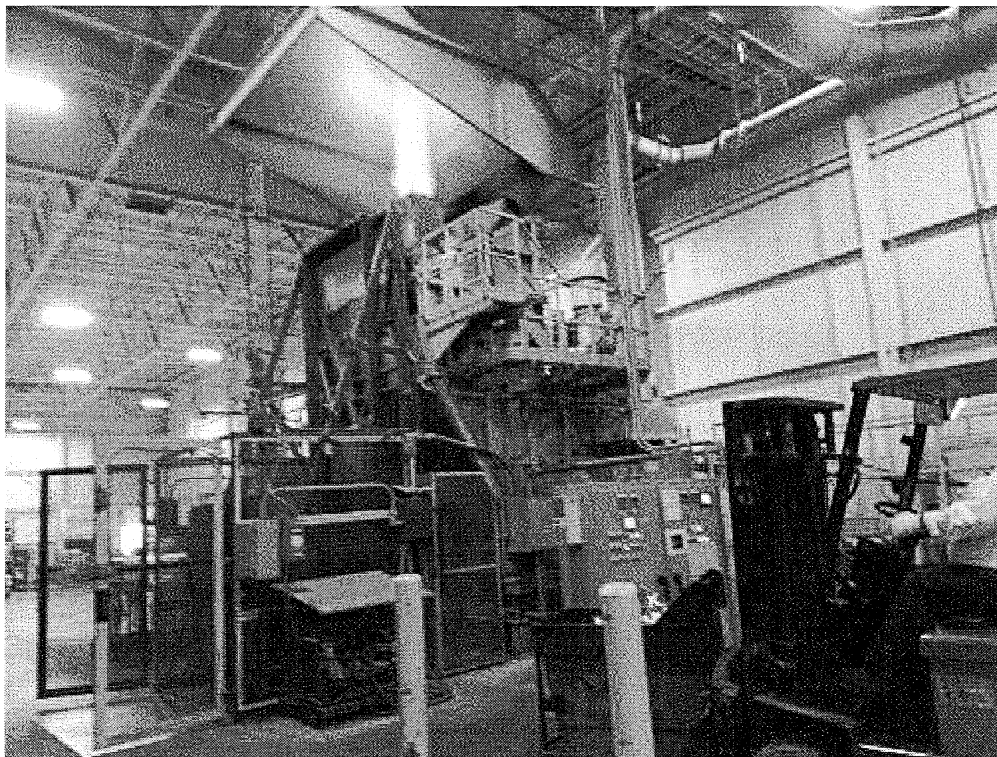
EUFURNACE5(DC-2100) was operating. The hold zone metal temperature was 1331 degrees F., and the hold zone chamber control temperature was 1489 degrees F. Initially, no smoke was observed. Some smoke was observed later when some melt was being added to the furnace. All smoke appeared to be captured by the ventilation system. (See photos.)

Image 6(DC-2100) : Furnace DC-2100

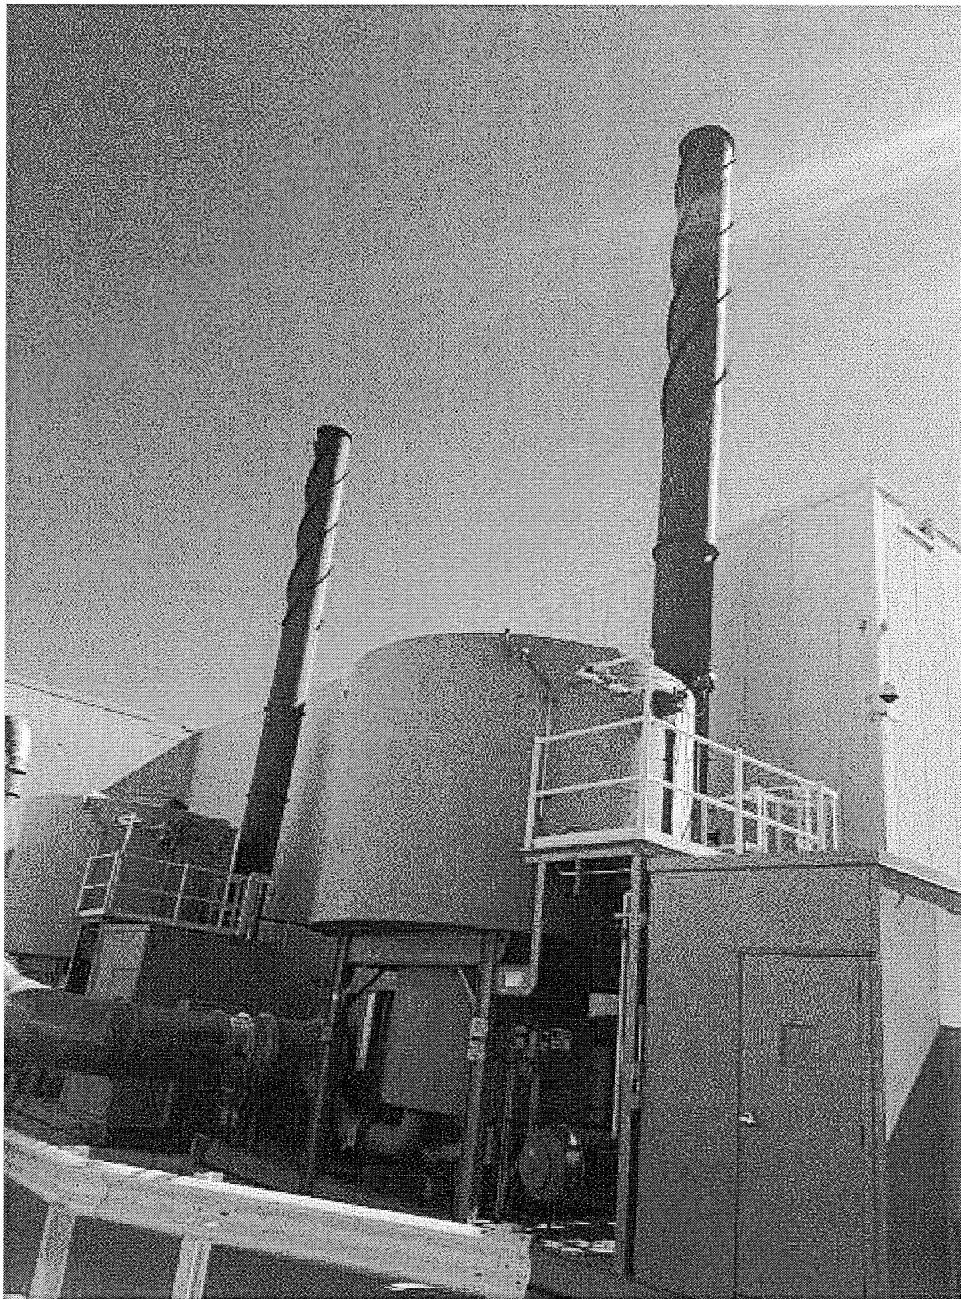
First RTO we inspected with the RTO for EUHubline 6. It was operating at a temperature of 1612 degrees F.(Limit 1550 Deg. F.) The RTO appeared to be good shape and no opacity was observed coming from the exhaust stack. (See photo. Shows RTO For EUHUBLINE 4 and the one for EUHUBLINE 4 &5)

The next RTO we inspected was for the EUHublines 4 & 5. It was operating at an instantaneous temperature of 1575 degrees F.(3 hour three- hour rolling average limit of 1550 Deg. F.) The RTO appeared to be good shape and no opacity was observed coming from the exhaust stack.

Image 7(6 and 4 & 5) : RTO for EUHUB 6 and RTO for 4 & 5

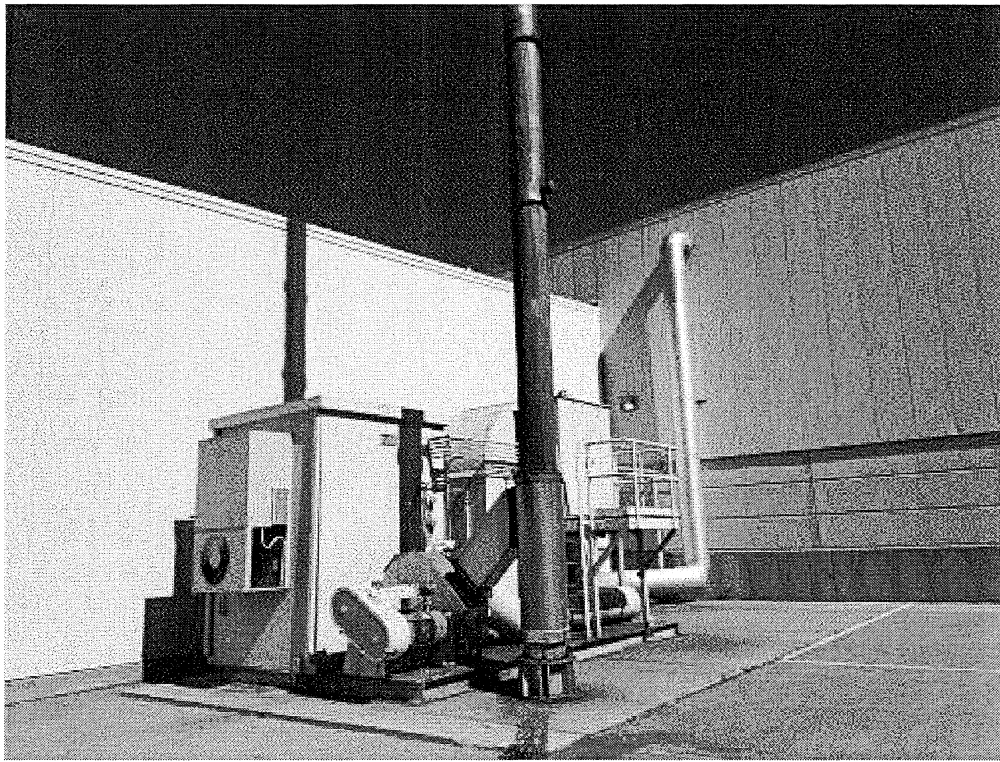
The third RTO we inspected was for the EUHubline 3. It was operating at a temperature of 1600 degrees F.(Limit 1450 Deg. F.) The RTO appeared to be good shape and no opacity was observed coming from the exhaust stack. (See photo.)

**Image 8(RTO 3) : RTO for EUHUBLINE 3**

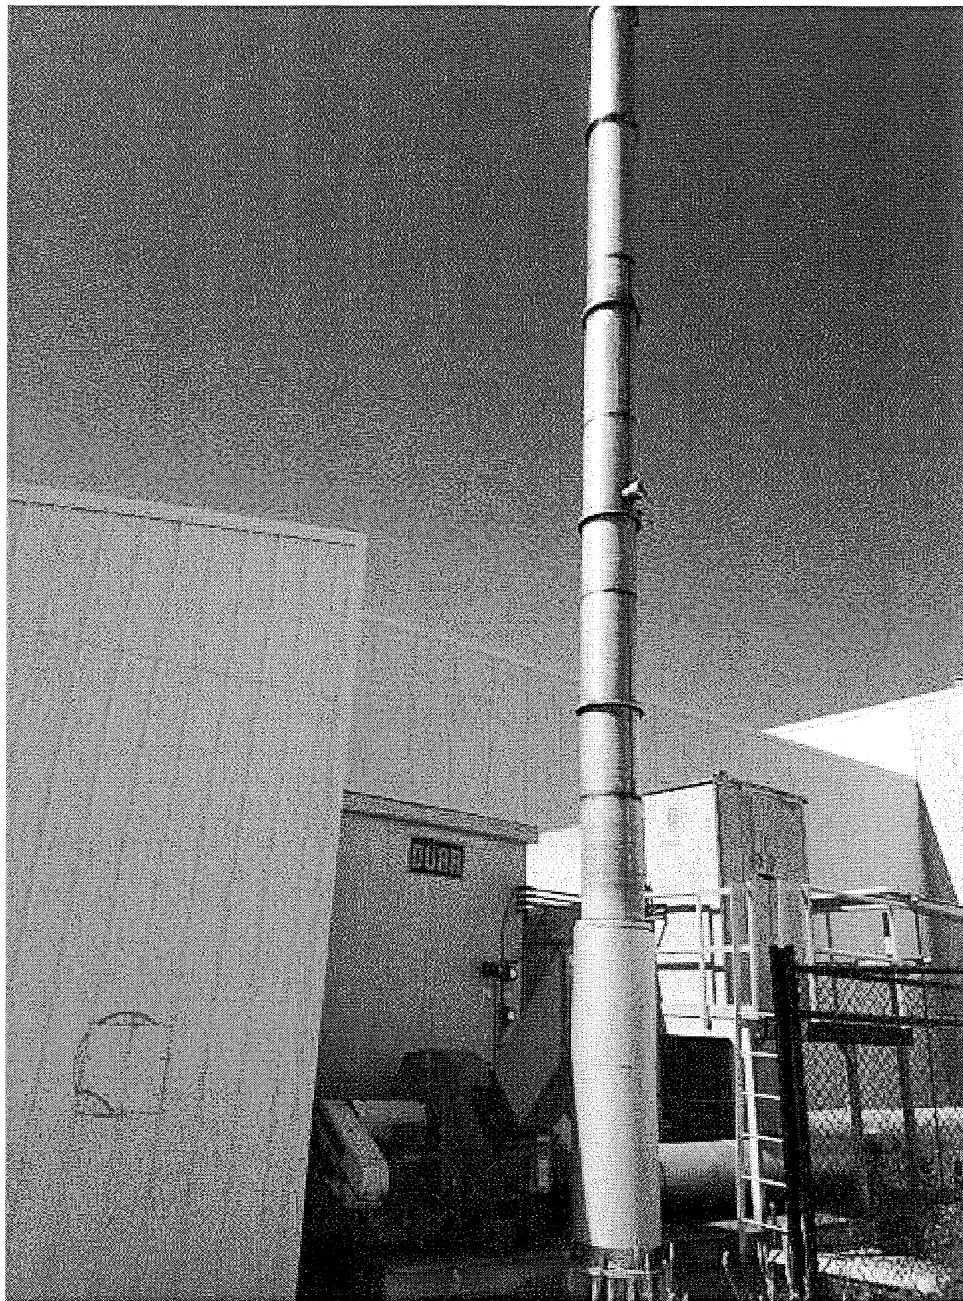
The final RTO we inspected was for EUHubline 1. It was operating at a temperature of 1558 degrees F. (Limit 1450 Deg. F.) The RTO appeared to be good shape and no opacity was observed coming from the exhaust stack. (See photo.)

**Image 9(RTO 1) :** RTO for EUHUBLINE 1

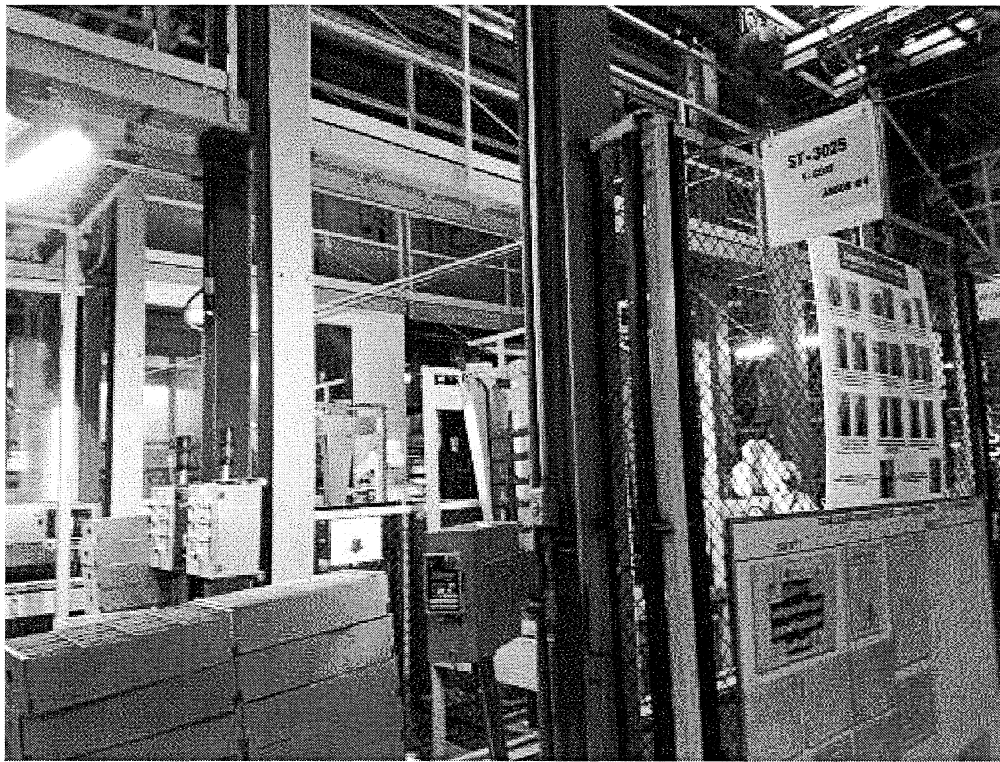
Image 10(E-Coat) : E-Coat

We next visited the E-Coat lines. (See photo.)

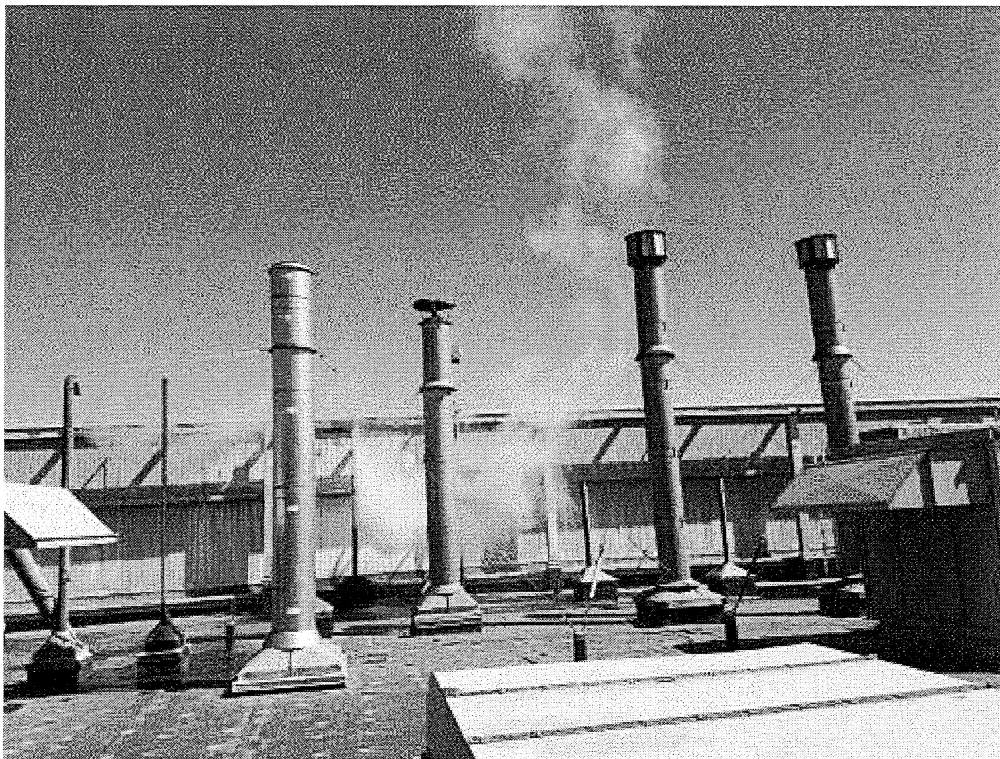
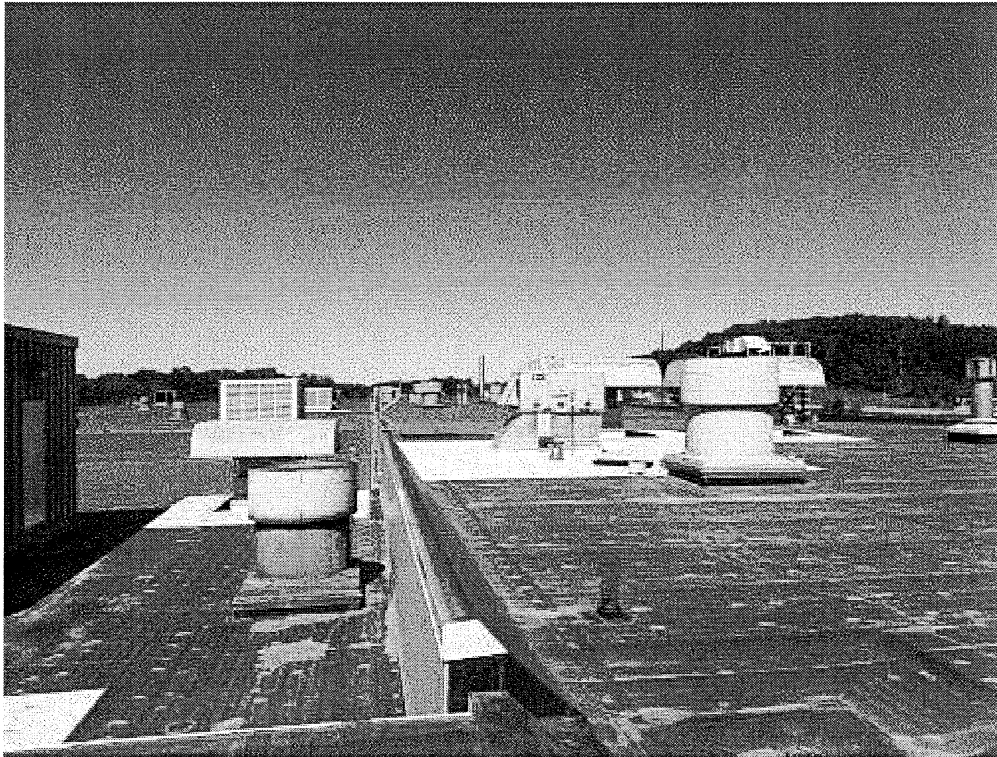
Next, we accessed the roof on the NE side of the facility via stairs inside the building. (See photos.) From there, an enclosed ladder was used to access a higher roof in order to get a view of the entire roof the facility. Overall, the roof and ventilation related equipment all appeared to be in excellent shape. No smoke was observed although what appeared to be steam was coming from a few stacks. No fallout was observed on the roof. No odors were smelled. South of my position on the roof, I observed on stack that appeared to have some black paint stains on it. (See photo.) No other findings.

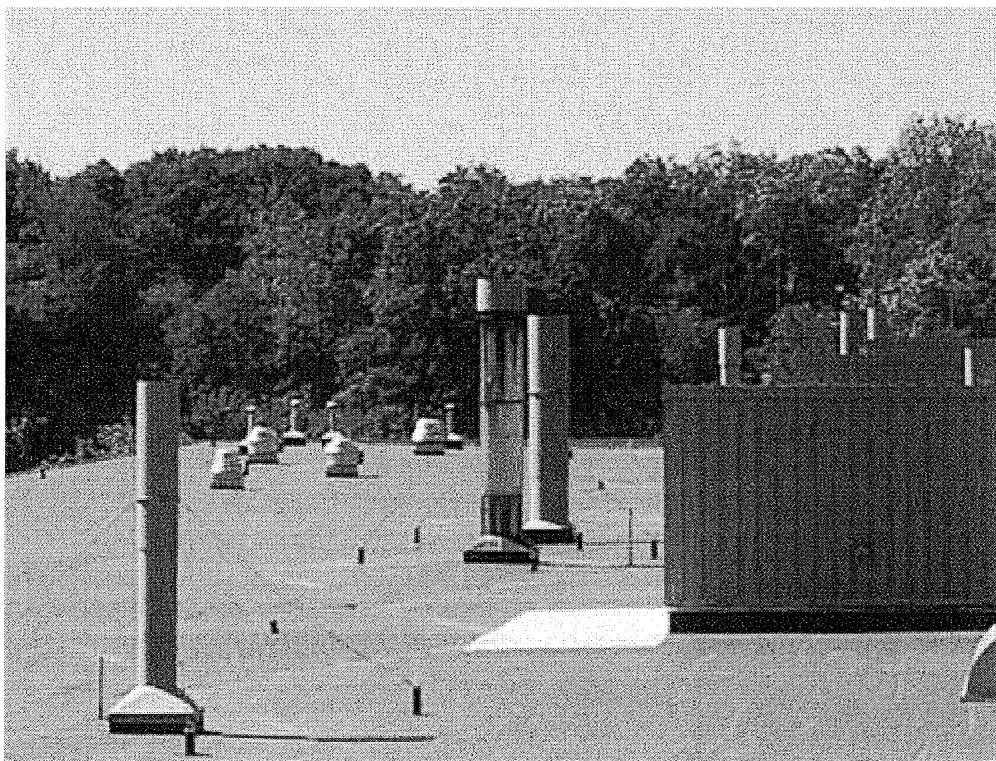
- 20) I observed one stack on the roof that appeared to have dried black paint coming down all sides of it. Please explain what caused this and how it was fixed.*

**Image 13(Paint covered stack) :** Paint covered stack

*20. The stack on the roof had a build-up coating inside the stack from several years ago. The stack was cleaned and set up on Preventative Maintenance schedule for periodic cleaning. A filter unit was also installed.*
