**DEPARTMENT OF ENVIRONMENTAL QUALITY
AIR QUALITY DIVISION
ACTIVITY REPORT: Self Initiated Inspection**

FACILITY: Advanced Disposal Services Arbor Hills Landfill Inc		SRN / ID: N2688
LOCATION: 10690 W. SIX MILE RD, NORTHVILLE		DISTRICT: Jackson
CITY: NORTHVILLE		COUNTY: WASHTENAW
CONTACT:		ACTIVITY DATE: 04/12/2019
STAFF: Mike Kovalchick	COMPLIANCE STATUS: Non Compliance	
SUBJECT: Deployed Flir E8 Infrared camera to check for hotspots at landfill.		SOURCE CLASS: MAJOR
RESOLVED COMPLAINTS:

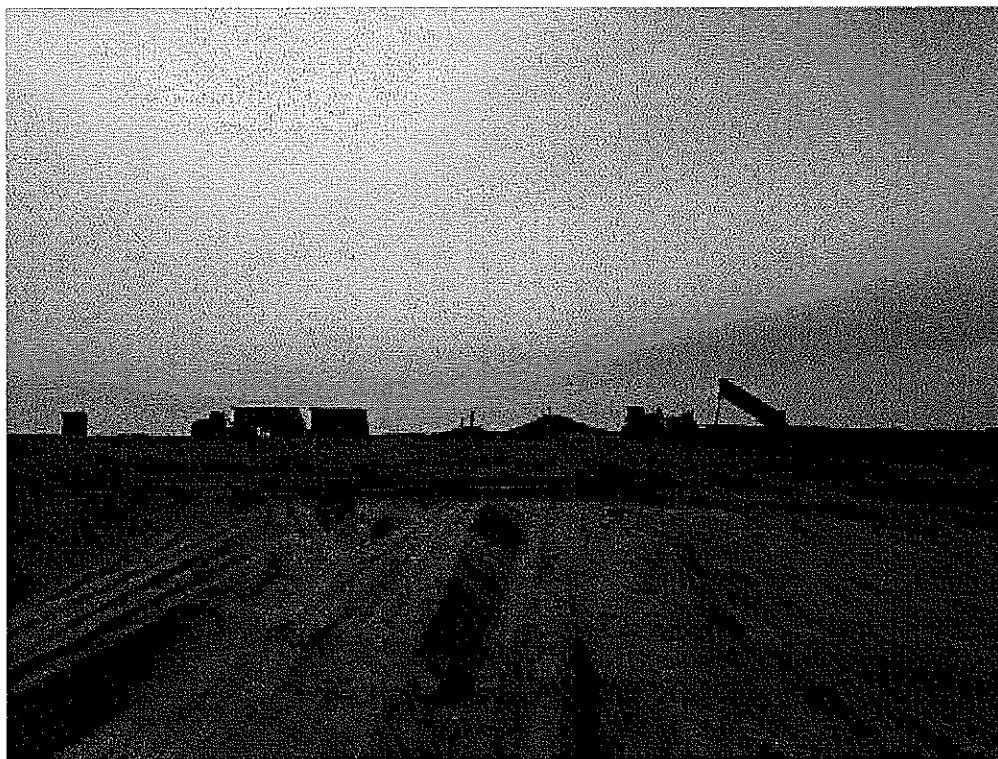
At the top, they were actively grading over the area so that it looked vastly different than the previous visit. I even noticed that entire shape of the hill had changed as viewing from Beck/5 mile road area. This area is being graded over to help with storm water runoff and also in preparation to lay pipes down on the ground. After getting a flat tire to our truck fixed, we headed down to the South side of the landfill to view TS-01. While headed that way, Mark outlined a number of leachate issues. In the last couple of days, the whole leachate collection system had been shutdown for one day due to blockage in the outlet pipe. Somewhere in the pipe, is a narrow area. An

Image 1(Top of landfill) : New grading of top of landfill.

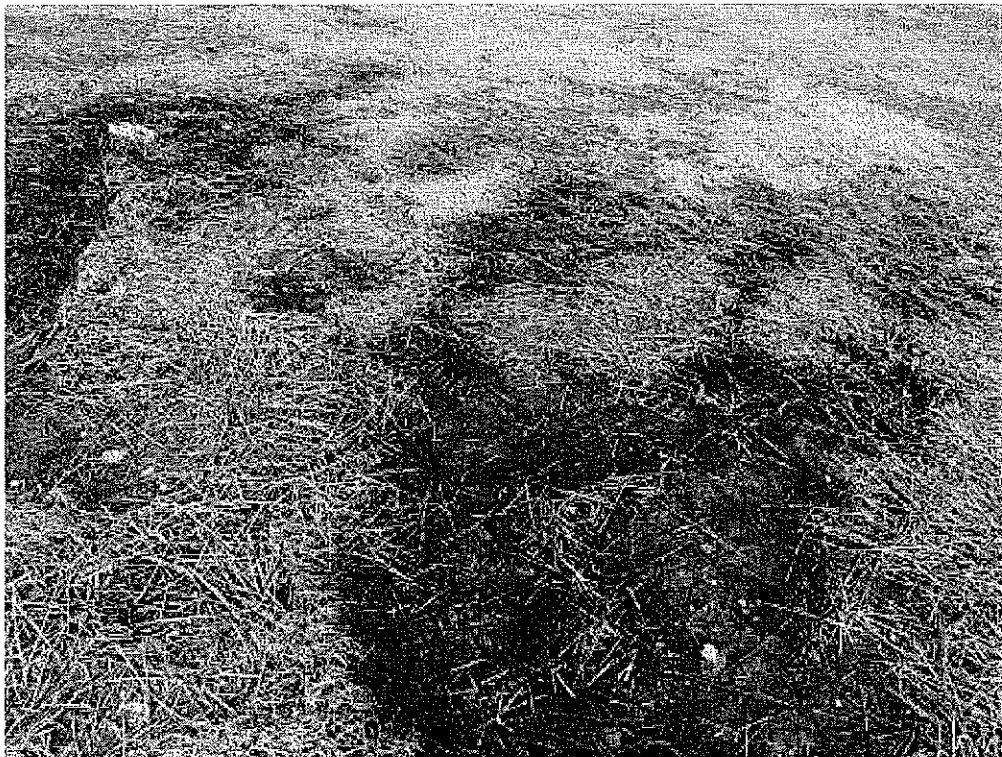
Image 3(New leachate seep) : New leachate seep North side.

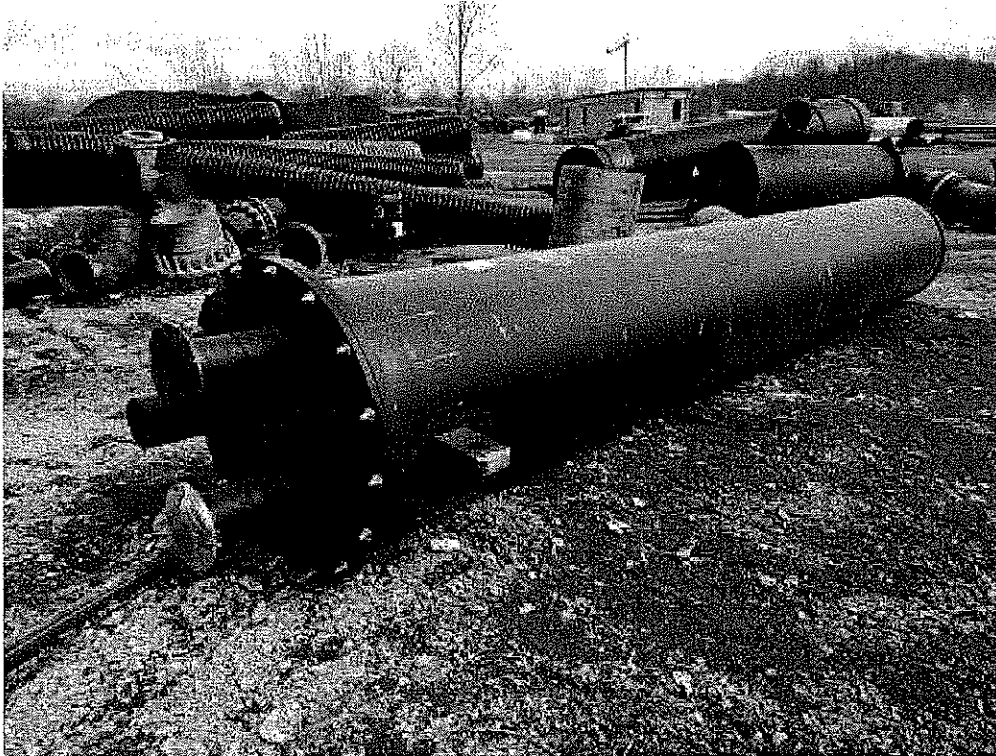
We arrived at TS-01. It was very active. Leachate had once again overwhelmed the pump and was close to breaching the small leachate dams. I could see actively flowing from various locations. The leachate appeared to have turned darker in color and was foamy. (Marks says recent tests show that it hasn't changed characteristics but not sure exactly what they are testing it for.) The leachate had swamped the well head itself so it was completely surrounded and mostly submerged. Thermal scan showed the leachate was hot at or above 110 degree F. The well head itself appeared cool. Mark got on the phone and called in a truck to pump out all the excess leachate. That concluded the visit.

Image 4(New Sump) : New TS-01 Sump

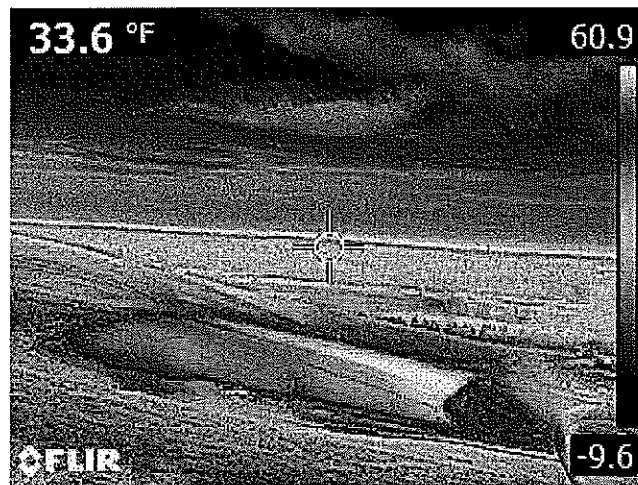
Image 5(North liner IR) : IR image of North liner showing heated gas bubble.

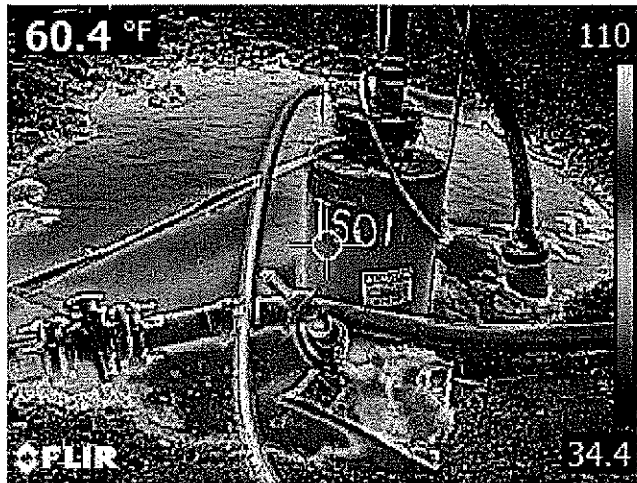
Image 7(IR Well Head) : IR image of TS-01 leachate pond with temperatures of up to 110 degrees F.
