DEPARTMENT OF ENVIRONMENTAL QUALITY  
 AIR QUALITY DIVISION  
 ACTIVITY REPORT: Self Initiated Inspection

FACILITY: Advanced Disposal Services Arbor Hills Landfill Inc		SRN / ID: N2688
LOCATION: 10690 W. SIX MILE RD, NORTHVILLE		DISTRICT: Jackson
CITY: NORTHVILLE		COUNTY: WASHTENAW
CONTACT:		ACTIVITY DATE: 04/25/2019
STAFF: Mike Kovalchick	COMPLIANCE STATUS: Non Compliance	SOURCE CLASS: MAJOR
SUBJECT: Site visit of Fortistar to investigate an issue with Turbine 4 and discrepancy in power rating. Also site visit at the landfill to continue on-going investigation/observation of ETLF event.		
RESOLVED COMPLAINTS:

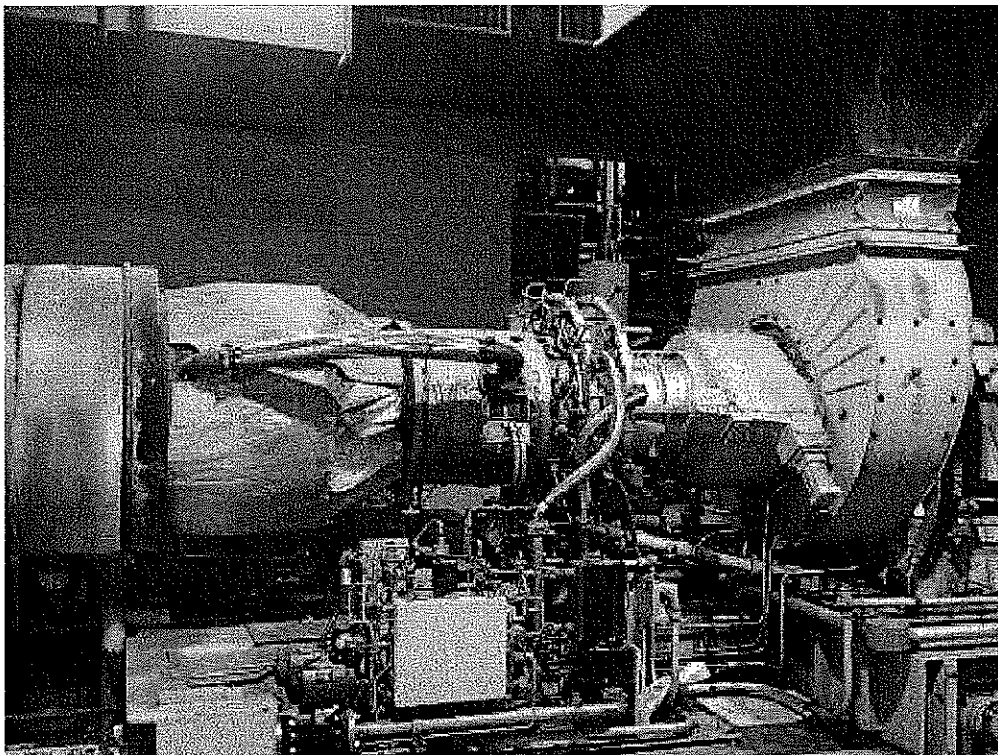
**Image 1(Turbine 4) : Turbine 4**

Carlos showed me Turbine 4. Verified that turbine 4 had a name plate of 5200 KW dated 2014. The generator plate showed 5300 KW dated 2004 so it does appear to be the original.

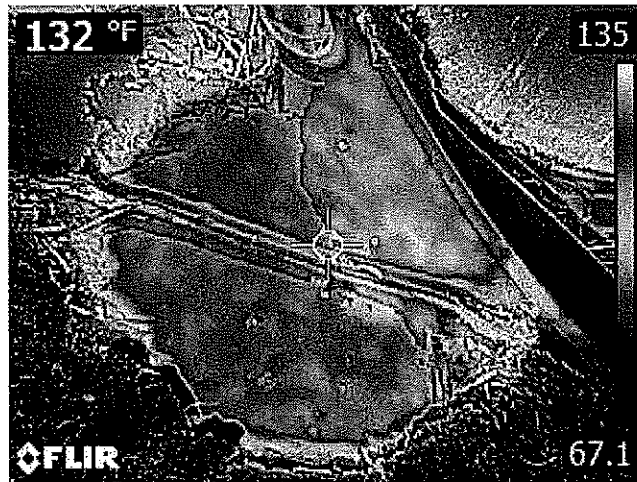
TS-01 was very active with very high levels of odors. It appeared once again to be close to overtopping the small levees. Steam was visible coming off the upper pond with obvious bubbles coming up. Temperatures measured 135 degrees F, which was a significant increase from the 110 degrees F measured 2 weeks prior. Mark mentioned that they recently measured 10 ppm (10 min OSHA exposure limit is also 10 ppm). We used our meter and detected 6.5 ppm. Downwind odors were so strong that I had to place the monitor on the ground and retreat to where the air was cleaner and came back later to pick up the device. H<sub>2</sub>S were drastically higher than from the previous visit. A number of areas above TS-01 appeared to have gas coming out of the ground. (Didn't have methane detector with me.) It appeared that gas had broken through areas where dirt cover had been placed previously to stop leaks.

Image 3(TS-01 Temp) : TS-01 Temperature scan

Mark mentioned that there was a delay in starting the project to re-engineer TS-01. It was determined that the previous design wouldn't work, so a much more elaborate system was necessary in order for a permanent fix. He gave no new times for when it would be installed.

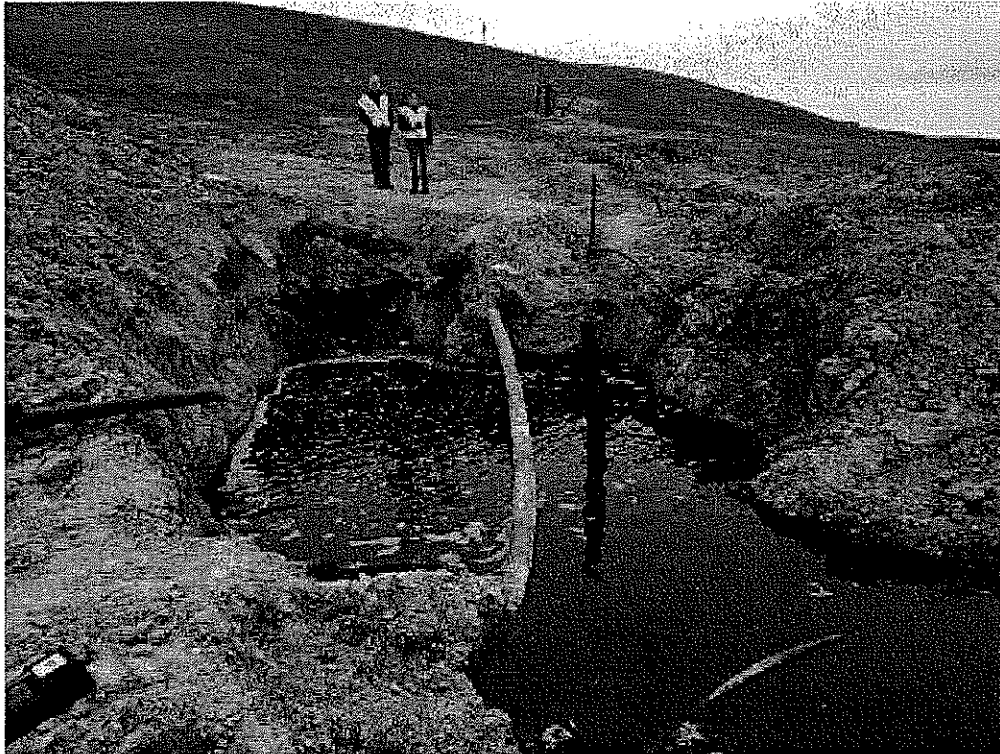
Next, we went to the brand new leachate pond couple of hundred yards west of TS-01 and about the same elevation. It appeared to likely contain even more leachate than TS-01. It appeared that workers previously dug a hole to work on repairing a French drain leachate collection pipe that ran East downwards a sump/pump station. (Note: This definitely was a separate location than the previously reported French drain leachate incident.) Mark immediately noted that a rather massive area of bubbling was occurring in this pond. He quickly determined that a main leachate header line had ruptured. Mark believed it had just occurred as workers had been there earlier in the day and didn't see it. Odors/H<sub>2</sub>S levels were minimal from this leachate and temperatures were not elevated. He had to quickly go back to the truck and call in a repair crew. It appeared that pump in the nearby sump area was able to keep up with all the liquid collecting in this pond. They would have to dewater it in order to make repairs.

**Image 5(New Leachate Break)** : Horizontal well leachate breakout 200 yards West of TS-01.

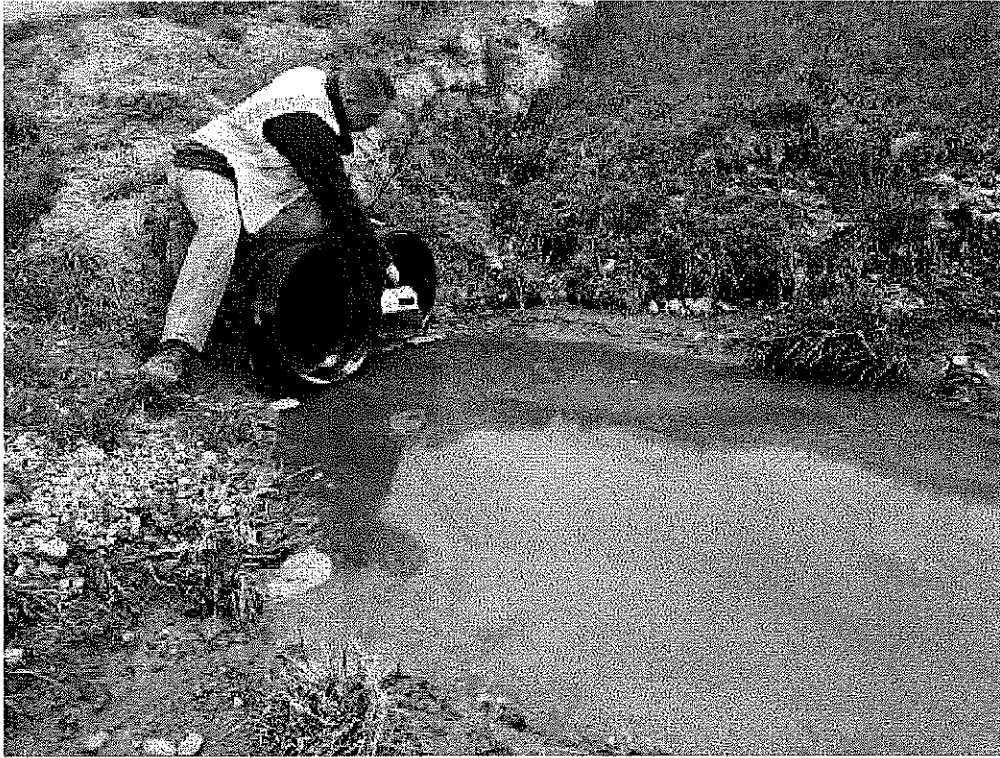
On the way to TS-01, we took the west perimeter road and stopped at various locations where there are storm drain outlet pipes to test for H<sub>2</sub>S. Mark noted that landfill gas has infiltrated these pipes and used them as conduits. These pipes are cracked in many places. Only minor odor levels were detected during this visit. Mark discussed his plans to dig-up/replace these. This area is one of the main persistent areas of odors at the landfill.

**Image 6(H2S monitoring) :** H2s monitoring from drain title.
