DEPARTMENT OF ENVIRONMENTAL QUALITY
 AIR QUALITY DIVISION
 ACTIVITY REPORT: Self Initiated Inspection

FACILITY: Advanced Disposal Services Arbor Hills Landfill Inc		SRN / ID: N2688
LOCATION: 10690 W. SIX MILE RD, NORTHVILLE		DISTRICT: Jackson
CITY: NORTHVILLE		COUNTY: WASHTENAW
CONTACT:		ACTIVITY DATE: 05/30/2019
STAFF: Mike Kovalchick	COMPLIANCE STATUS: Non Compliance	
SUBJECT: Visit to test CAIRPOL H2S sensor and find location for its placement.		SOURCE CLASS: MAJOR
RESOLVED COMPLAINTS:

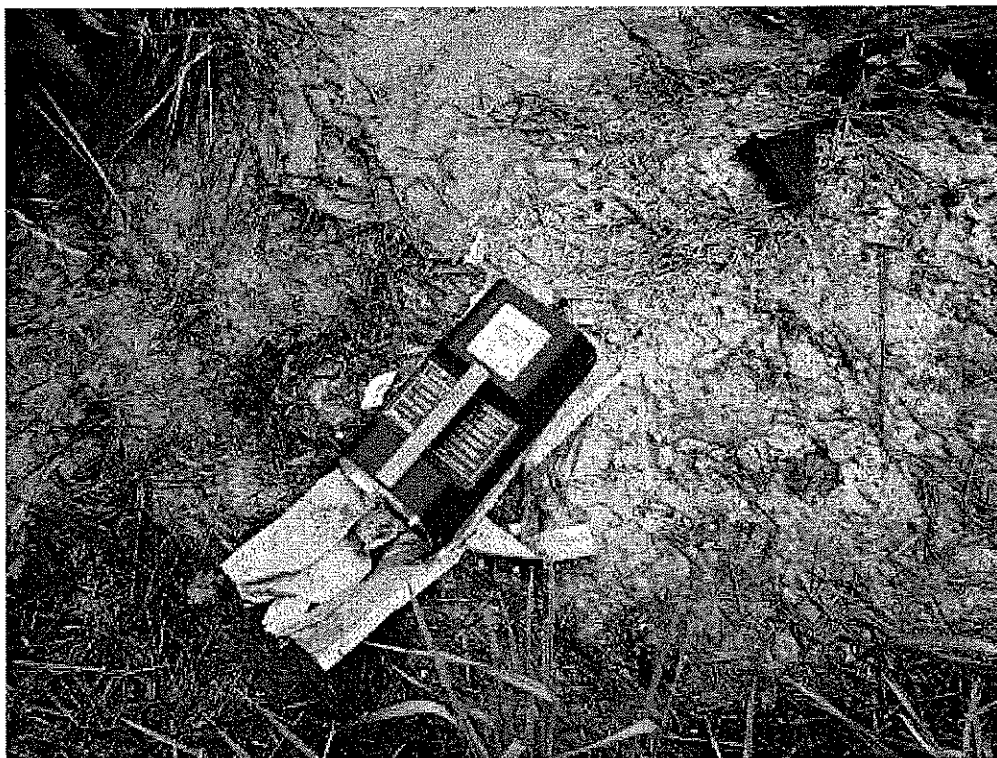
Intense/nauseating H2S odors were noted near TS-01. However, there was no odors coming from TS-01 itself which was very odd. After a few minutes of searching, Mark was able to find the source. (See attached photo.) It was from a small area of no vegetation with some black sulfide stains on the ground. It was directly adjacent to a shutoff valve pole associated with TS-01 and clearly had been there for quite awhile. I first deployed my little cheap methane detector; it alarmed and it pegged the instrument from multiple holes at 10,000 ppm+. I deployed the Jerome and detected H2S at a rather unhealthy 23 parts per million. (Only a few feet away it was drastically lower.) I then turned the Cairpol on and walked around TS-01 (holding it in my hand) for a few minutes being careful not to get too close in order to avoid saturating the sensor. I turned it off after leaving the area and just before getting back into the truck. See attached spreadsheet of the data it recorded. It detected levels up to 700 parts per billion. It appears the Cairpol is operating as expected.

Image 1(Killed vegetation) : Killed vegetation methane/H2S.

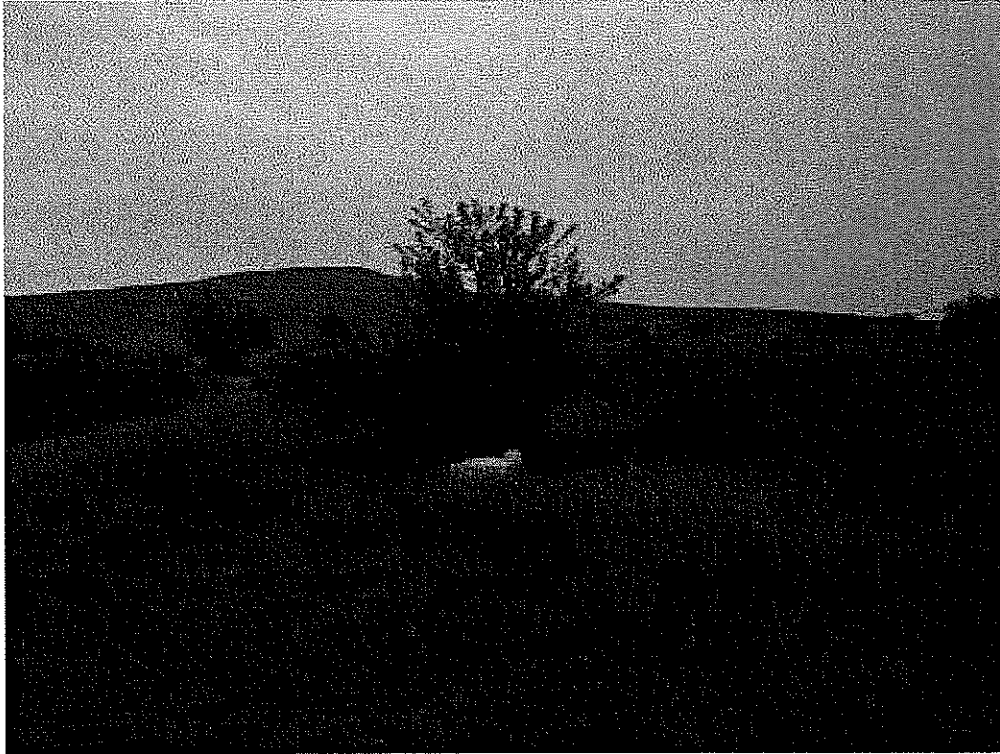
We went to the proposed location for the Cairpol sensor on the east side of Napier. The access road had a gate on it but it wasn't locked. We proceeded to where the fenced in building was located. Mark did not have a key to fence but was pretty sure that a key was available back at the office. The location appears to be perfect for our purposes either just outside the fenced in area or inside. See attached photos. We have mentioned to access this location at anytime and promised to notify Mark whenever we go out there. If a key is available, we will need to stop by to pick up the key prior to accessing the Cairpol. Overall, Mark is very pleased with our monitoring plan and thinks that it is a good thing.

Image 2(New CAIRPOL site) : New CAIRPOL site looking west towards landfill.

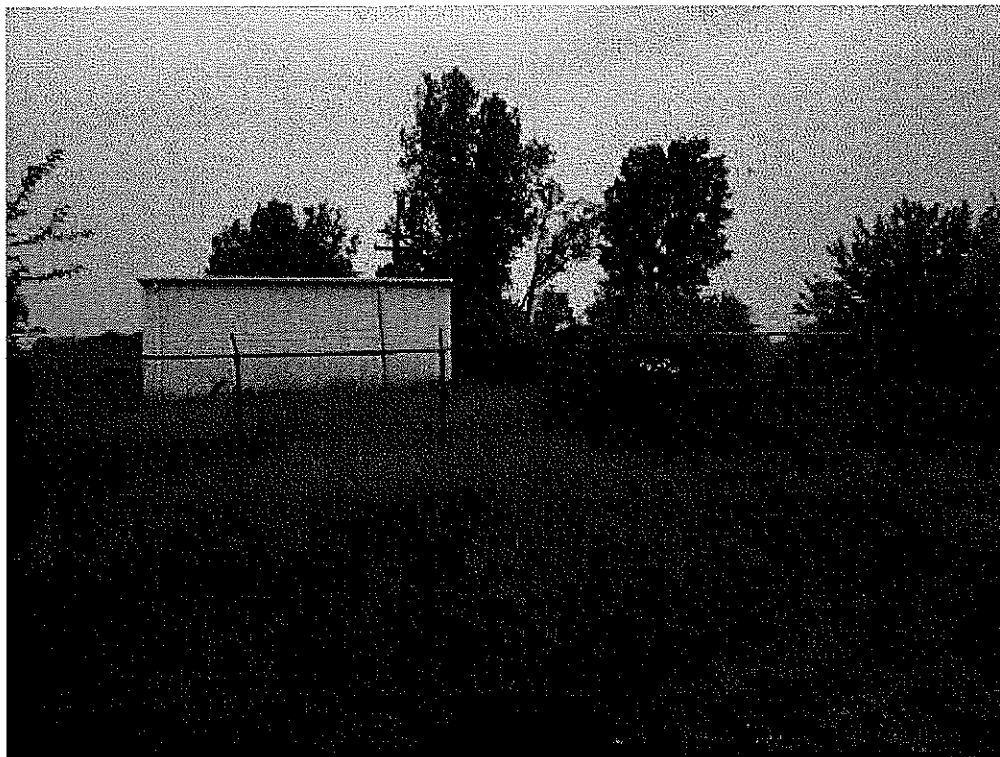
Image 3(New CAIRPOL site) : New CAIRPOL site.

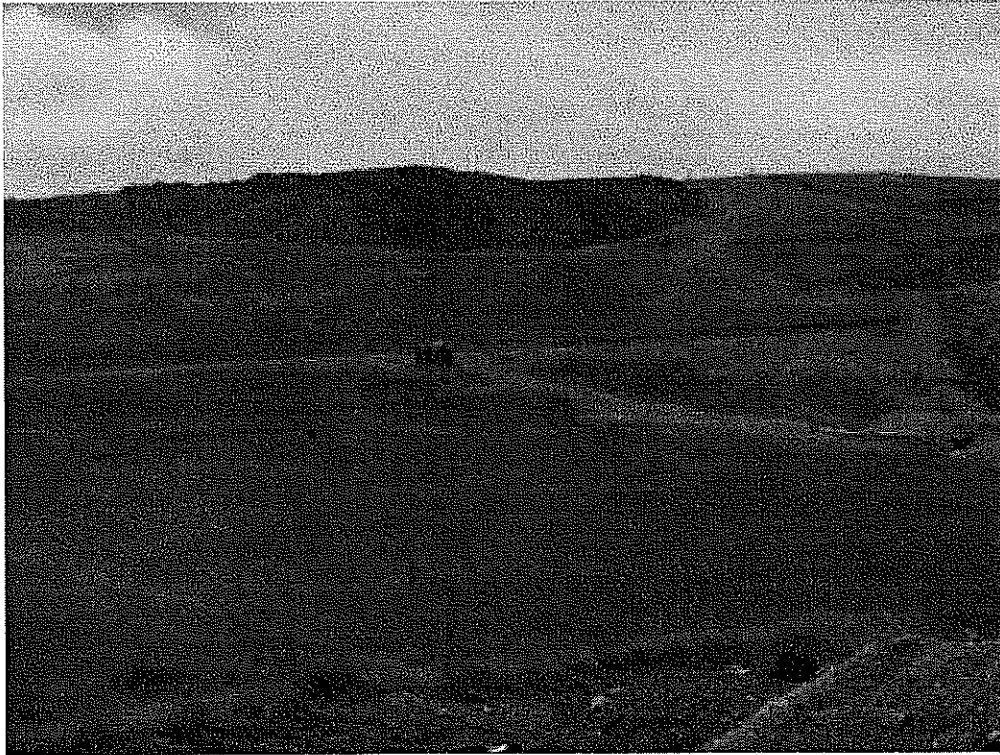
Mark says there is little gas odor noted on the Northside of the landfill near the subsidence area. I noted a very large pile of dirt had been placed just to the East of it. (See attached.) Mark says as soon as the weather dries up some, they will start to grade this pile of dirt in preparation for the possible new geo-liner.

Image 4(North slope) : North slope.

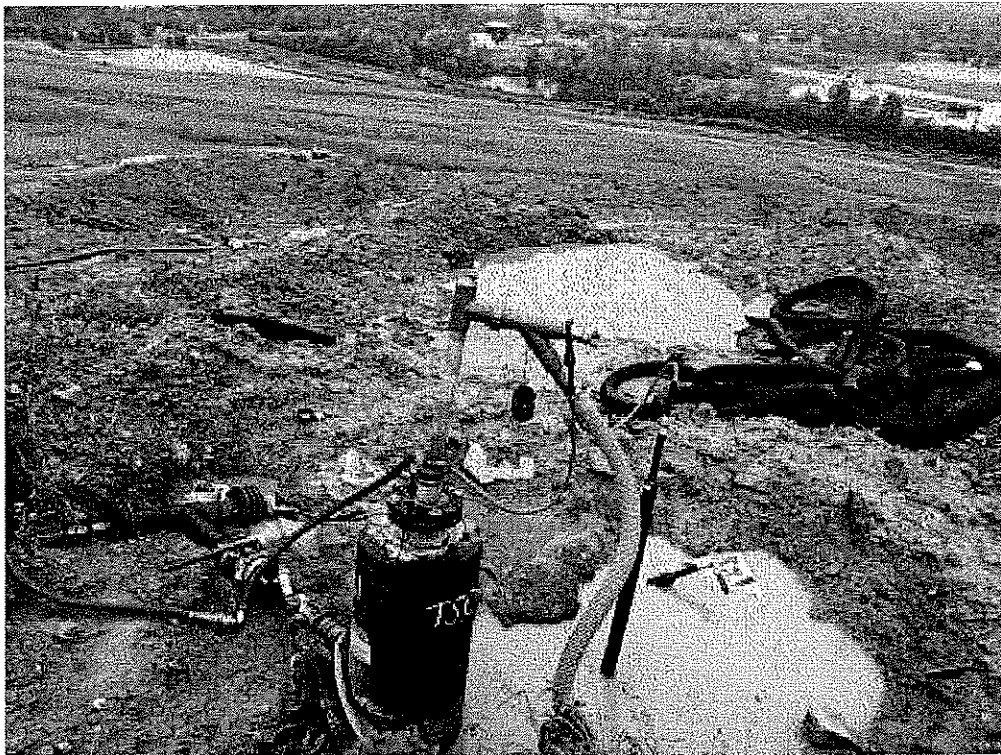
We visited TS-01. (See attached photo.) Fairly quickly, Mark was able to determine something was wrong. It was determined that they were working on a lift station directly below TS-01 this morning. They were replacing a pump on this lift station. Prior to starting work, they shutoff the airflow to the TS-01 sump pump. (This project started this morning.) As a result, the pump wasn't pumping. Mark noted that recently, the sump pump has been able to keep up with the liquid flowing into TS-01 due to overall improved air pressure at the landfill which has improved performance of the TS-01 pump. Nevertheless, there was only low levels of water in the containment area beyond TS-01 and it appeared to be mostly muddy storm water compared to the jet black, hot bubbly water last time. (I could seem steam coming off the frac tanks below but was too far away to detect odors from them.)

Image 5(TS-01) : TS-01 sump ponds.
