DEPARTMENT OF ENVIRONMENTAL QUALITY
AIR QUALITY DIVISION
ACTIVITY REPORT: Self Initiated Inspection

FACILITY: Advanced Disposal Services Arbor Hills Landfill Inc		SRN / ID: N2688
LOCATION: 10690 W. SIX MILE RD, NORTHVILLE		DISTRICT: Jackson
CITY: NORTHVILLE		COUNTY: WASHTENAW
CONTACT:		ACTIVITY DATE: 06/07/2019
STAFF: Mike Kovalchick	COMPLIANCE STATUS: Non Compliance	
SUBJECT: Landfill visit observations.		SOURCE CLASS: MAJOR
RESOLVED COMPLAINTS:

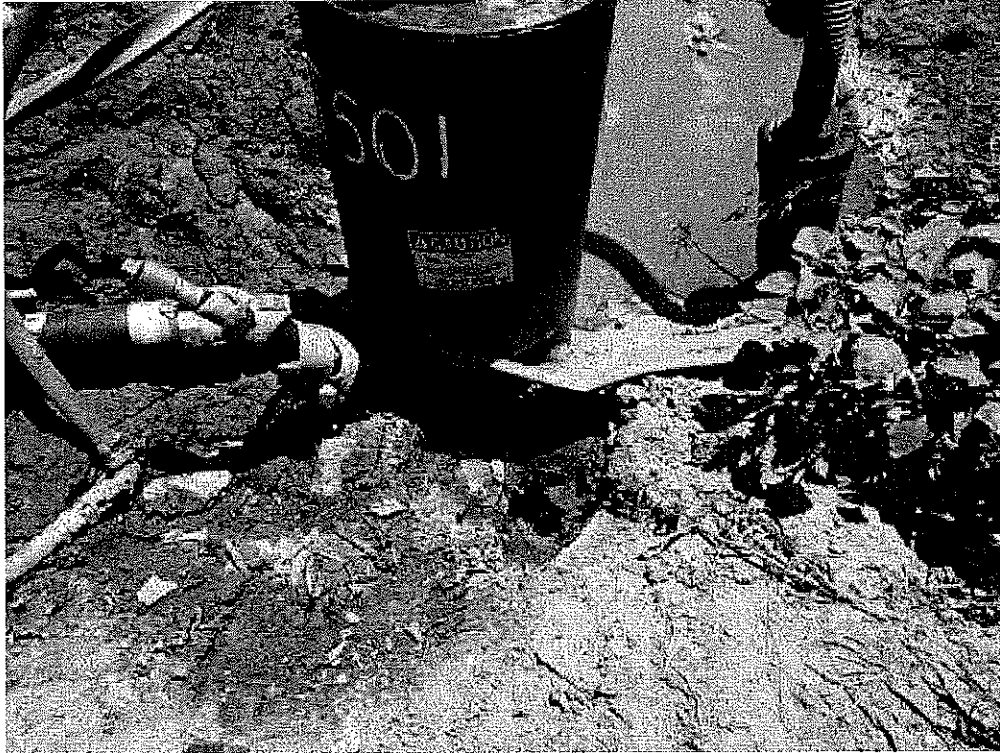
TS-01 pump seemed to be functioning this time with little over spill liquid into the adjacent retention ponds. No gas was coming out of the ground at the adjacent valve shutoff pole like the last time but instead had moved back directly next to TS-01 itself. (Methane meter showed only a few ppm lingering at the shutoff pole.) This time, 2 ground hog size holes had opened up creating intense odors downwind (this time towards the SW). (See attached pics of both holes that likely are a single hole that Y's out at the surface.) They had the characteristic black sulfide staining and were by far the largest gas holes that I've seen. (These holes may have been present before but would have been flooded with liquid so would have not been able to see them.) I attempted to sample it using the Jerome meter approaching the hole from upwind direction. However, disconcertingly the likely very high levels of gas saturated the sensor so I was unable to obtain a H2S reading. Methane was in excess of the methane sensor maximum of 10,000 ppm. Construction to re-engineer TS-01 has yet to commence. They are putting out to bid shortly for the installation of new force main that will run from a new lift station that will be associated with TS-01 to the leachate tank farm. Anthony would not hazard a guess on when this project would be completed.

Image 1(TS-01 Gas hole) : TS-01. Note gas hole at base.

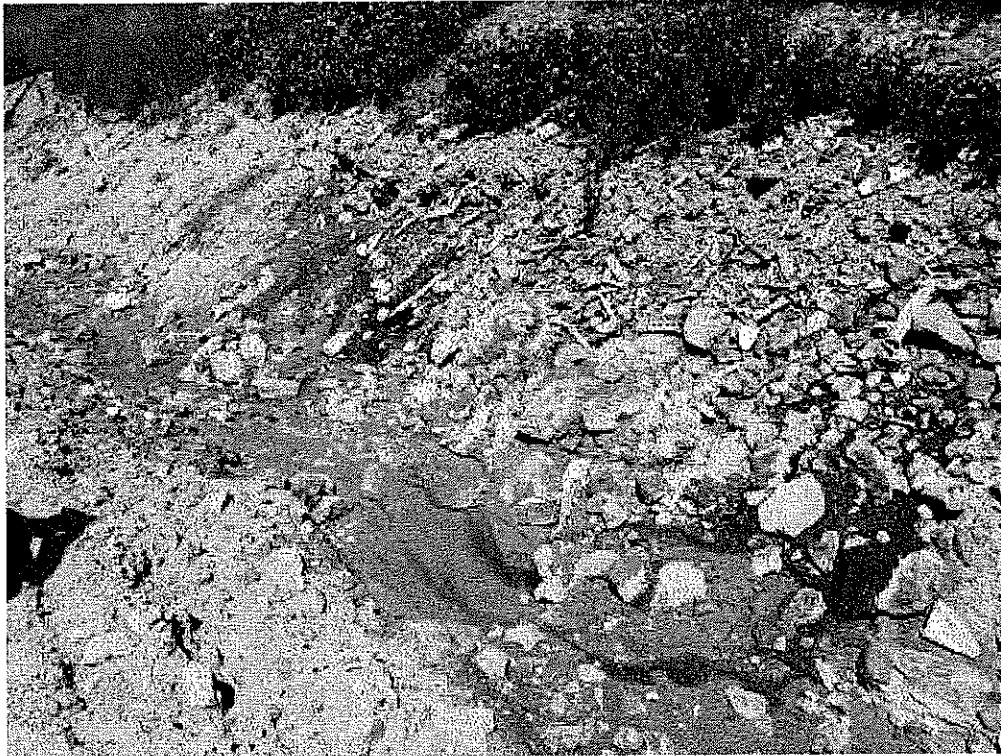
Image 3(Small leachate seep) : Small leachate seep along West haul road ditch.
