DEPARTMENT OF ENVIRONMENTAL QUALITY
AIR QUALITY DIVISION

ACTIVITY REPORT: Self Initiated Inspection

FACILITY: Advanced Disposal Services Arbor Hills Landfill Inc		SRN / ID: N2688
LOCATION: 10690 W. SIX MILE RD, NORTHVILLE		DISTRICT: Jackson
CITY: NORTHVILLE		COUNTY: WASHTENAW
CONTACT:		ACTIVITY DATE: 06/18/2019
STAFF: Mike Kovalchick	COMPLIANCE STATUS: Non Compliance	SOURCE CLASS: MAJOR
SUBJECT: Visit included H2S monitoring walk inside the landfill and check of known odor locations.		
RESOLVED COMPLAINTS:

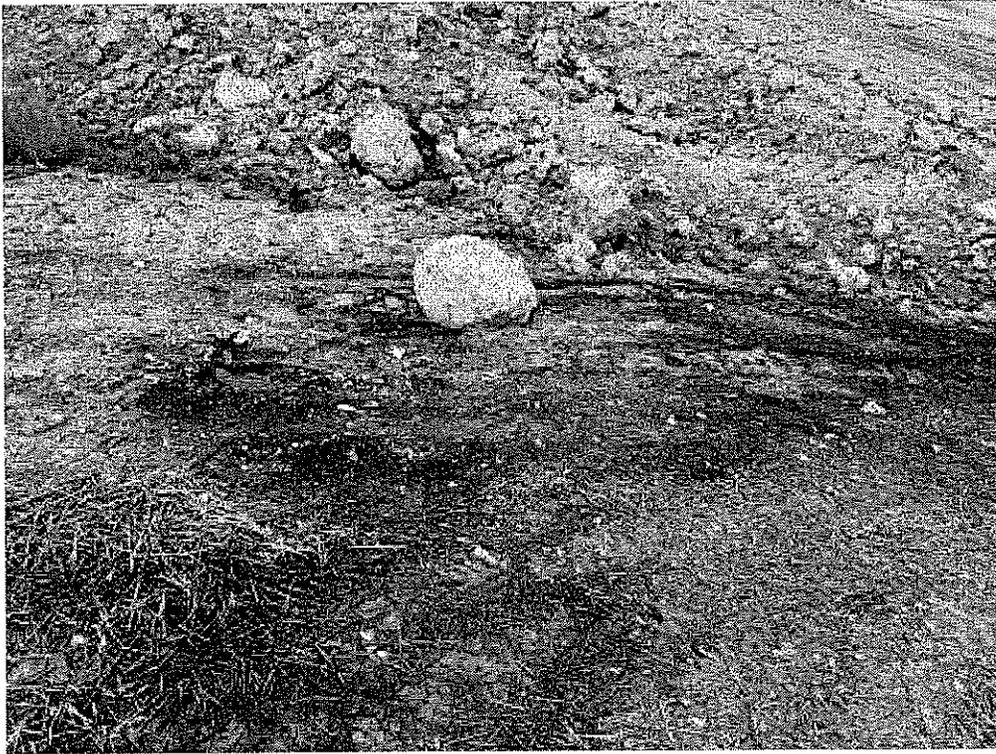
Just below the new dirt was a leachate seep. The seep had been discovered during previous visit but now was extending in a line more than 100 yard long. (See attached photos.) It wasn't visited during the last visit as it was assumed that it was already covered up. Anthony mentioned that they will continue to push more dirt down the hill which should cover up this area.

Image 1(Leachate seep-North) : Leachate seep-North slope.

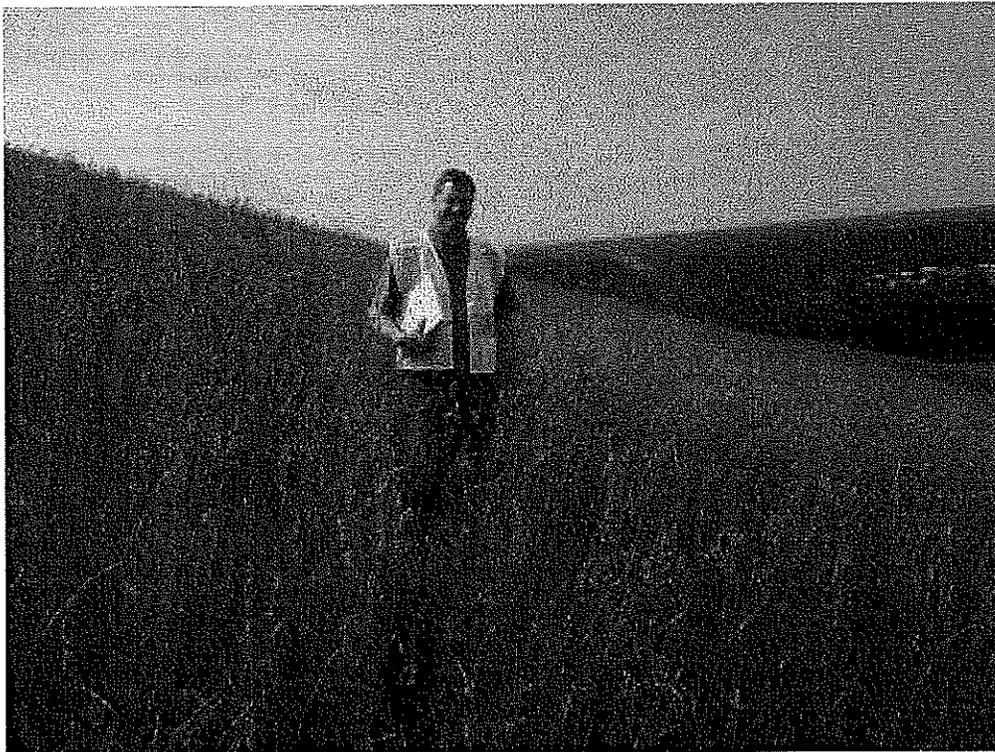
Image 2(Tall grass) : Tall grass.

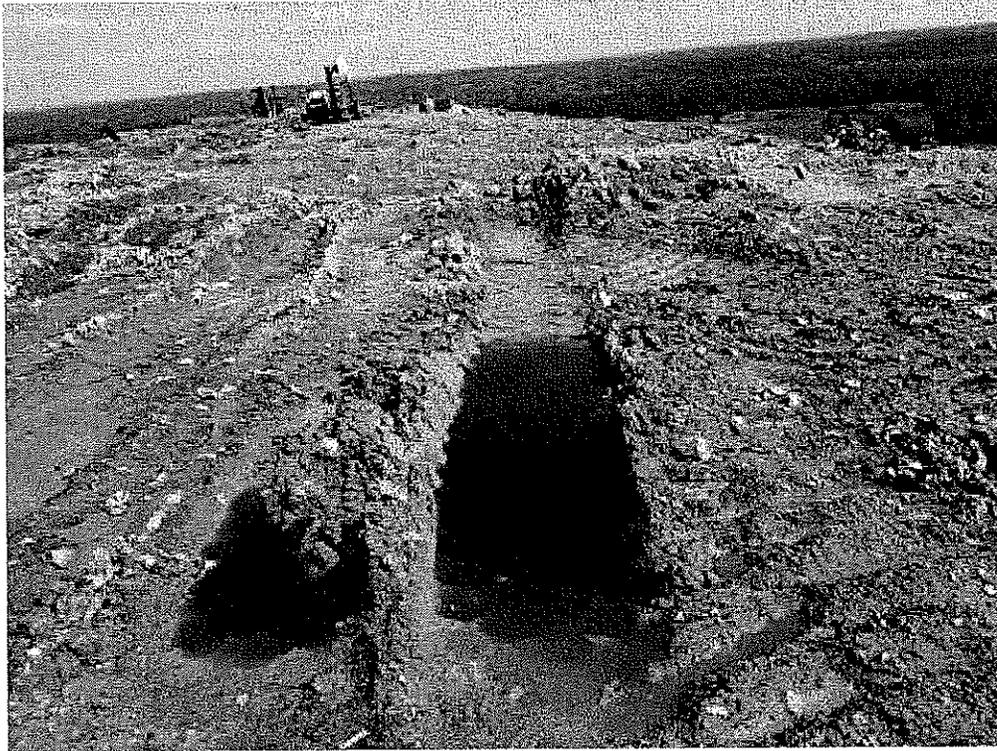
Image 3(Leachate) : Leachate NW part of landfill.

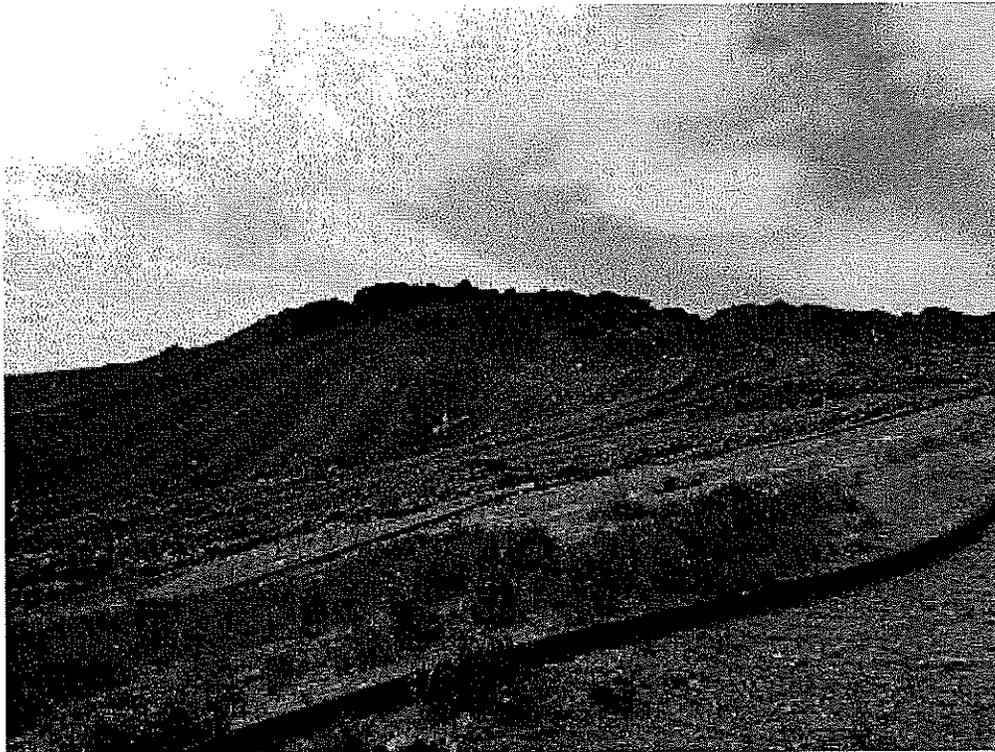
At the NW portion of the landfill, we encountered intense trash/sewage type odors over a wide area which is downwind of the North active face. H₂S was also somewhat elevated. (Mark later remarked that he thought they have been receiving sewage from Ann Arbor.) This part of the walk was very unpleasant due to the nauseating odors and hazardous walking conditions. It became increasingly difficult to proceed. We spotted Anthony off in the distant so walked towards him and then followed him back to where his truck was parked at the top of the hill. I then proceeded down the hill in a trash free area so could examine the area below the subsidence area. Moderate unpleasant odors likely due to the elevated temperature event continue although H₂S readings were only moderately elevated. It appears to be in the area just below 35 feet high pile of dirt that had been placed on the subsidence area. (See attached photo.)

Image 4(North slope) : North slope

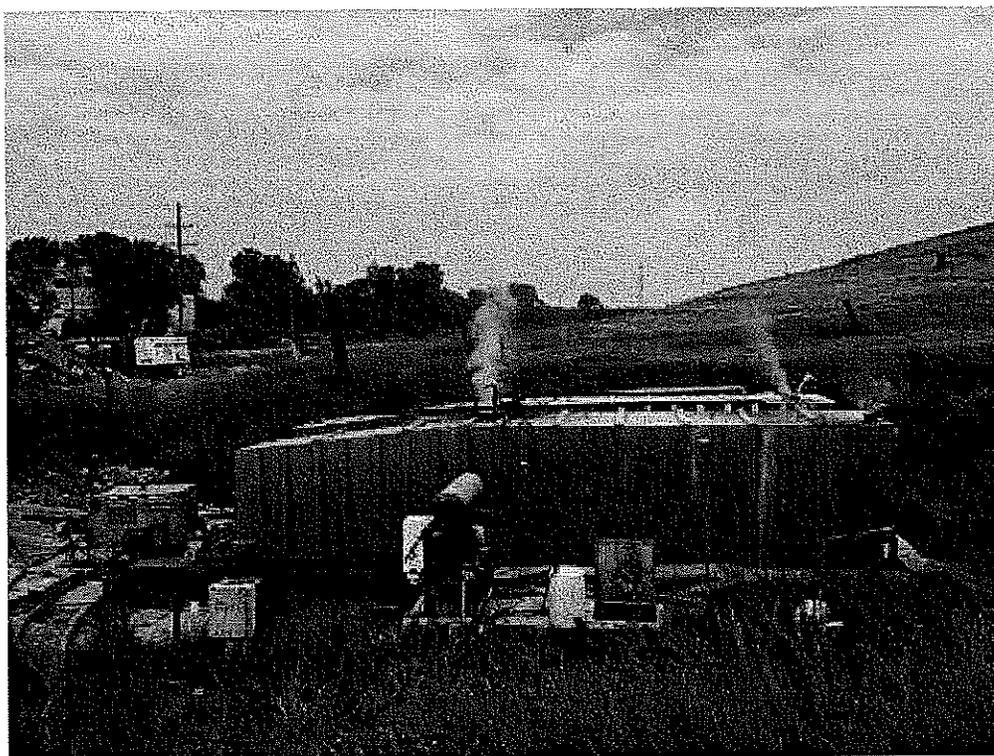
Visited the Frac tanks. Intense odors; gas mixed with some other type of nasty odor. Strong odors and elevated H2S readings noted well down wind. The amount of gas/steam coming out the top of the frac tanks appeared to far exceed the quantity of gas coming out at TS-01 and easily is a larger source of odors than TS-01. Anthony insisted that the aeration system was working as quite possibly if it wasn't, it would be far worse. Mark noted that the TS-01/aeration tank/lift station is now at least 1 month behind schedule so current target is August 1. (See attached photo.)

Image 6(Frac tanks) : Frac tanks with unknown gaseous emissions.

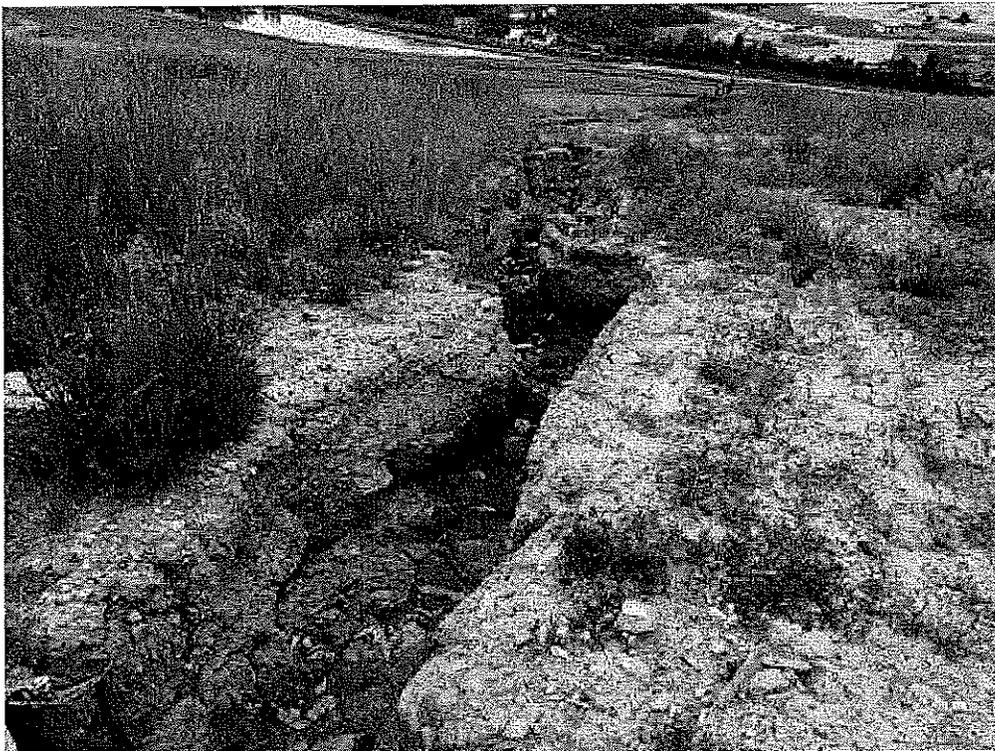
Image 8(Drainage ditch) : Drainage ditch on North slope with high methane/H₂S.

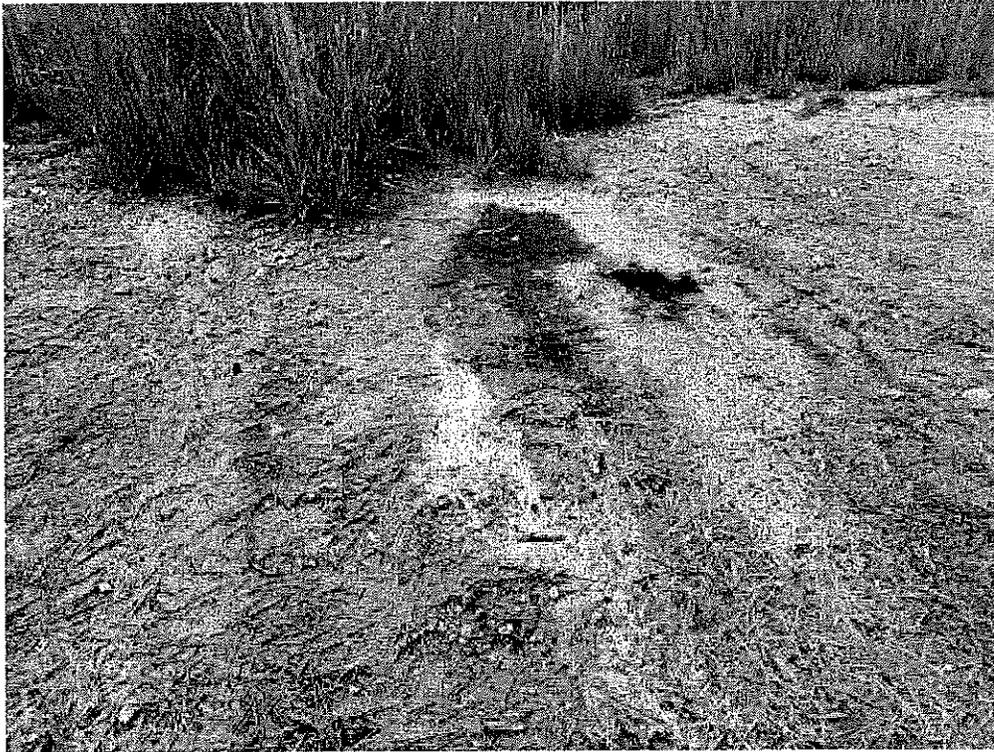
Image 9(Leachate seep) : Leachate seep.

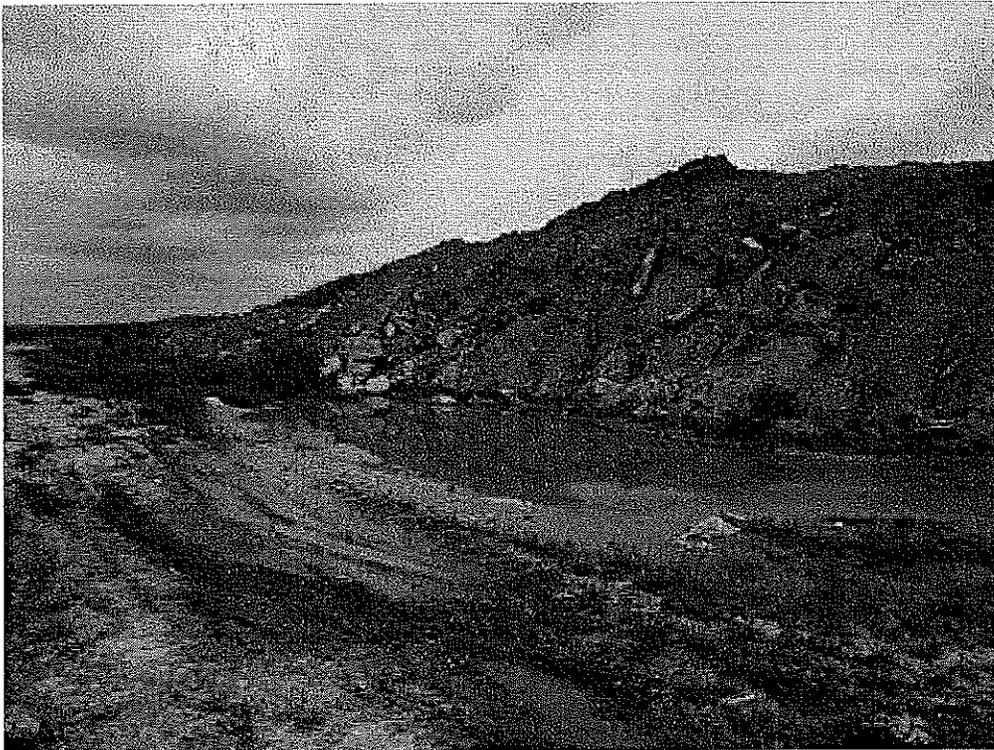
Proceeded just below the top of the landfill in Arbor Hills East area. No odors were noted in this area. Near the top, on the SE/S facing side noted a small pond. Adjacent to the pond, the water had eroded an enormous ditch at least 6 feet deep. See attached photos. I noted to Mark that it isn't a good idea to have all this standing water near the top of the hill and mentioned previous engineering study that noted standing water in a similar location which added to a potential slope stability problem on the southside. Mark mentioned that they working on it.

Image 10(Small pond-South) : Small pond just below top of hill on South side.

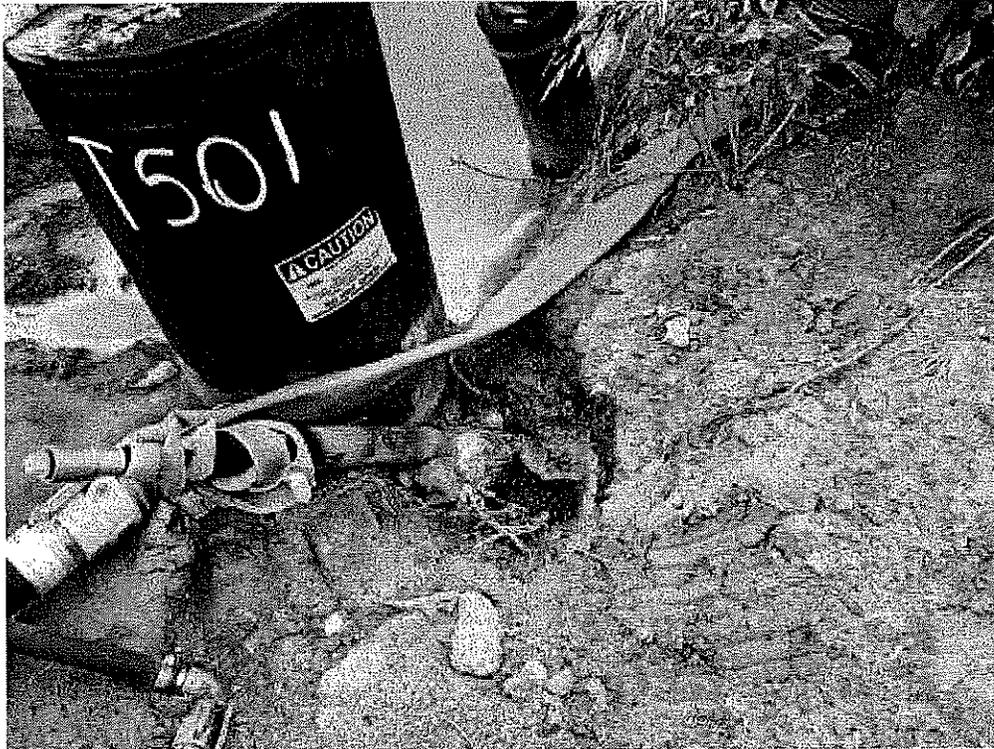
TS-01 overflow catch ponds still contained less than normal liquid levels as Mark had explained that they have high air pressure lines now over the entire landfill making all the pumps to work better. TS-01 is pumping nearly 15,000 gallons per day compared to previous estimates of 10,000 gpd. The ground hog size holes of gas directly adjacent TS-01 were still there but one of them had filled partially with water creating a lot of bubble action. I estimate that the amount of gas being released is no more than a normal well that isn't controlled so probably in the 150 scfm range. Intense odors were noted downwind (wind very light out of the East but occasionally SE and even NE-mixing was fair to poor due lingering morning inversion.) Jermon meter showed elevated H2S levels but I did not get close to where it was coming out of the ground to avoid saturating the sensor as what happened during the previous visit. (See attached photo. Took video etc.)

Image 11(TS-01 gas hole) : TS-01 gas hole.
