DEPARTMENT OF ENVIRONMENTAL QUALITY
 AIR QUALITY DIVISION
 ACTIVITY REPORT: Self Initiated Inspection

FACILITY: Advanced Disposal Services Arbor Hills Landfill Inc		SRN / ID: N2688
LOCATION: 10690 W. SIX MILE RD, NORTHVILLE		DISTRICT: Jackson
CITY: NORTHVILLE		COUNTY: WASHTENAW
CONTACT:		ACTIVITY DATE: 08/14/2019
STAFF: Mike Kovalchick	COMPLIANCE STATUS: Non Compliance	SOURCE CLASS: MAJOR
SUBJECT: Landfill site visit.		
RESOLVED COMPLAINTS:

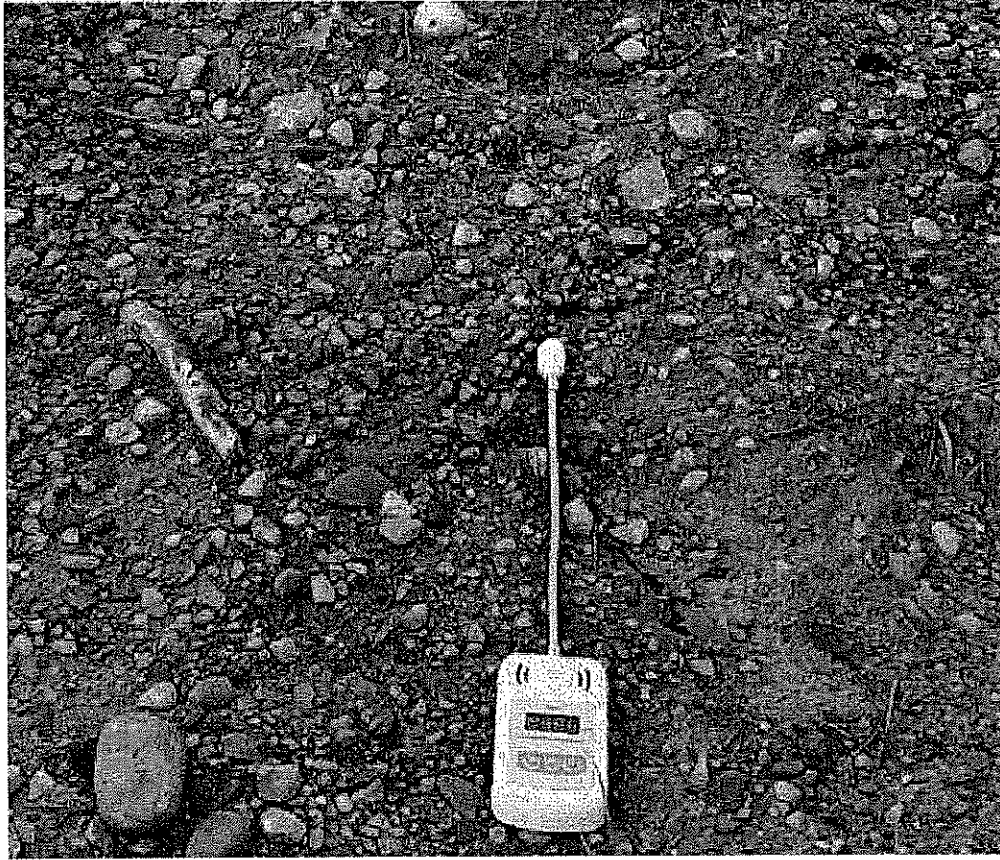
Image 9(Methane crack) : Another methane crack.

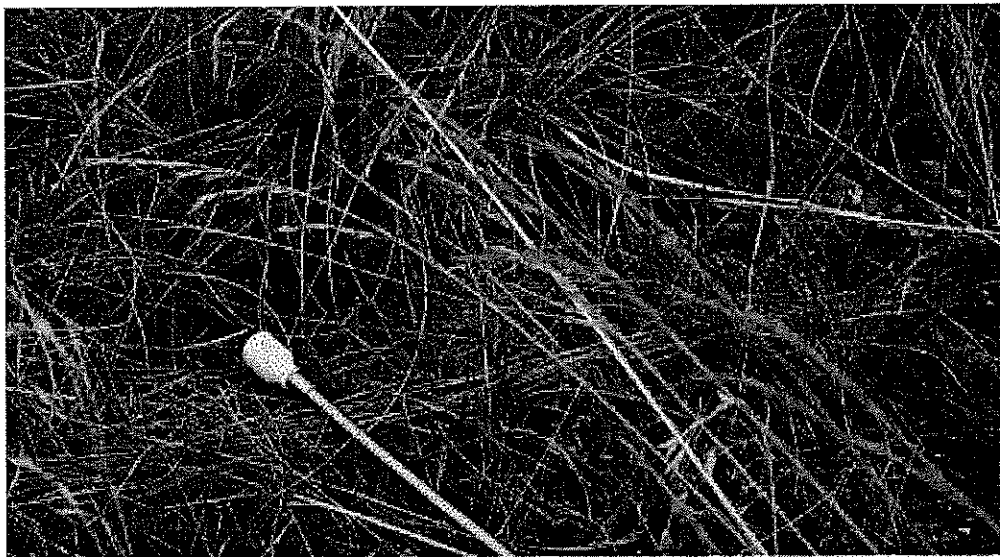
Image 10(Another methane spot) : Another methane hot spot.
