DEPARTMENT OF ENVIRONMENTAL QUALITY
AIR QUALITY DIVISION
ACTIVITY REPORT: Self Initiated Inspection

N268850864

FACILITY: Advanced Disposal Services Arbor Hills Landfill Inc		SRN / ID: N2688
LOCATION: 10690 W. SIX MILE RD, NORTHVILLE		DISTRICT: Jackson
CITY: NORTHVILLE		COUNTY: WASHTENAW
CONTACT: Brian Sanders, General Manager		ACTIVITY DATE: 09/25/2019
STAFF: Mike Kovalchick	COMPLIANCE STATUS: Non Compliance	SOURCE CLASS: MAJOR
SUBJECT: Latest landfill site visit.		
RESOLVED COMPLAINTS:

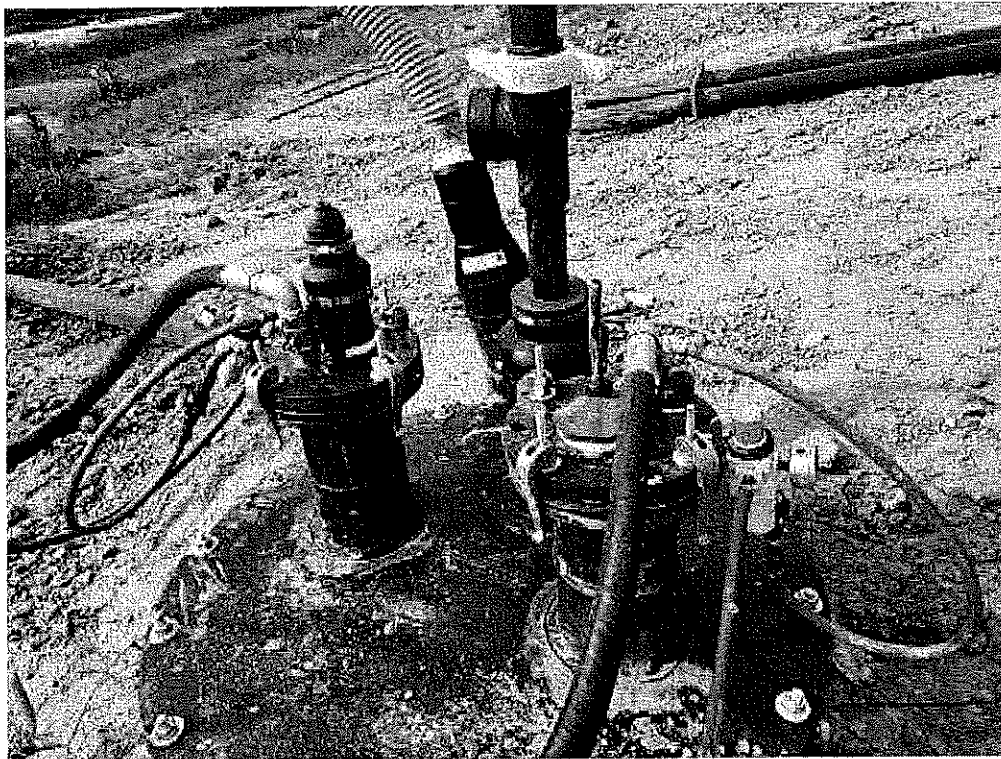
Next, we visited the new TS-01. It definitely appeared to be operating. No odors were noted around the old TS-01 and the pump wasn't on. The pumps were running in the new TS-01. I noted some local high levels of gas next to the new sump head. Upon closer inspection, all the gas odors were coming from the 2 small well pump exhaust ports. It may be worth the bother to control those 2 vent pipes. (Does NSPS require this? I would think it does if above 500 ppm methane?) I was surprised that odors were so strong from it since many similar wells elsewhere that have the pumps don't have noticeable odors. Brian noted that TS-01 has the highest H₂S levels of any well in the landfill.

Image 4(New TS-01) : New TS-01

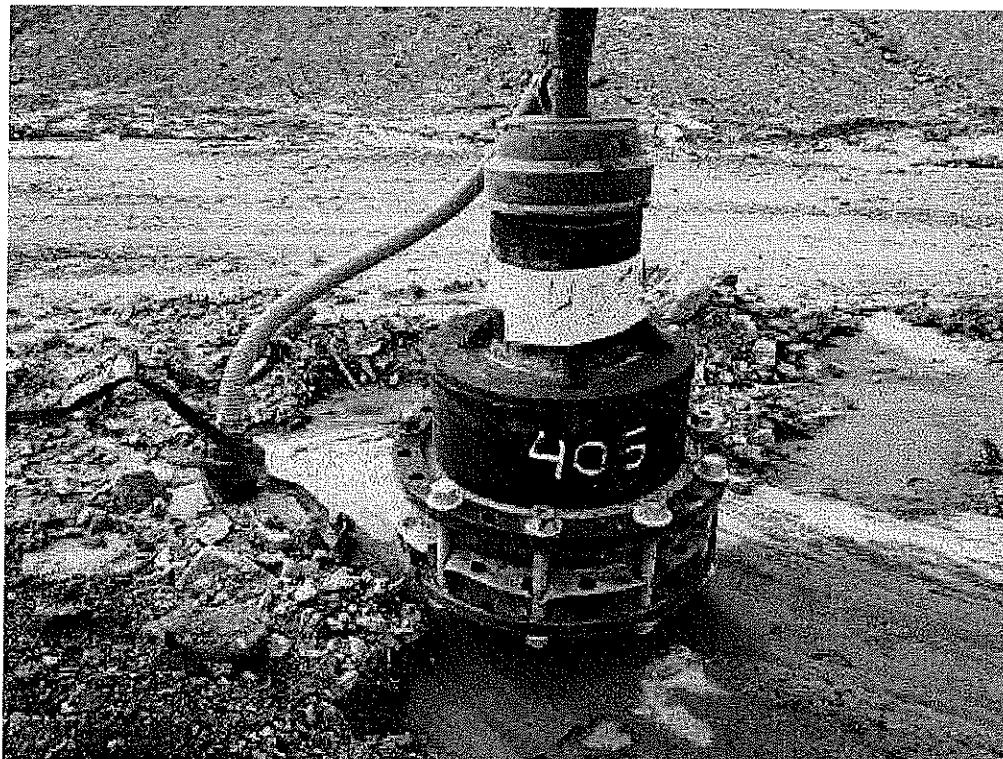
Just West of the frac tanks along the perimeter road is what he called the Super Sump. All the leachate from Arbor Hills West (besides TS-01) flows into it and then on to a nearby lift station. As soon as we stepped out of the truck, was assailed by strong odors similar in quantity/quality to how TS-01 use to be. Brian warned me not to get too close due to potentially high levels of H₂S. It was quickly obvious that a plastic hose had popped off that connected captured emissions with a carbon barrel style unit. Brian quickly attached the hose and adjusted a pump associated with a 35 % hydrogen peroxide solution that was being pumped down into the sump. He said that they add this solution to control odors and to knock down the COD levels. Odors dissipated after Brian finished his adjustments. The Super Sump could be problematic if leachate quantity/quality changes which likely overwhelm the barebones system that is in place or not well maintained. (See attached photos.) I noted that the leachate level gauge in the sump showed that it contained 27 inches of liquid. Brian didn't know how deep the sump went down.

Image 10(Super sump) : Super sump carbon control.
