STATE OF MICHIGAN
DEPARTMENT OF
ENVIRONMENT, GREAT LAKES, AND ENERGY
JACKSON DISTRICT OFFICE

SUBJECT: SRN: N5984, Pine Tree Acres Landfill., Macomb County

On August 8, 2023, the Department of Environment, Great Lakes, and Energy (EGLE), Air Quality Division (AQD) conducted an unannounced inspection of the Pine Tree Acres Landfill owned and operated by WM (Company) located at 36600 29 Mile Road, Lenox, Michigan. The purpose of this inspection was to determine if this facility was in compliance with the requirements of the federal Clean Air Act; Part 55, Air Pollution Control, of the Natural Resources and Environmental Protection Act, 1994 PA 451, as amended (Act 451); the conditions of Renewable Operating Permit (ROP) number MI-ROP-N5984-2019; the National Emission Standards for Hazardous Air Pollutants (NESHAP): Municipal Solid Waste Landfills, 40 CFR Part 63, Subpart AAAA; and the Federal New Source Performance Standard (NSPS) for Municipal Solid Waste Landfills That Commenced Construction, Reconstruction, or Modification After July 17, 2014, 40 CFR Part 60, Subpart XXX.

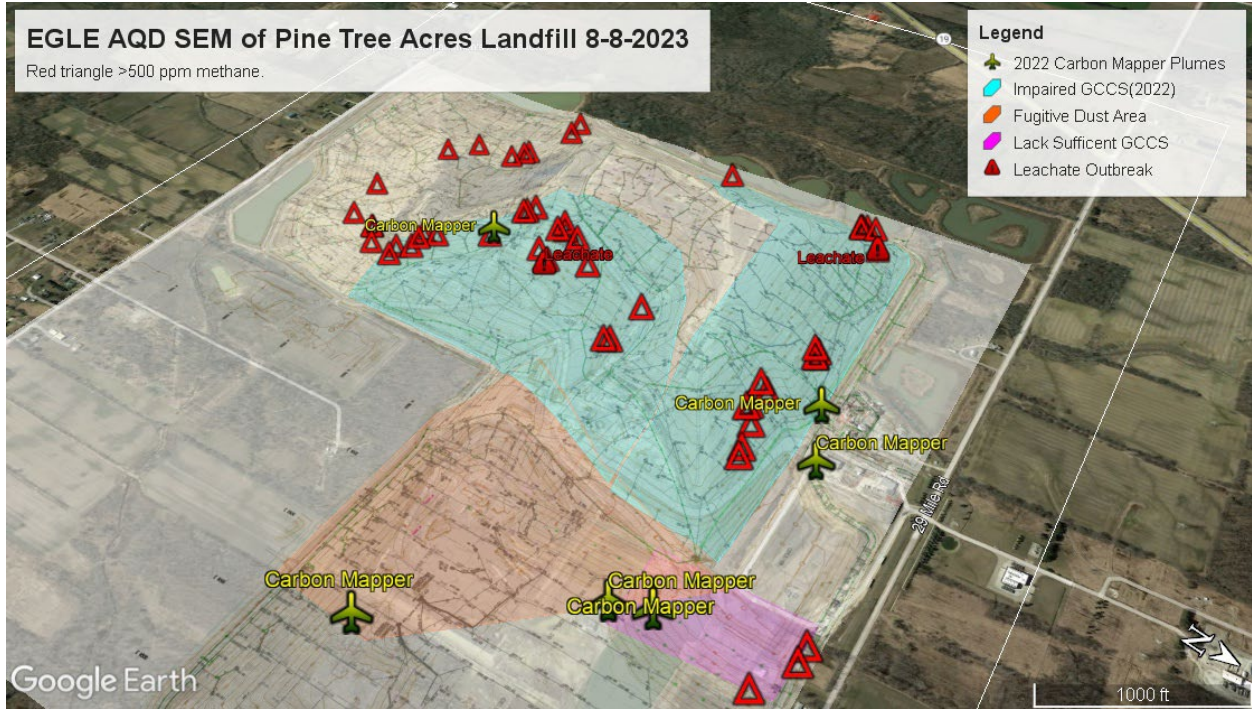
During the inspection, AQD performed an abbreviated surface emission monitoring (SEM) inspection according to the standard and found fifty-five (55) areas with surface methane concentrations greater than 500 ppm. Pursuant to 40 CFR 63.1958(d) owners and operators of landfills are required to operate the gas collection and control system (GCCS) so that surface methane concentrations are less than 500 ppm. AQD staff used two separate SEM 5000 methane detector devices. Instrument specifications and calibration information are available in Attachment (1) while detailed spreadsheets/reports of the data collected have already been provided electronically to the Company via email. Attachment (2) provides an aerial image of the landfill showing the locations of methane concentrations above 500 ppm and depicts areas of concern.

Four areas of concern were documented. As mentioned previously, impairment of the GCCS was noted on the NW, N, NE sides of the main portion of the landfill. A second area of concern was a newer active waste cell on the North side. This cell only has “belly” horizontal collectors at the base of the cell for collection. Excess ambient air methane was encountered at the edge of the cell that was suggestive that additional vertical gas wells are needed. A third area of concern was an area of excessive dust that was encountered on the southside of the active areas due to heavy truck traffic. A wearable AtmoTube device measured PM₁₀ values at an unhealthy 300 micrograms per cubic meter. Finally, two leachate outbreaks were documented with locations noted in the SEM hit list.

As provided in Table 1, fifty-five (55) locations were found to have exceeded the 500 ppm above background threshold during the inspection. This aerial image of the Pine Tree Acres Landfill below shows the locations of methane concentrations above 500 ppm and areas of concern.

- Address/fix all 55 SEM hits per federal requirements.
- Investigate how existing quarterly SEM surveys are being conducted. Note this NESHAP AAAA requirement: “where visual observations indicate elevated concentrations of landfill gas, such as distressed vegetation and cracks or seeps in the cover.” Also, cover integrity problem areas identified during required monthly cover integrity inspections should be included in the quarterly SEM survey.

- Upgrade the GCCS on the newer waste cell on the north side.
- Investigate the cause of the impaired GCCS on the NW, N, NE sides of the main landfill. Check if the wells are impaired by liquid. It is noted that recent changes to Michigan’s Part 115 Material’s Management regulations will require monitoring of liquid levels in gas wells and addressing as needed starting in 2024.

- Address the two leachate outbreaks as required.
