DELTA SOLID WASTE MANAGEMENT AUTHORITY

March 13, 2023

This is a response letter from DSWMA on the Violation Letter dated February 23, 2023. An inspection of Delta County Landfill was performed on December 13, 2022. Listed below are the response and corrections listed based on each violation. Our job is to comply to state regulations and that is what we always strive to do therefore, as soon as we were notified that Ms. Luce wanted changes made, we started the process immediately.

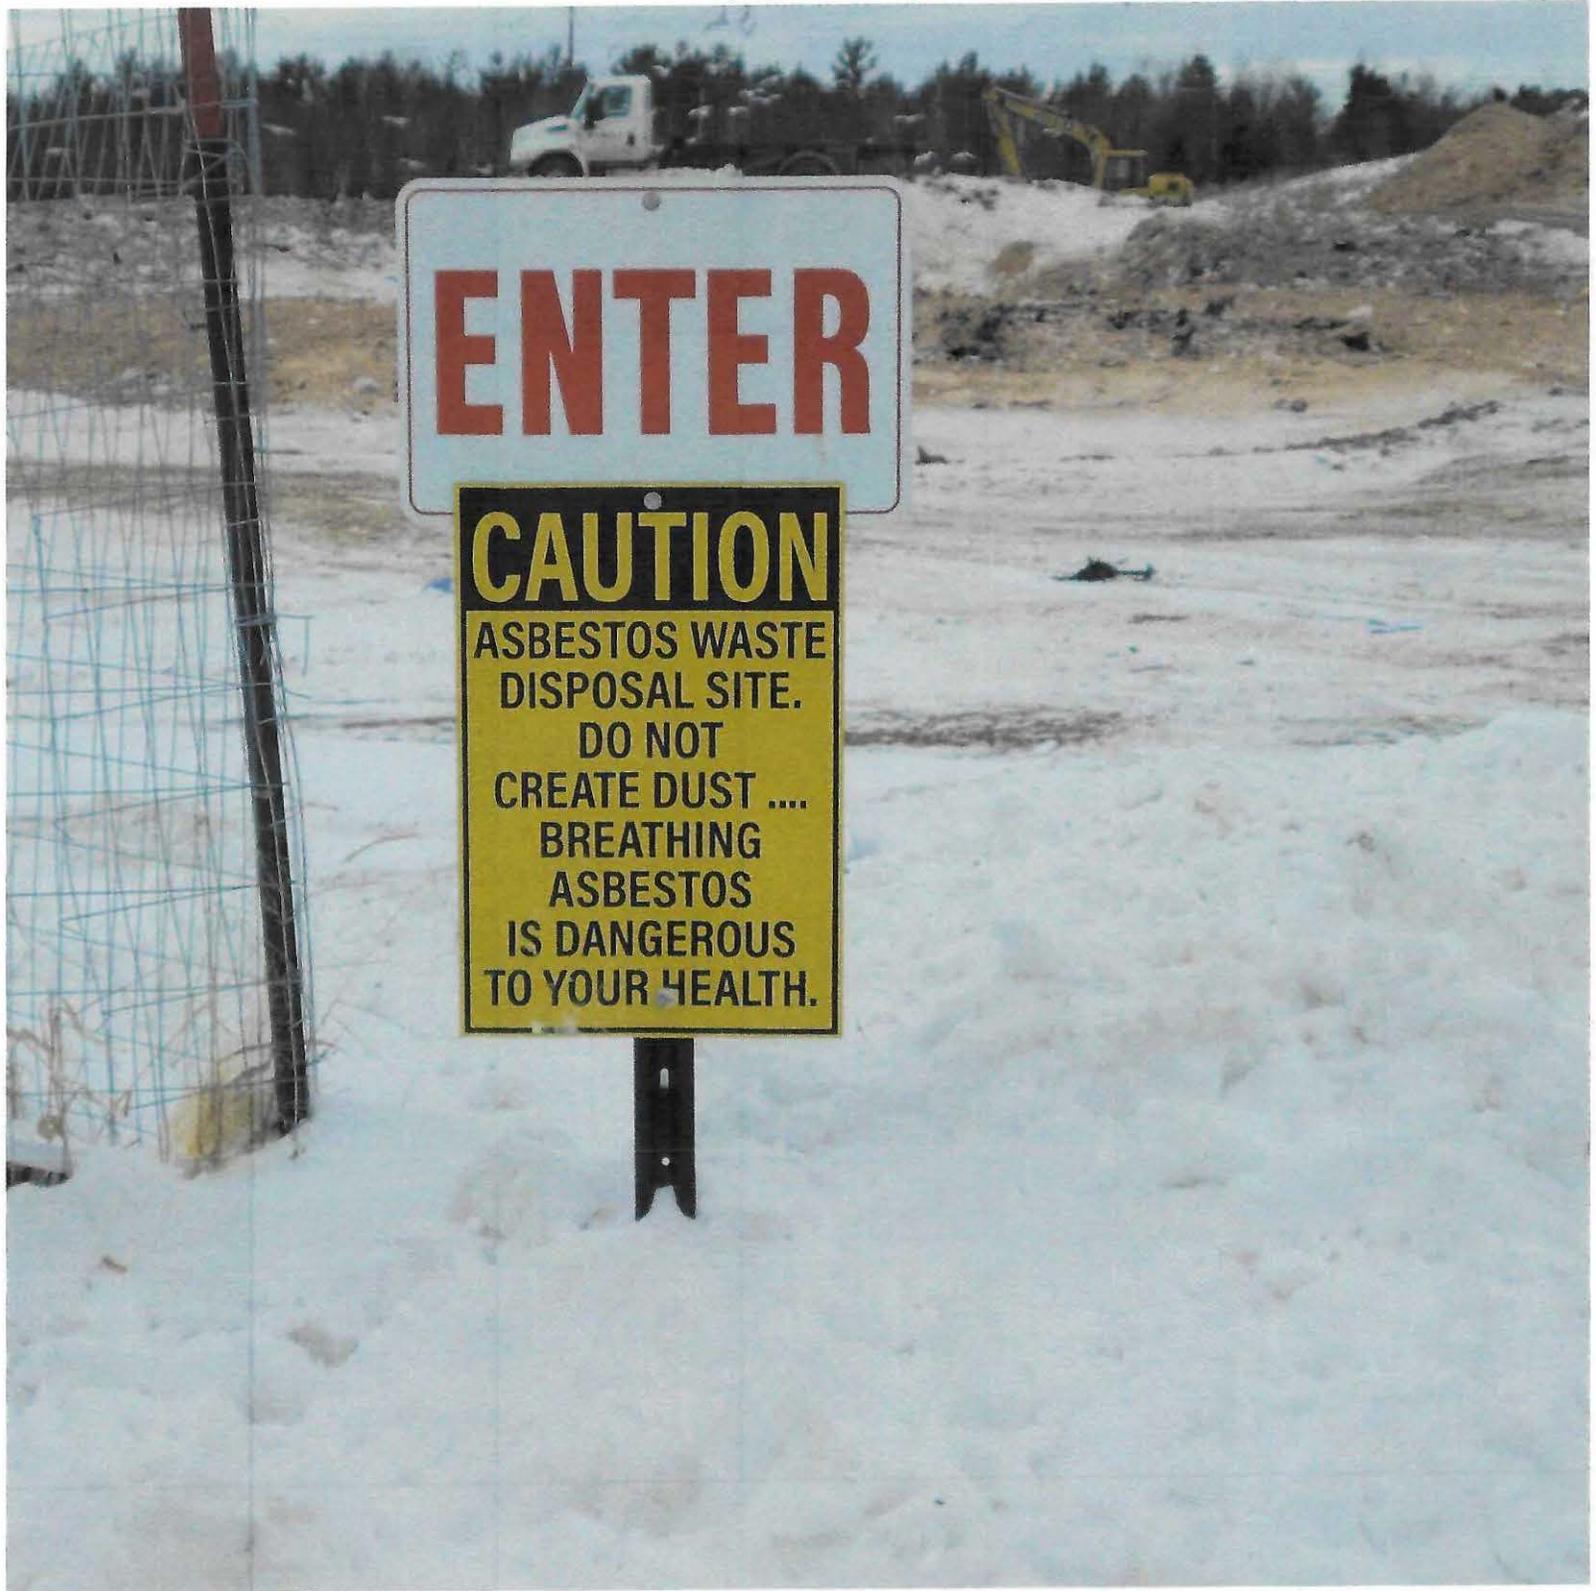
1

In response to EUASBESTOS first and foremost we were unaware that we were out of compliance as under the previous administrator our 3/16/2021 inspection done by Sydney Hewson states in these words exactly "warning signs and an adequate barrier are present." Therefore, it was believed we were in compliance. As soon as we were notified that we were out of compliance proper signage was placed at the entrance of each cell along with perimeter signage placed at 330 ft intervals and a sign placed at the area of the asbestos hole on cell 6A, as the picture shows (#1). We started correcting this violation on December 14, 2022 and completed the correction on December 22, 2022.

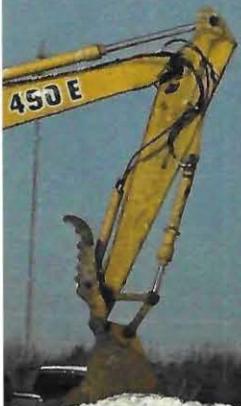
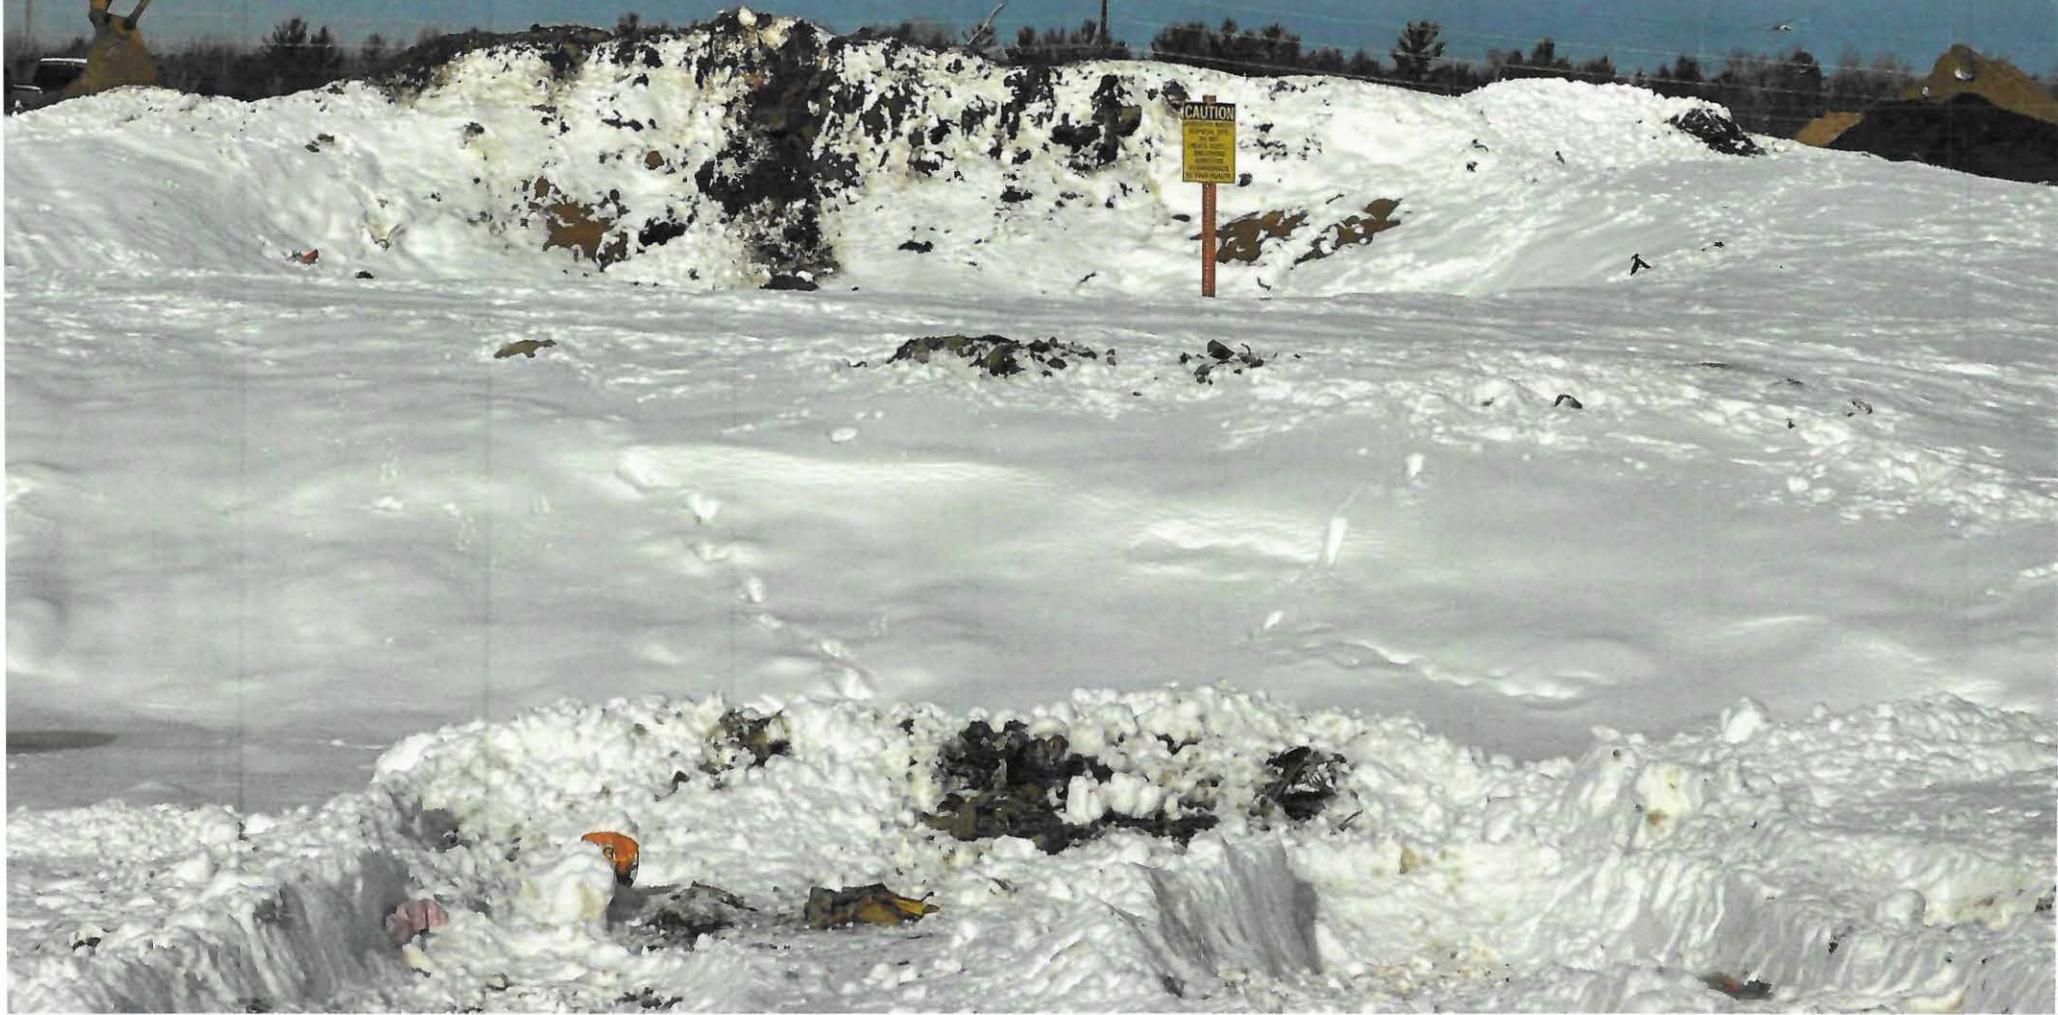
#2

The second violation under EUASBESTOS was on the asbestos hole. Asbestos is being placed in the one area on cell 6A. We took it upon ourselves to berm the area better as you can see in the attached photo (#2) so that the area cannot be entered and the asbestos is being covered with 6" of soil at the end of each operating day, this was corrected on December 14, 2022. We were not having staff members drive in to cover asbestos daily as it was a health risk, after berming the area the cover can be dropped in the hole to cover the asbestos and does not require them to come in contact with the asbestos.

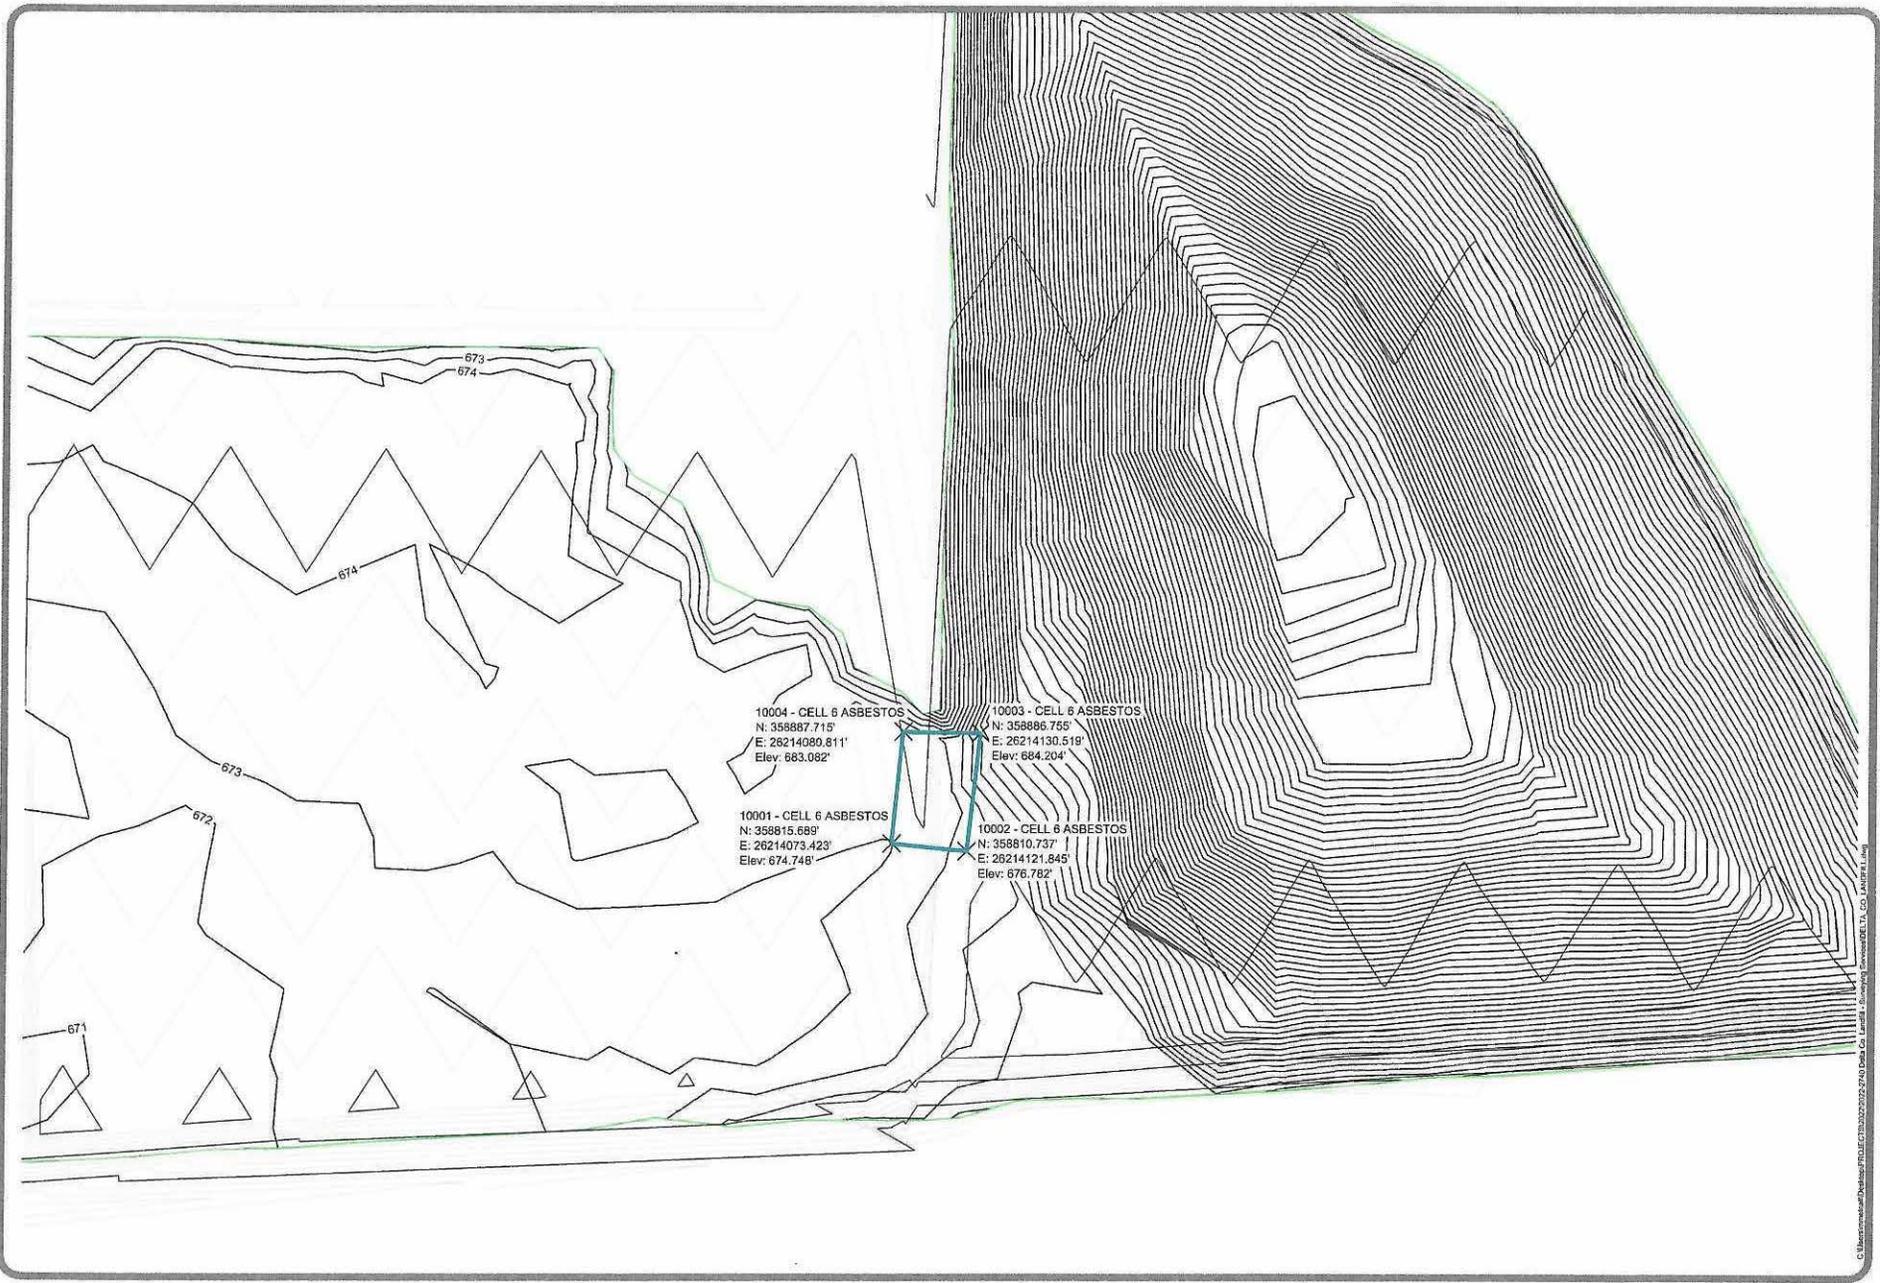
The third violation listed under EUASBESTOS, I have attached a copy of the asbestos hole map and coordinates on cell 6A for additional review (#3), we always have maps constructed with our annual volume survey but unfortunately we had to obtain our volume survey from a new company this year, so they did not have the asbestos portion completed on the map at the time of the inspection, this was corrected on January 26, 2023 when they provided us the actual map, prior to that we had the area constructed on our GPS unit only on our Bomag.
