DEPARTMENT OF ENVIRONMENTAL QUALITY
AIR QUALITY DIVISION
ACTIVITY REPORT: Scheduled Inspection

N728338661

FACILITY: UNILOY MILACRON, INC.		SRN / ID: N7283
LOCATION: 5550 OCCIDENTAL HWY, TECUMSEH		DISTRICT: Jackson
CITY: TECUMSEH		COUNTY: LENAWEE
CONTACT:		ACTIVITY DATE: 02/16/2017
STAFF: Mike Kovalchick	COMPLIANCE STATUS: Compliance	SOURCE CLASS: MINOR
SUBJECT: Unannounced compliance inspection. No findings.		
RESOLVED COMPLAINTS:

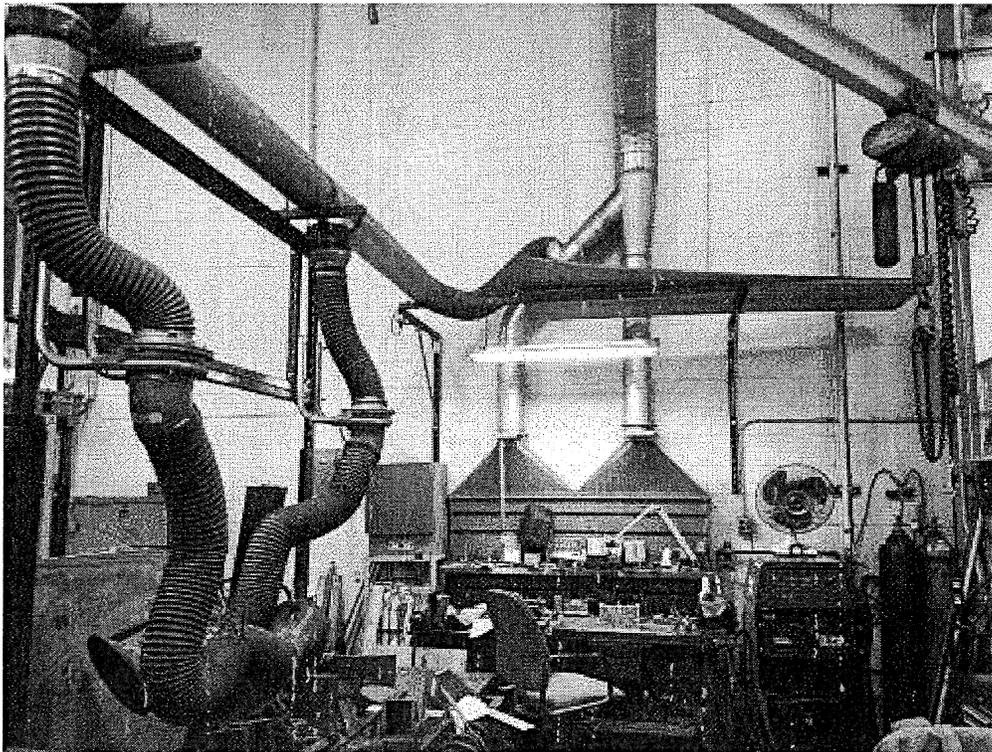
There is one small welding station that is exhausted outside but is considered exempt from permitting per Rule 285 (2) (i). (Note: When welding parts that contain chromium, the potential exists for hexavalent chromium fumes to be generated.)

Image 2(welding station) : Welding station. Just to the left of the picture are the polishing booth stations.

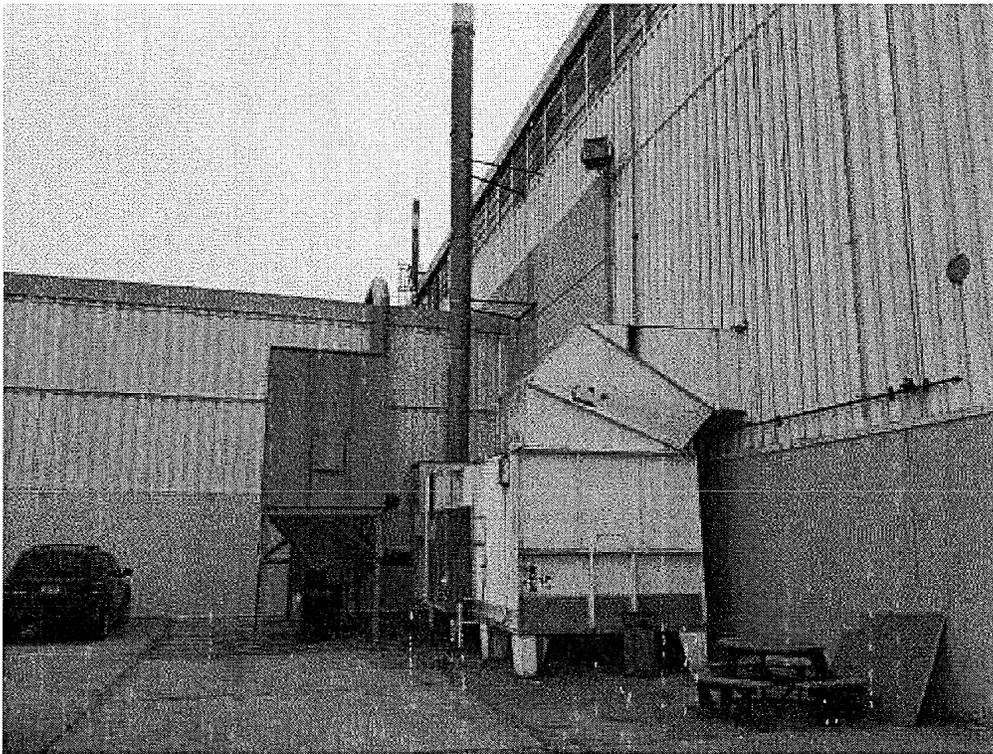
Next I went outside to take a look at the dust collector and the hepa filter system that is attached to it. (See attached photos.) The dust collectors appeared to be in good shape and were operating. No sign of any fallout nor was there any visible emissions. I did not see any indication of a pressure gauge that measured pressure drop across it. The bottom of the dust collector was attached to two 55 gallon barrels to collect any waste material. After talking with plant personnel, GS was unable to tell me when the barrels had been emptied last or when the last time the dust collectors had been serviced. (Note: They do service the fan on a regular basis.) It was felt that the polishing stations were generating so little dust that it was not surprising that more servicing wasn't required. Based on my observations of the very small size of the polishing stations, I tend to agree with them. (Based on review of previous inspection report, the barrels underneath the bag house were only about 1/4 full after 7 years of use. The Company at that time indicated that they planned to service the filters in the Fall of 2010.)

Image 3(Dust collector) : Dust collector and associated stack.

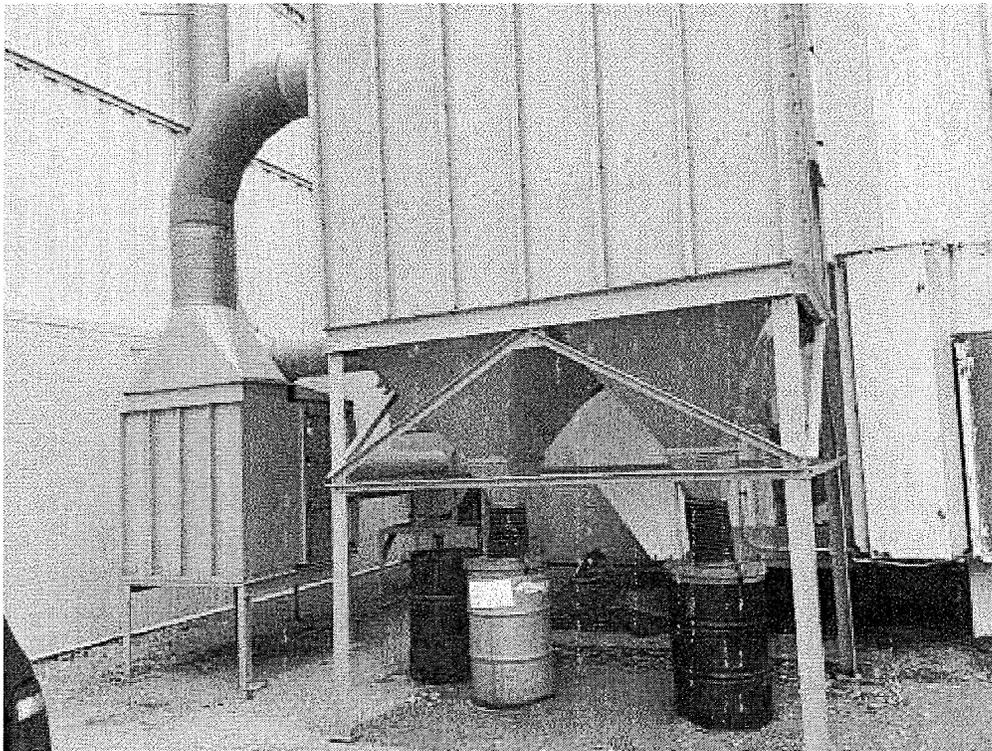
Based upon the facility inspection, review of the records, and review of applicable requirements, the Company is in full compliance with their PTI. There is some concern that the Company does not have a pressure drop indicator on their duct collectors or otherwise a way to monitor the performance of the dust collectors especially since very long periods of time go by between service calls on the filters due to the very low amount of particulate loading.

Image 4(Dust collector) : Hepa dust collector on the left with the primary dust collector on the right. Note the two barrels under the primary dust collector. (Left most barrel contained general trash.)
