DEPARTMENT OF ENVIRONMENTAL QUALITY
 AIR QUALITY DIVISION
 ACTIVITY REPORT: Self Initiated Inspection

FACILITY: MACK TRUCK & WIEGAND'S CRUSHED CONCRETE		SRN / ID: N7392
LOCATION: 37580 MOUND RD (NORTH OF 16 MILE RD), STERLING HTS		DISTRICT: Southeast Michigan
CITY: STERLING HTS		COUNTY: MACOMB
CONTACT: Kevin Deahart , Supervisor		ACTIVITY DATE: 10/30/2013
STAFF: Robert Elmouchi	COMPLIANCE STATUS: Pending	SOURCE CLASS: MINOR
SUBJECT: Self-initiated inspection.		
RESOLVED COMPLAINTS:

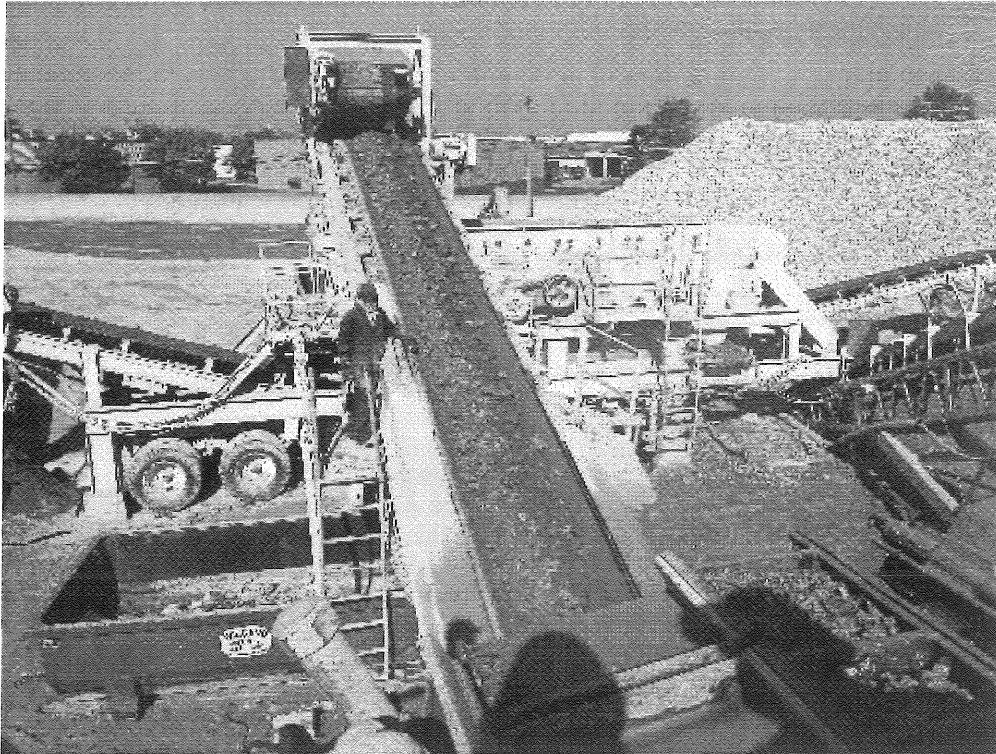
The person operating the crusher is called the Lever Operator. I observed the Lever Operator while he was using a handheld water spray nozzle to wet the raw (unprocessed) concrete that was in the hopper. The hopper feeds the crusher that outputs to the plate/vibratory feeder, which then feeds the underjaw belt conveyer. I observed that the spray pattern appeared to concentrate the water on the far side of the hopper from the Lever Operator's position. This spray pattern appeared to result in non-uniform wetting of the crushed concrete as it exited the crusher and was transported by the conveyer (see photo). I discussed the uneven wetting of the material and suggested that the Lever Operator change the spray pattern to more thoroughly wet the raw concrete closer to the operator. The Lever Operator tried my suggestion, which more evenly wet the crushed concrete output.

Image 1(20131030 121853 Wall) : Conveyer downstream of the crusher. Note that the material on right side of the conveyer appears darker than the left side, which appears to result from incomplete wetting of the uncrushed material while it is in the crusher's feed hopper.

I also discussed with Mr. Deahart, the need to control the particulates exiting directly below the crusher. Mr. Deahart and I discussed the possibility of adding a fine spray or misting nozzles to control the particulate emissions directly below the crusher. Mr. Deahart verbally committed to installing a control spray in a timely manner during the start of the 2014 crushing season. I will follow up on the control of particulates from the crusher and other emissions points at this facility. The compliance status of this facility is pending follow up inspections.
