DEPARTMENT OF ENVIRONMENTAL QUALITY
AIR QUALITY DIVISION
ACTIVITY REPORT: On-site Inspection

FACILITY: PREMIER FINISHES LLC		SRN / ID: N7896
LOCATION: 28060 GROESBECK HWY, ROSEVILLE		DISTRICT: Warren
CITY: ROSEVILLE		COUNTY: MACOMB
CONTACT: Brian Borowski , Partner		ACTIVITY DATE: 05/14/2021
STAFF: Robert Elmouchi	COMPLIANCE STATUS: Non Compliance	SOURCE CLASS: MINOR
SUBJECT: Unannounced on-site inspections on March 17, and May 14, 2021.		
RESOLVED COMPLAINTS:

MAY 14, 2021, ON-SITE INSPECTION

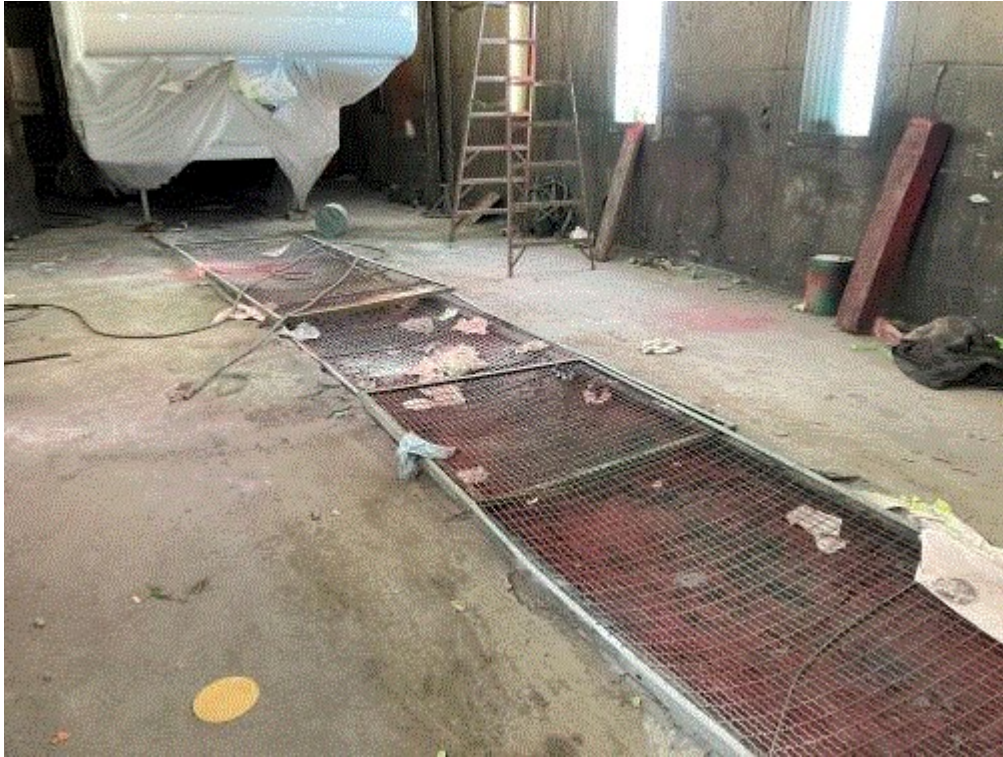
I observed that the EUBOOTH2 west-half floor grates had been cleaned. The east-half floor grates had been removed and temporarily replaced with lightweight grates (see photo) while the original grates were out for cleaning. Mr. Lowery turned on the EUBOOTH2 exhaust system so I could observe the pressure drop values. I observed pressure drops of -0.12 inches of water column for the west half of EUBOOTH2, and -0.10 inches of water column for the east half of EUBOOTH2. The observed pressure drop values were outside the manufacturer's specified pressure drop range of 0.00 to +0.80 inches of water column, per the "paint zone" range on the manufacturer's pressure drop gauges. I observed that the damper actuator on the EUBOOTH2 west exhaust stack was removed and was replaced with two vice grip pliers (see photo). Mr. Lowery attempted to manually adjust the dampers with limited success. It appears Premier Finishes LLC failed to maintain and operate the EUBOOTH2 double-wide spray booth pressure drop across the dry particulate filter control device in a satisfactory manner per R 336.1910 because the exhaust damper control actuator was not replaced, which resulted in a pressure drop outside the manufacturer's indicated operating range. This noncompliance shall be cited in a violation notice.

Image 1(IMG_0164.JPG): March 17, 2021. East half of double-wide spray booth showing temporary grates while original grates are being cleaned in a burn-off oven at another facility.

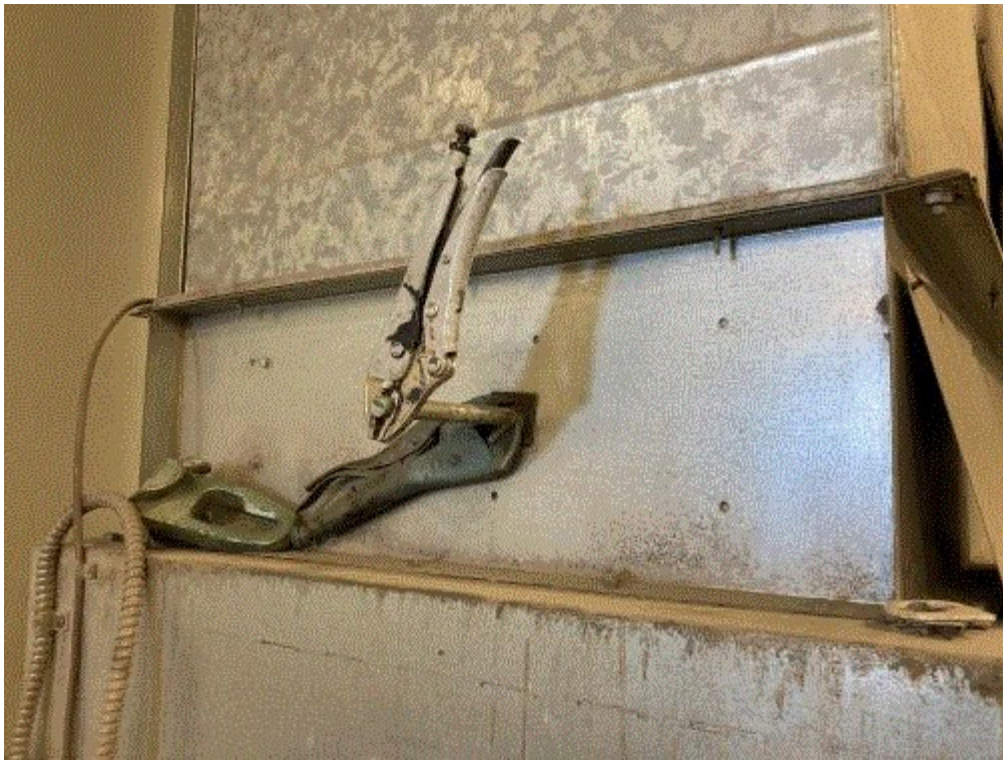
It appears that Premier Finishes is in violation of R 336.1910. The permittee failed to maintain and operate the EUBOOTH2 double-wide spray booth control device in a satisfactory manner because the exhaust damper control actuator was removed and not replaced. It appears that the failure to maintain the damper control actuator resulted in

observed pressure drops of -0.12 and -0.10 inches of water column, which are outside the manufacturer's specified pressure drop range of 0.00 to +0.80 inches of water column.

Image 2(IMG_0214.JPG) : May 14, 2021, Image of a broken damper actuator on the west plenum of the double-wide spray booth that has been replaced with vice grip pliers. This is one of two actuators on the double-wide spray booth that automatically adjust the pressure drop.

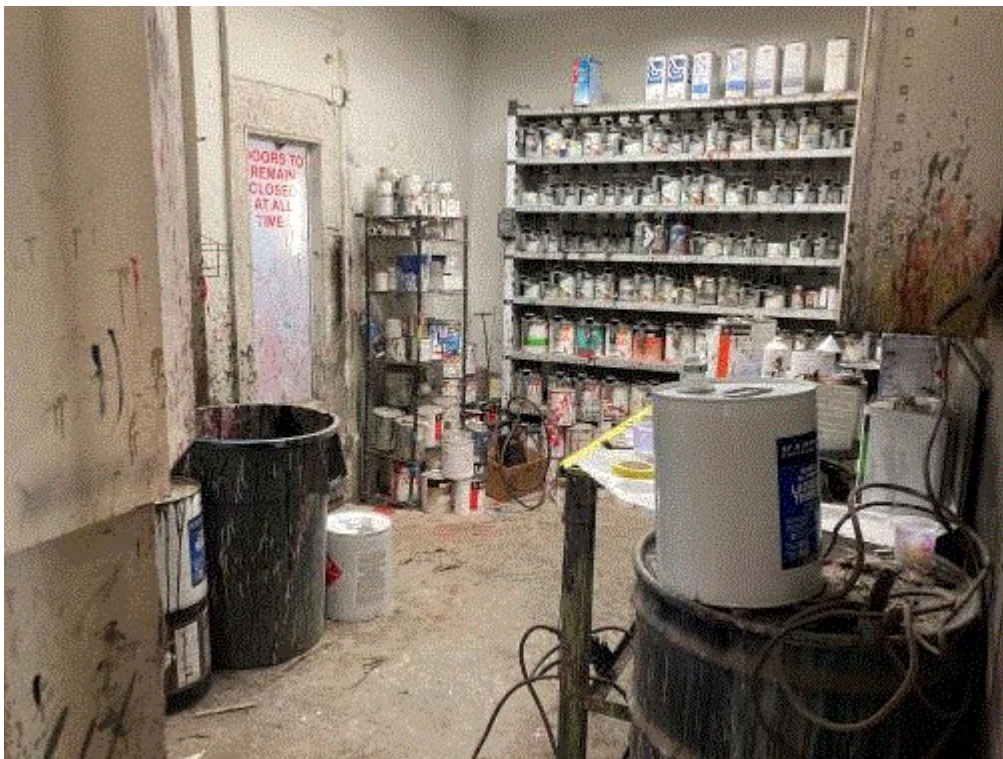
I observed an uncovered garbage can in the paint mixing room that contained paint and solvent-soaked materials (see photo). I also observed open cans of solvent and an open cup of solvent (see photos). I commented on the strong solvent odor in the paint mixing room. I discussed the requirements to control fugitive emissions with Mr. Lowery. Mr. Lowery stated that Mr. Borowski had purchased a safety lid, but the purchase of a matching drum was pending. Mr. Lowery escorted me to the front office so I could verify the safety lid had been purchased (see photo). These observed fugitive emission noncompliances appear to be violations of PTI No. 36-18, FGBOOTHs Special Conditions III.1 and III. 3, and Consent Order AQD No 219-05, 9.A.1., which shall be cited in a violation notice.

It appears that Premier Finishes in violation of PTI No. 36-18, FGBOOTHs Special Condition III. 3, and Consent Order AQD No 219-05, 9.A.1., because the permittee failed to handle all VOC and HAP containing materials, including coatings, reducers, solvents, and thinners, in a manner to minimize the generation of fugitive emissions, and the permittee failed to keep containers covered at all times except when operator access is necessary.

Image 3(IMG_0218.JPG) : May 14, 2021, The paint mixing room with multiple sources of uncontrolled fugitive

emissions.

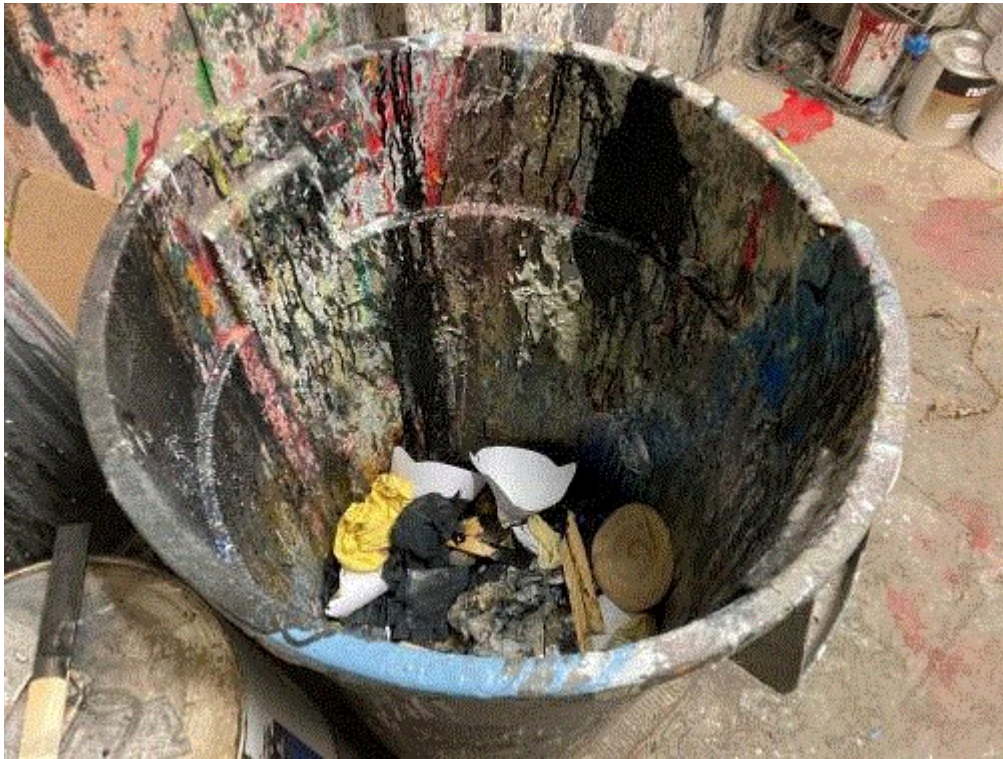
It appears that Premier Finishes in violation of PTI No. 36-18, FGBOOTHs Special Condition III.1, and Consent Order AQD No 219-05, 9.A.1., because the permittee failed to capture all waste materials and store them in closed containers.

Image 4(IMG_0219.JPG) : May 14, 2021, uncovered waste can containing paint and solvent contaminated wastes located in the paint mixing room.

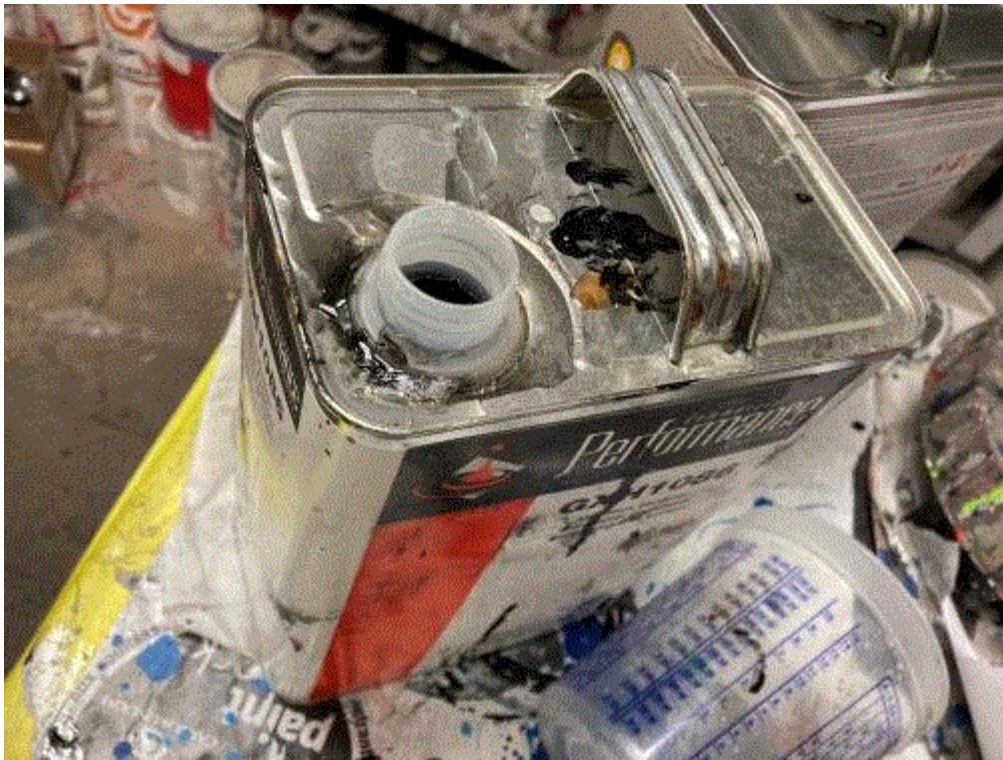
Image 5(IMG_0222.JPG) : May 14, 2021, uncovered can of solvent thinner that was one of the sources of fugitive emissions in the paint mixing room.

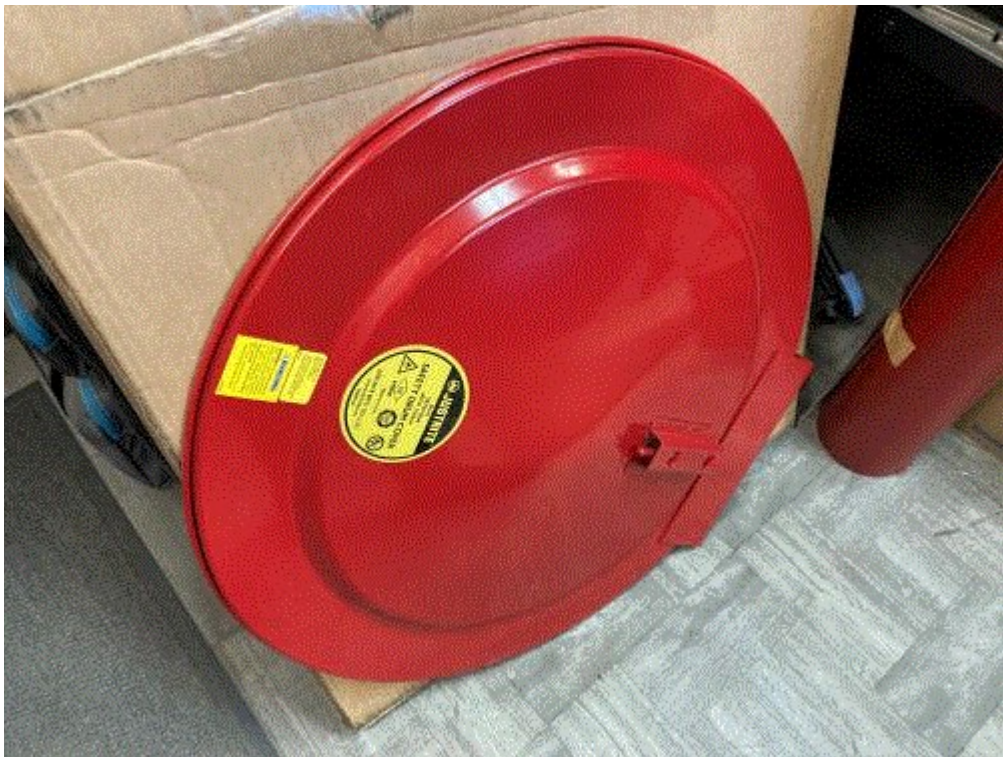
Image 6(IMG_0223.JPG) : May 14, 2021, image of hinged safety cover for a waste paint and solvent contaminated materials trash can stored in the front office. Installation is pending the purchase of a metal drum.

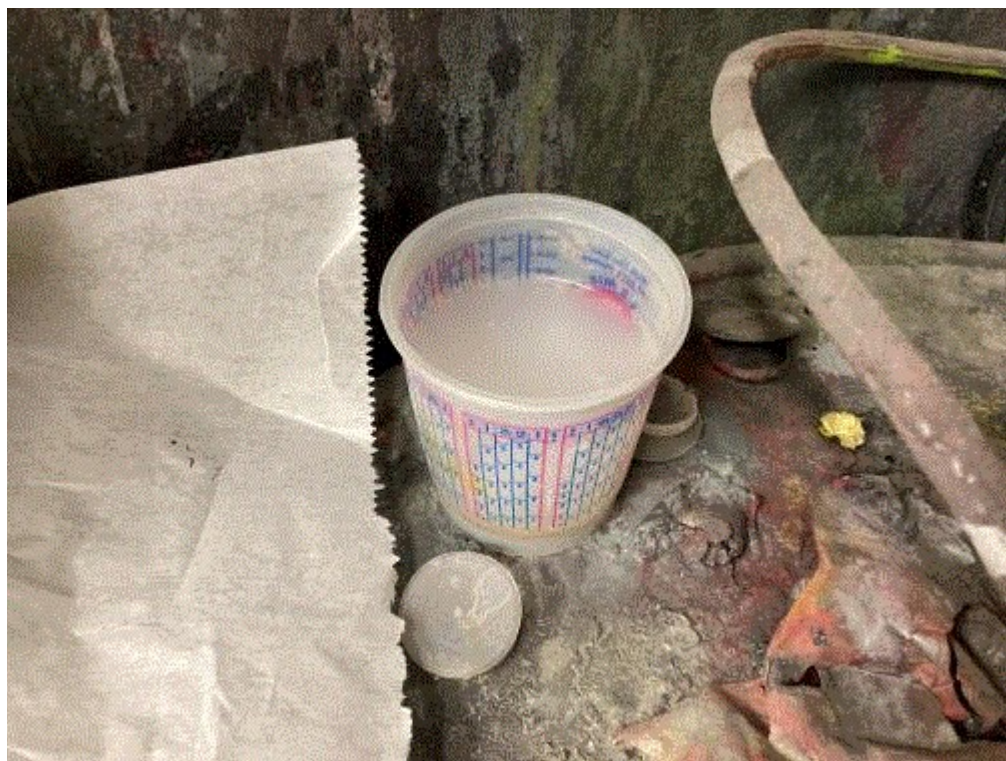
Image 7(IMG_0221.JPG) : May 14, 2021, open cup of solvent in the paint mixing room.
