DEPARTMENT OF ENVIRONMENTAL QUALITY  
AIR QUALITY DIVISION  
ACTIVITY REPORT: On-site Inspection

P114564317

<b>FACILITY:</b> Alta Cremation & Services, Inc.		<b>SRN / ID:</b> P1145
<b>LOCATION:</b> 13425 Capital Street, OAK PARK		<b>DISTRICT:</b> Warren
<b>CITY:</b> OAK PARK		<b>COUNTY:</b> OAKLAND
<b>CONTACT:</b> Kenneth Allen Sr. , Owner		<b>ACTIVITY DATE:</b> 08/31/2022
<b>STAFF:</b> Robert Elmouchi	<b>COMPLIANCE STATUS:</b> Non Compliance	<b>SOURCE CLASS:</b> Minor
<b>SUBJECT:</b> Unannounced scheduled inspection.		
<b>RESOLVED COMPLAINTS:</b>

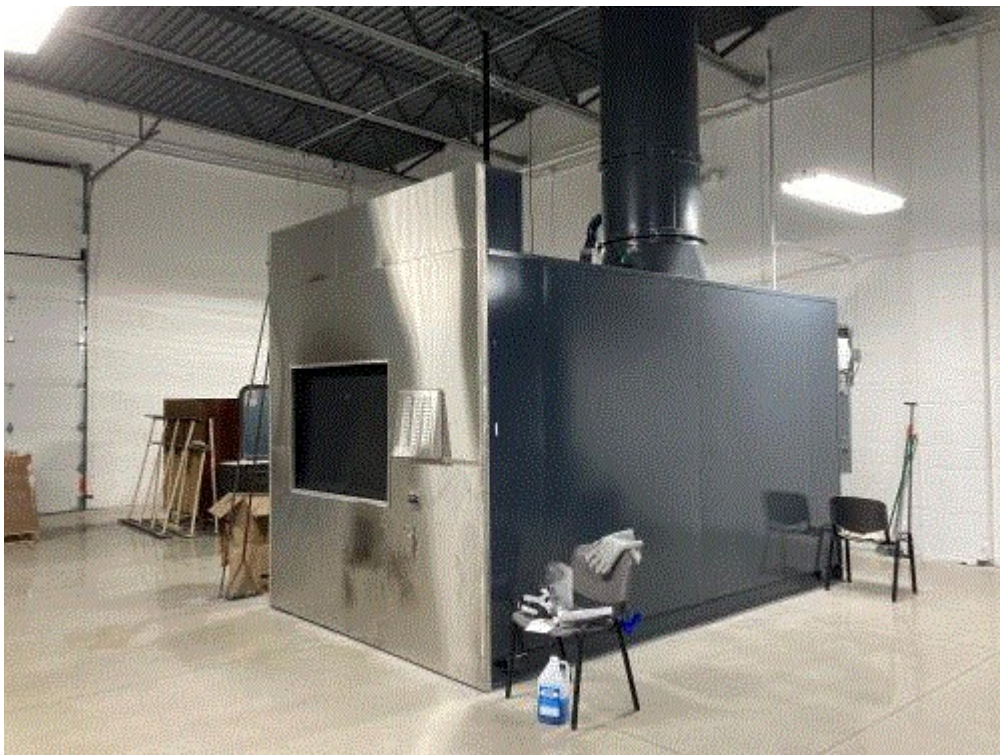
**I observed the B&L Cremation Systems, Phoenix II-3 cremation unit (EUCREMATORY1). The exterior had minor soot deposits (Image 1). Mr. Allen Sr. stated that the cremation unit is operated about two to three times per week. It is my understanding that Infrequent incinerator operation subjects the refractory lining to excessive expansion and contraction, which can cause long cracks that can be larger than 3/16" wide. Mr. Allen opened the primary combustion chamber (PCC)**

**Image 1(IMG 0398)** : B&L Cremation Systems, Phoenix II-3 cremation unit. This image shows the whole cremation unit with the primary combustion chamber charge door on the front (left) of the emission unit, and the control panel on the back (right) of the emission unit

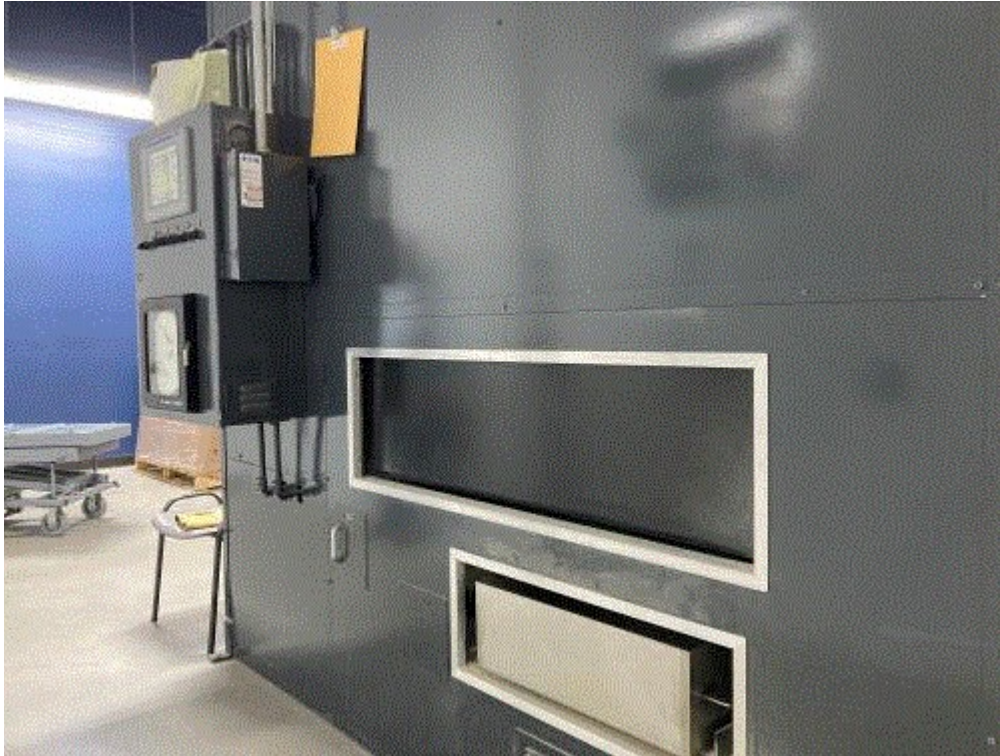
**Image 2(IMG 0407)** : View of the rear of EUCREMATORY1. The control panel and temperature chart recorder are mounted on the left. The long black rectangle is the primary combustion chamber rear door. The smaller silver rectangle is the cremains collection bin.

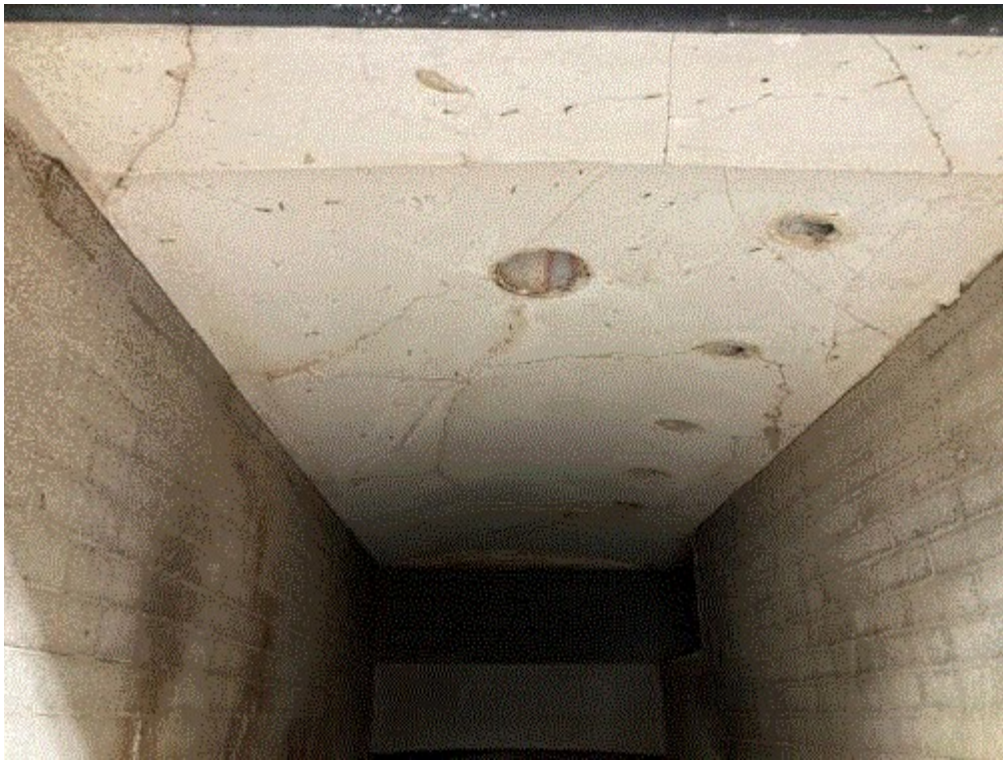
door to allow me to inspect the condition of the refractory lining. I observed less cracking in the ceiling than expected. No significant cracks were observed.

**Image 3(IMG 0402)** : Upward view of the front of EUCREMATORY1 primary combustion chamber ceiling. No significant cracks were observed. Cremains are swept to the rear floor of the primary combustion chamber. The cremains are then collected through a rear door.

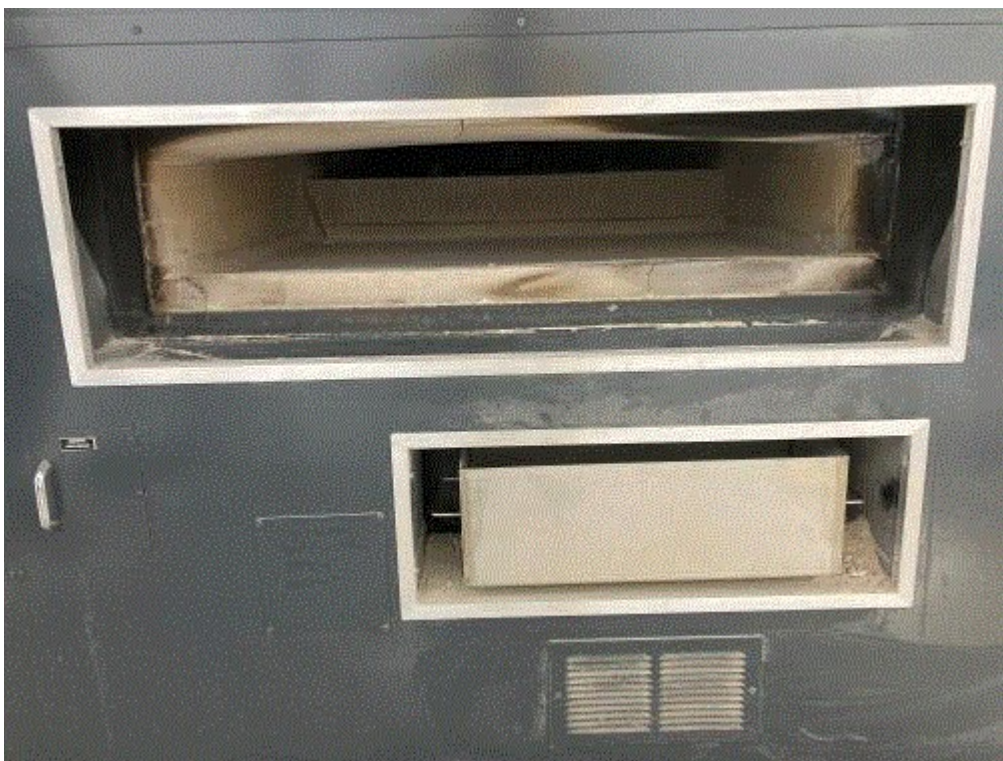
Second, Mr. Allen Sr. stated that a mechanical malfunction causes the Primary Combustion Chamber rear door to occasionally open about a half inch, which requires the operator to manually close the rear door. Mr. Allen Sr. stated that service on this door is pending a return visit by the technician. I stated that the partially open PCC door may reduce the SCC temperature by introducing cooler air into the exhaust stream. This may cause, or contribute to, the SCC operating temperature dropping below the permitted minimum of 1600°F. I discussed this issue again with Mr. Allen Sr. by cell phone later on August 31, 2022. Mr. Allen Sr. reiterated that he thought the low-temperature records were due to a calibration error. I stated that all reasonable causes of this temperature malfunction must be evaluated. Mr. Allen Sr. agreed. The mechanical malfunction of the PCC rear door constitutes a violation of PTI No. 115-20, EUCREMATORY1, III.2, which states in part, “The incinerator shall be installed, maintained, and operated in a manner satisfactory to the AQD District Supervisor to control emissions from EUCREMATORY1.” This violation shall be cited in a violation notice.

**Image 4(IMG 0404)** : EUCREMATORY1 primary combustion chamber open rear door (top rectangle). Cremains

are swept from the front of the primary combustion chamber (PCC) to the rear of the PCC, and then pushed into a narrow chute that empties into a collection bin (bottom).

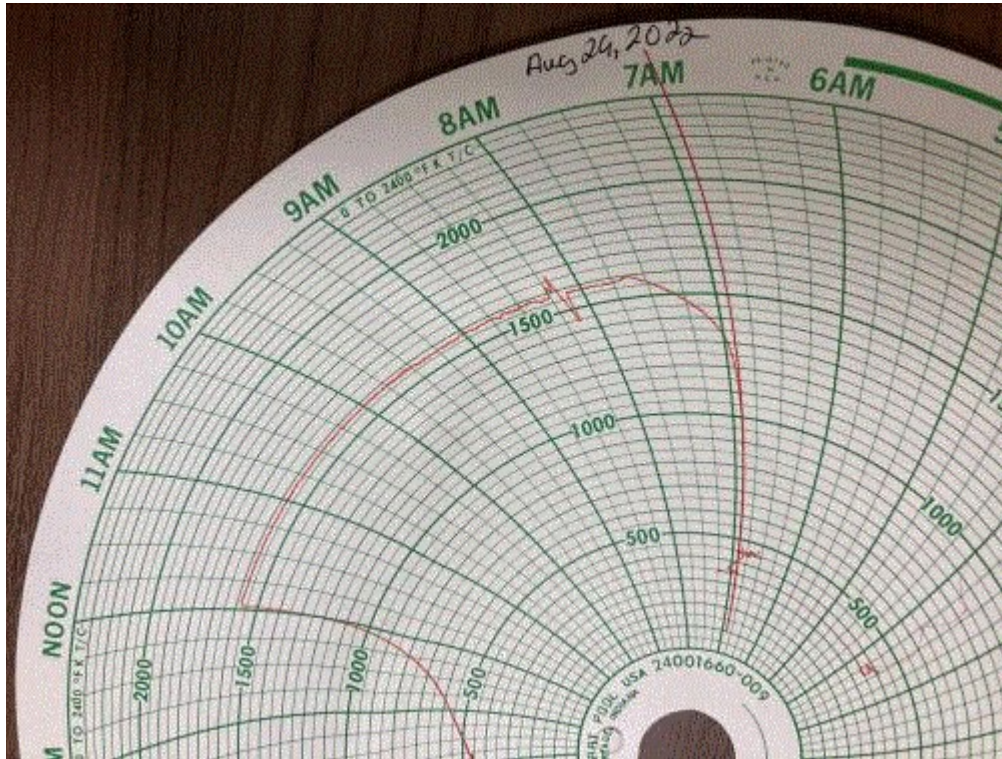
The March 4, 2021, temperature record (Image 6) indicates compliance with the minimum secondary combustion chamber (SCC) of 1600°F. Therefore, the EUCREMATORY1 SCC has operated above 1600°F. The temperature records from August 29 through August 31, 2022, (Images 5 and 7), indicate EUCREMATORY1 was operated at 1575 degrees Fahrenheit, which is 25 degrees less than the permitted minimum of 1600 degrees. This constitutes a violation of PTI No. 115-20, EUCREMATORY1, III.1, which states, "The permittee shall not combust waste in EUCREMATORY1 unless a minimum temperature of 1600°F and a minimum retention time of 1.0 second in the secondary combustion chamber are maintained." This also constitutes a violation of R 336.1910, which states, "An air-cleaning device shall be installed, maintained, and operated in a satisfactory manner and in accordance with these rules and existing law." These violations shall be cited in a violation notice.

**Image 5(IMG\_0409)** : Close-up view of EUCREMATORY1 temperature chart dated, "Aug 29, 2022." The record indicates the secondary combustion chamber was continuously operated at 1575 degrees Fahrenheit, which is 25 degrees less than the permitted minimum of 1600 degrees.

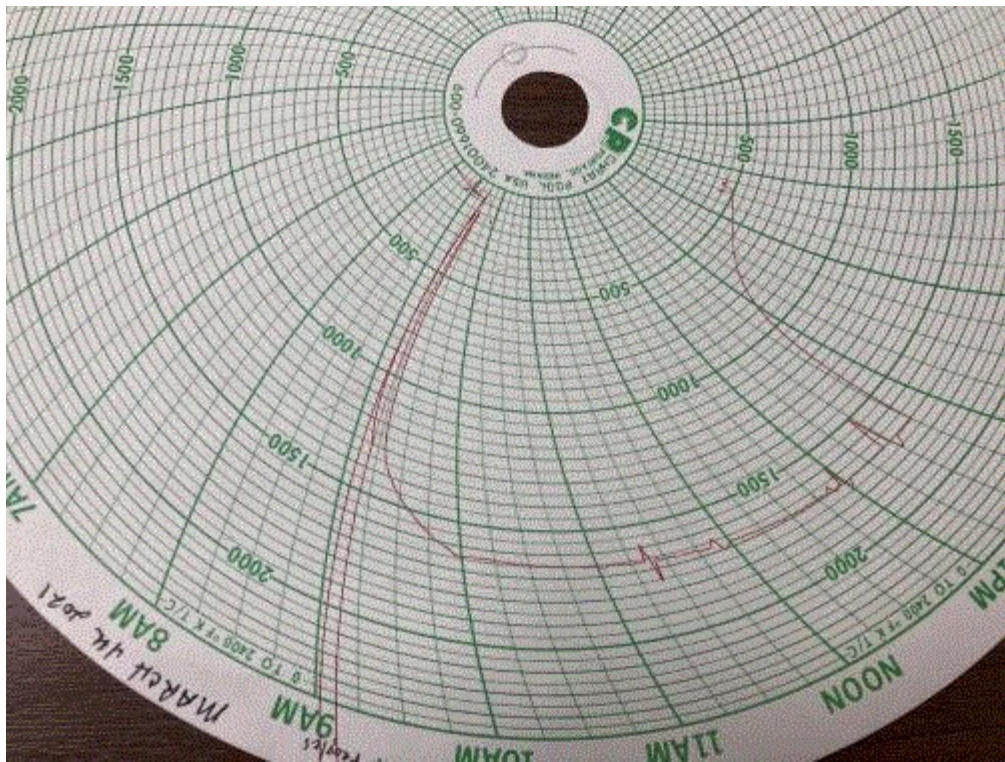
**Image 6(IMG\_0413)** : Close-up view of EUCREMATORY1 temperature chart dated, "March 4th, 2021." Records indicate the SCC operated at 1650 degrees F, which met the minimum temperature requirement of 1600 degrees Fahrenheit.

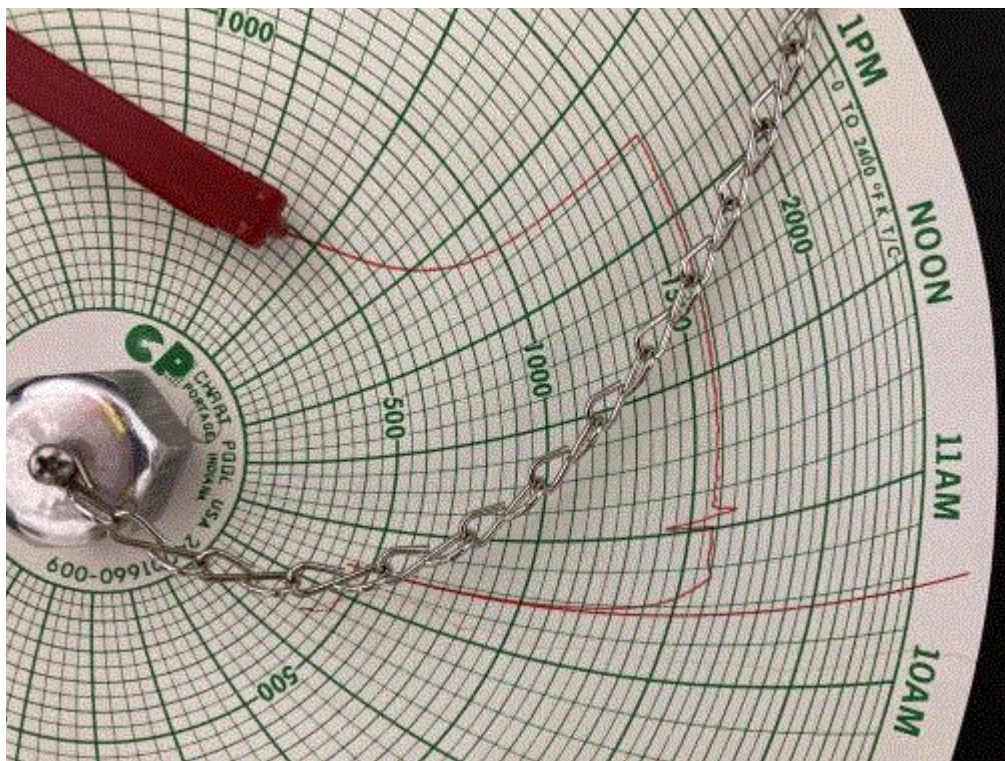
I reviewed temperature chart records for EUCREMATORY1. Mr. Allen Sr. was able to produce cremation records during this inspection. Mr. Allen Sr. stated that a new paper chart is used to record the temperature each operating day. During this inspection, I observed that the temperature chart (Image 7) on EUCREMATORY1 did not identify the date, and the time the charge was inserted. All temperature charts I reviewed did not identify the date, and the time the charge was inserted. Per my request, Mr. Allen Sr. wrote dates on some temperature charts during this inspection. We also reviewed the cremation logs. The weight was recorded for each cremation. I learned that the start time recorded on the cremation logs is when EUCREMATORY1 starts up, not when the charge is inserted. Furthermore, the permittee failed to record the end time of each cremation, therefore the duration of each burn was not recorded. Mr. Allen Sr. and I discussed these recordkeeping deficiencies and how to resolve them by writing legible information on each temperature chart. Alta Cremation failed to keep satisfactory records of the date and time (duration of burn) of each charge combusted. This constitutes a violation of PTI No. 115-20, EUCREMATORY1, VI.3, which states in part, "The permittee shall keep, in a manner satisfactory to the AQD District Supervisor, daily records of the time (duration of burn), description and weight of the charge combusted in EUCREMATORY1, as required by SC II.2." This violation shall be cited in a violation notice.

**Image 7(IMG\_0391)** : EUCREMATORY1 temperature chart on the machine (8/31/2022 inspection). The record

indicates the secondary combustion chamber was continuously operated at 1575 degrees Fahrenheit, which is 25 degrees less than the permitted minimum of 1600 degrees.

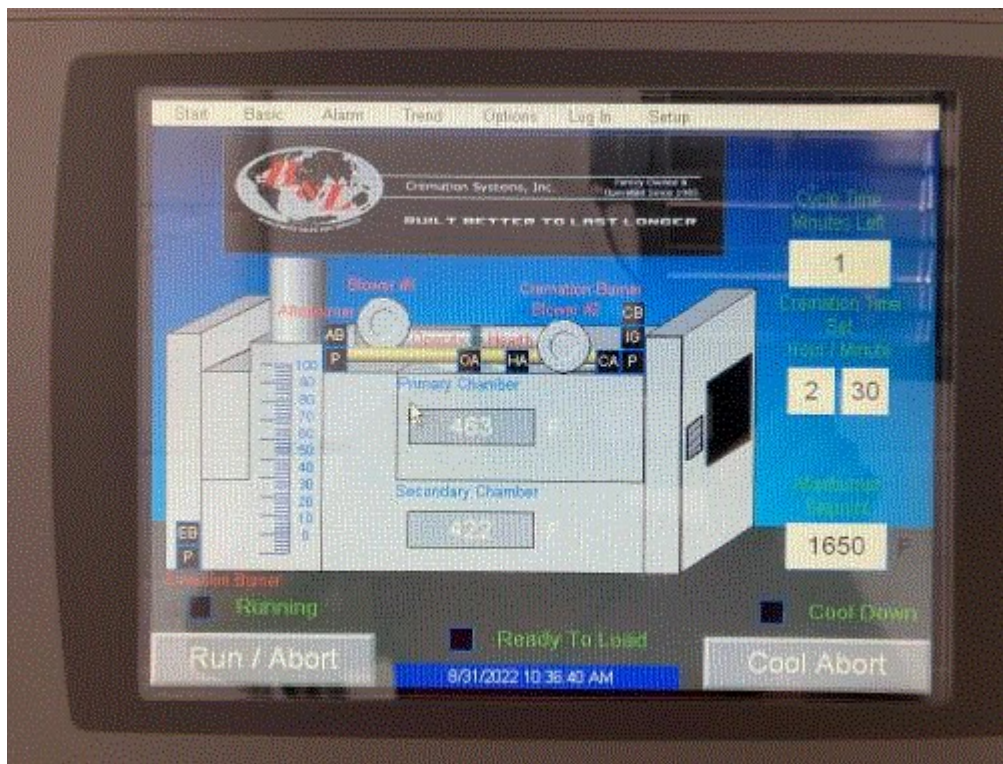
I have noted two items while evaluating compliance. First, Mr. Allen Sr. asserted that the low-temperature records may be caused by a chart recorder calibration error rather than a failure to maintain 1600°F in the SCC. This assertion appears to be supported by Image 8 below, which is a close-up view of the EUCREMATORY1 control panel. The control panel shows that the Afterburner (SCC) Setpoint is 1650° F. A chart recorder calibration error constitutes a violation of PTI No. 115-20, EUCREMATORY1, IV.2, which states, "The permittee shall install, calibrate, maintain, and operate in a manner satisfactory to the AQD District Supervisor, a device to

monitor and record the temperature in the SCC of EUCREMATORY1 on a continuous basis.” This violation shall be cited in a violation notice.

**Image 8(IMG\_0395)** : EUCREMATORY1 control panel. Note that the Afterburner (secondary combustion chamber) Setpoint is 1650F, which appears to support Kenneth Allen Sr.'s assertion that the low-temperature records are due to a chart recorder calibration error.
