DEPARTMENT OF ENVIRONMENTAL QUALITY  
AIR QUALITY DIVISION  
ACTIVITY REPORT: On-site Inspection

P141069614

<b>FACILITY:</b> Padnos Wyoming Recycling	<b>SRN / ID:</b> P1410
<b>LOCATION:</b> 500 44th Street SW, GRAND RAPIDS	<b>DISTRICT:</b> Grand Rapids
<b>CITY:</b> GRAND RAPIDS	<b>COUNTY:</b> KENT
<b>CONTACT:</b> Kyle Daneff, Environmental Manager	<b>ACTIVITY DATE:</b> 10/10/2023
<b>STAFF:</b> April Lazzaro	<b>COMPLIANCE STATUS:</b> Non Compliance
<b>SOURCE CLASS:</b>	
<b>SUBJECT:</b> Unannounced inspection in response to a complaint forwarded from EPA Region 5.	
<b>RESOLVED COMPLAINTS:</b> C-24-00104

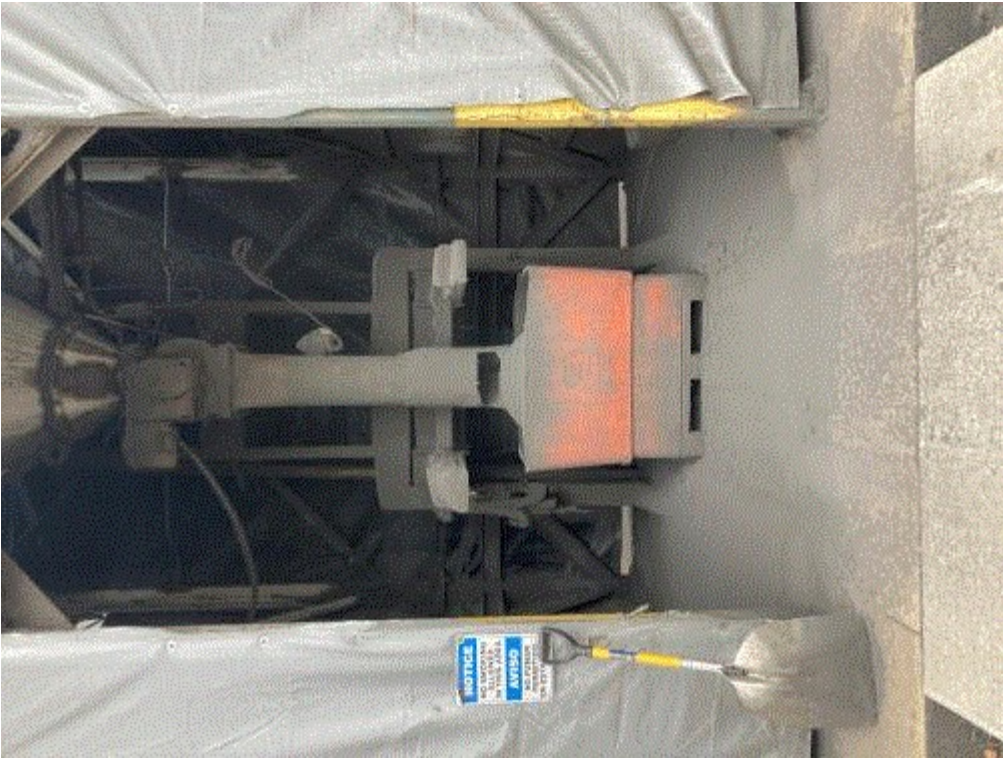
Baghouse #1 was installed to control the plastic shredder installed in ~2010. This material collection area was a solid tube pointed down toward an open top plastic container. This area had a tarped shroud built around it (see photos below), with a fully open space on the eastern side away from the wall that was exposed to the elements. Not only was there a fairly large drop distance between the tube and the

collection container, but at the time of the inspection, the plastic dust was mounding above the height of the container. There was significant accumulation of plastic “dust” on the ground and floating in the air outside of the shroud, as it dropped from the discharge tube. This material in the air was a fine particulate and was pointed out to Mr. Ignatowski as we observed the unit. Padnos asked what an acceptable capture system might look like, and we talked about a tube connected to a sealed roll off type ‘box’ like what is used by wood dust collection systems.

**Image 1(Shredder 1)** : Shredder 1 baghouse discharge. View photo one turn clockwise.

Neither system has a pressure drop or magnehelic gauge to help determine proper operation. I was informed that the bags in the baghouse are replaced annually. A Malfunction Abatement Plan will be requested pursuant to Rule 911 for both systems. The two plastic shredding emission units were not properly containing a collected air contaminant, which is required by Rule 370. As such, both emission units are in violation of Rule 370. Additionally, while this type of process could potentially utilize the Rule 285(2)(l)(vi) exemption, it does not meet the criteria because neither equipment had emissions being released only into the general in-plant environment, nor were they utilizing an appropriately designed and operated fabric filter collector. As such, both lines are also in violation of Rule 201 for failure to obtain a Permit to Install. A Violation Notice will be issued.

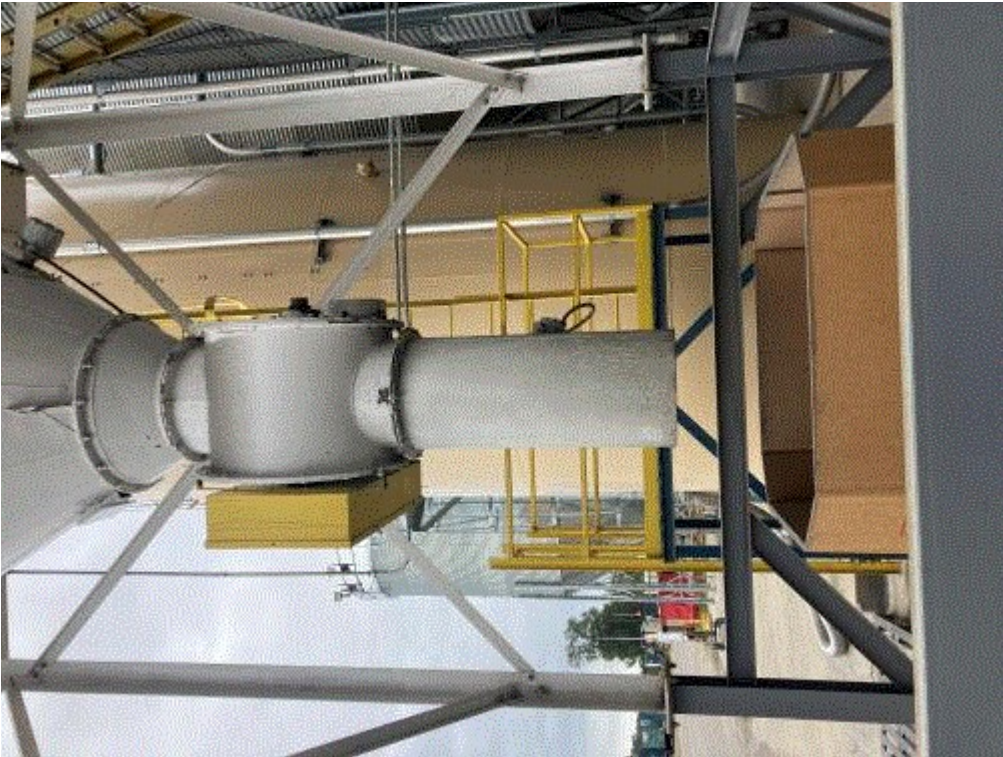
Baghouse #2 which was installed to control the second plastic shredder installed in 2023. This baghouse discharge tube was not enclosed by a shroud of any kind, which is intended to deposit the collected plastic dust into an open top cardboard tote kept below. There was a large drop distance between the discharge tube and the top of the cardboard tote. (see photos below)

**Image 2(Shredder 2)** : Shredder 2 baghouse discharge. View photo one turn clockwise.

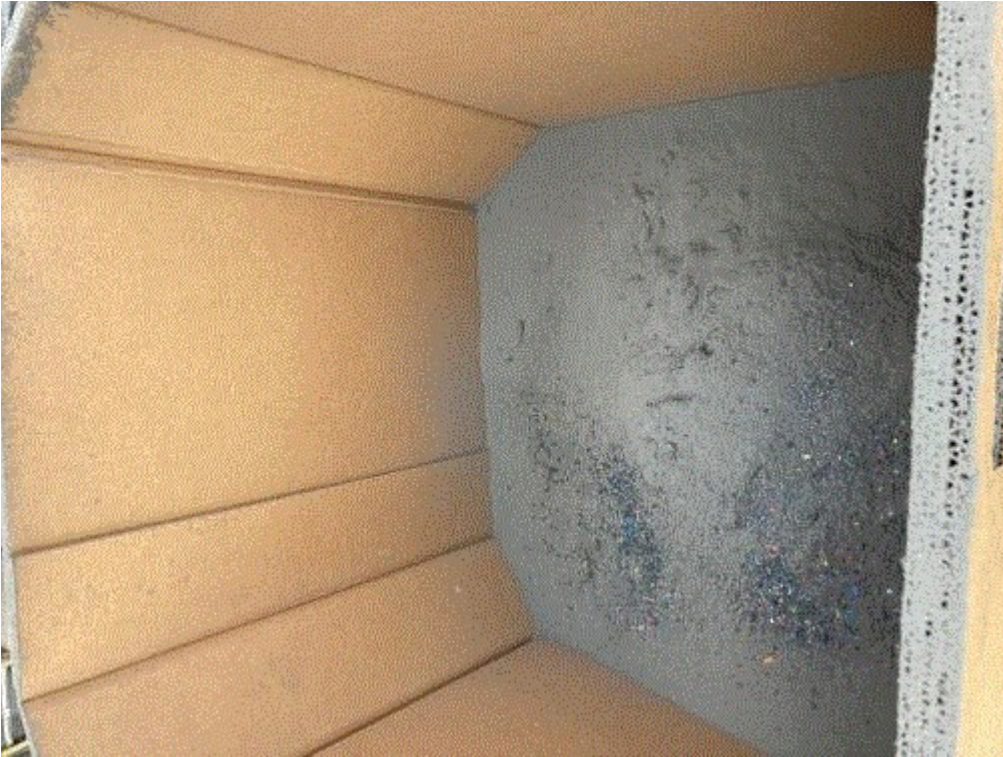
**Image 3(Shredder 2)** : Shredder 2 baghouse discharge material in open top box. View photo one turn clockwise.

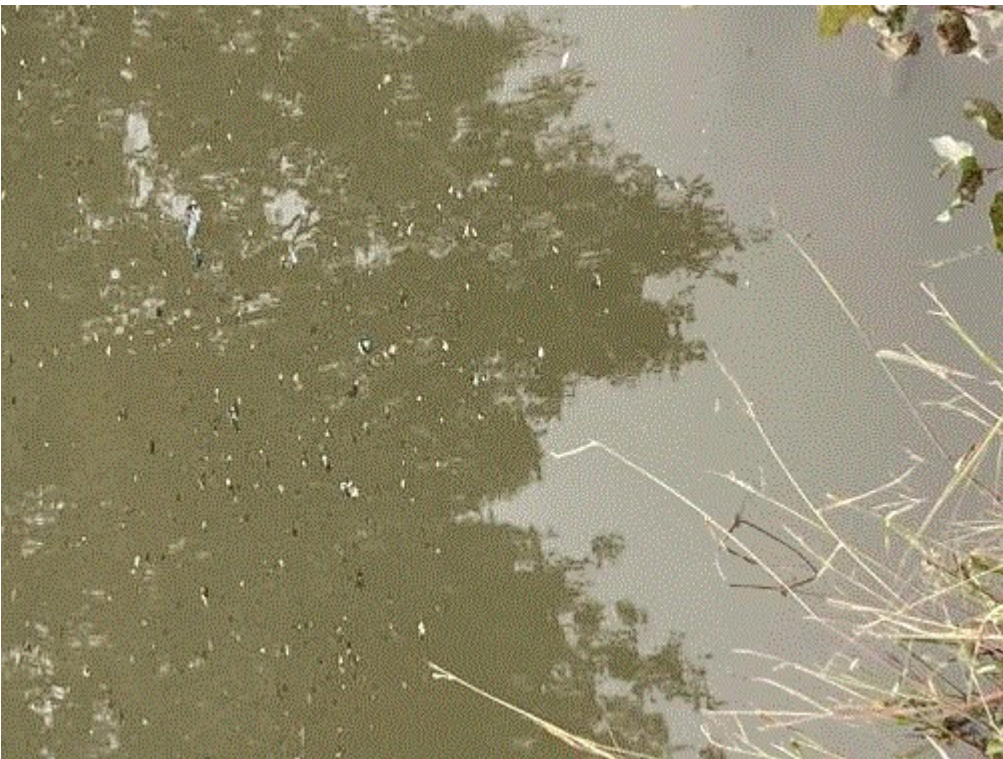
As the exterior WRD inspection continued, it was noted that progress toward characterizing the water collection system was ongoing. The majority of surface water drains collect water on-site and directs them to a type of underground separation system, prior to being contained in a surface water containment pond that is not connected to waters of the state. The access lid to the underground system was observed and was covered by dirt and debris. Padnos was unaware of how the system was designed or operated. The water in the containment pond was observed, and there was a large quantity of plastic debris floating on top, (see attached photo) although less than what WRD staff had observed during an inspection in December of 2022. It was noted that a family of ducks was on the pond and pecking at the

surface of the water, potentially consuming plastic debris. This is a concern that was discussed with Padnos staff at the conclusion of the inspection.

**Image 4(Surface water pond)** : Surface water retention pond, plastic on surface.

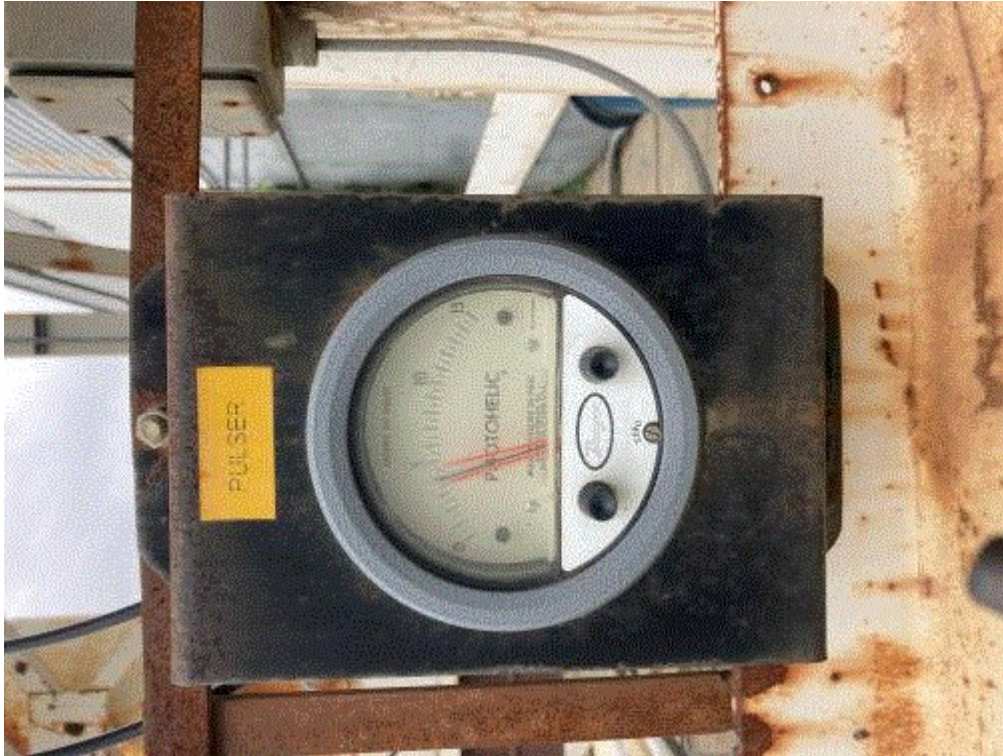
On the southeast side of the facility is a third baghouse that is used to control emissions from a copper grinding process. The pressure drop gauge read approximately 3.9" H<sub>2</sub>O at the time of the inspection. The low and high alarm setpoints were engaged at 3.5" and 4.8" H<sub>2</sub>O, however we identified that the wire that controlled this was not connected. It was unknown to Padnos staff how the baghouse operated and whether it was on automatic pulse to clear the bags. The baghouse fines collection was contained in a supersack, that was cinched around the discharge tube. The area was free of debris. Neither the baghouse or the collection system had been known to be inspected in at least three years. The baghouse exhaust is a return air configuration, where all exhaust air is directed back into the plant.

**Image 5(Copper grinding)** : Copper grinding baghouse magnehelic gauge. View photo one turn clockwise.

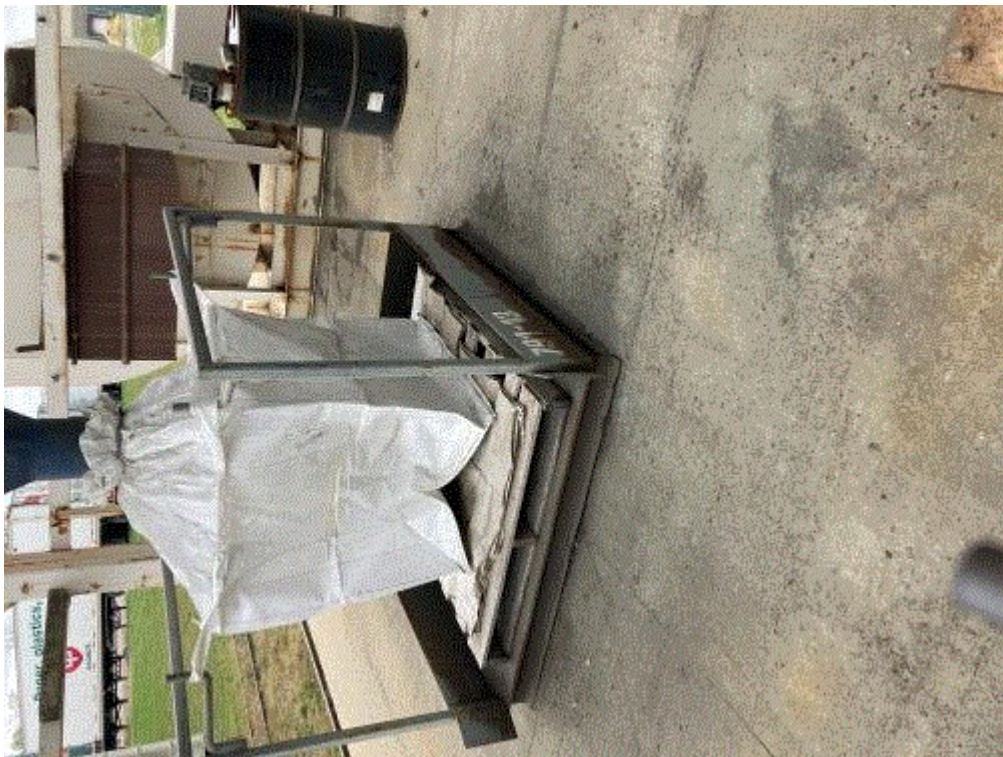
**Image 6(Copper grinding)** : Copper grinding baghouse supersack. View photo one turn clockwise.
