NESHAP Asbestos Survey Report

(For Planned Building Renovation)

SUBJECT PROPERTY: Multi Family Building Structures (3)

352 Bradley Avenue Buildings # 1, # 4 & # 5 Flint, Michigan 48503

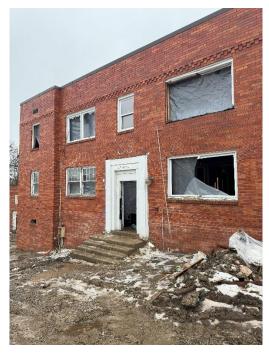
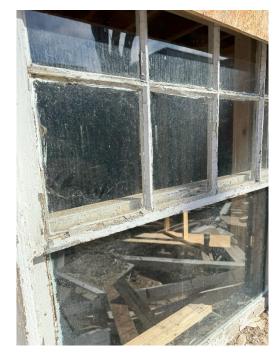
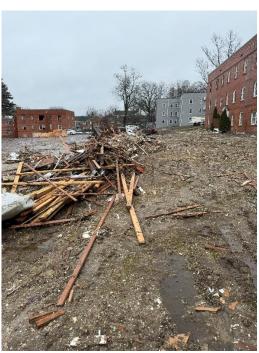
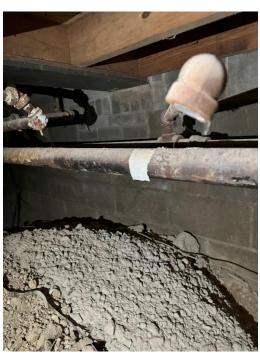
Sample # 65-A, (multi-level flooring sample) from debris piles between buildings # 4 & # 5 see attached marked up site plan.

Sample # 66-A, (multi-level flooring sample) from debris piles between buildings # 4 & # 5 see attached marked up site plan.

All Asbestos Containing Materials (ACMs) with greater than 1% asbestos content are required to be removed by a Contractor Licensed by the State of Michigan to perform Asbestos Abatement Services before any Building Demolition, Selective Demolition, or Building Renovations Commence.
