DEPARTMENT OF ENVIRONMENTAL QUALITY
AIR QUALITY DIVISION
ACTIVITY REPORT: On-site Inspection

FACILITY: Huyser Asphalt Paving & Sealcoating		SRN / ID: U412004219
LOCATION: , Grand Rapids		DISTRICT: Grand Rapids
CITY: Grand Rapids		COUNTY: KENT
CONTACT: Marc Buist ,		ACTIVITY DATE: 12/16/2020
STAFF: April Lazzaro	COMPLIANCE STATUS: Compliance	SOURCE CLASS:
SUBJECT: Unannounced, unscheduled inspection in response to a complaint.		
RESOLVED COMPLAINTS: C-21-00204

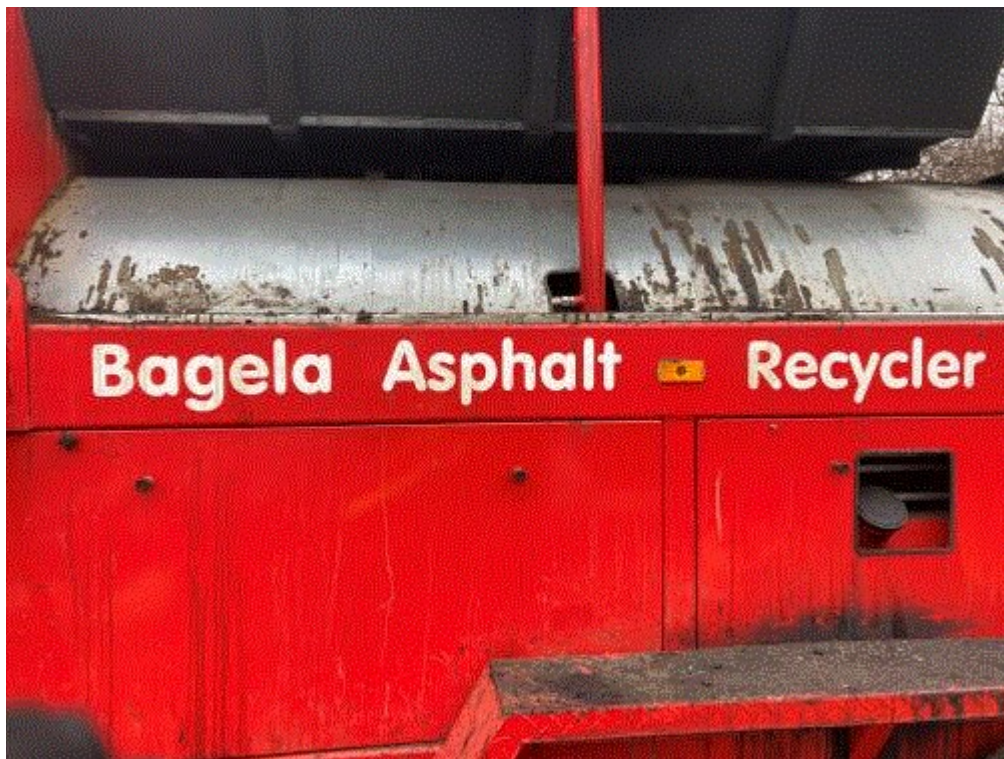
Other companies in Michigan operate the Bagela BA 10,000 pavement recycling unit. During an inspection and investigation into the unit in 2014 at a different asphalt company in the Grand Rapids area, I found that this common operation is exempt from permitting per Rule 290 across the state. However, while a permit is not required, it would still be subject to the AQD Rule 901 that prevents any smoke and odors generated by this equipment from causing an unreasonable interference of the comfortable enjoyment of life and property.

The Bagela BA 10,000 mixes virgin asphalt an additive/binder and crumb rubber and heats it to approximately 320°F to form a hot patch asphalt material. This unit has had a few small fires, but none that rendered it inoperable.

We continued our walk through and approached the Bagela BA 10,000 for an up-close visual inspection. There were totes of binder present with materials that had been spilled to the ground. Mr. O'Boyle provided education to Mr. Engleman regarding proper use of material and when it is spilled on the ground, it becomes a regulated waste.

Image 1(Bagela BA 10,000) : Asphalt recycling unit, likely cause of smoke and odor.

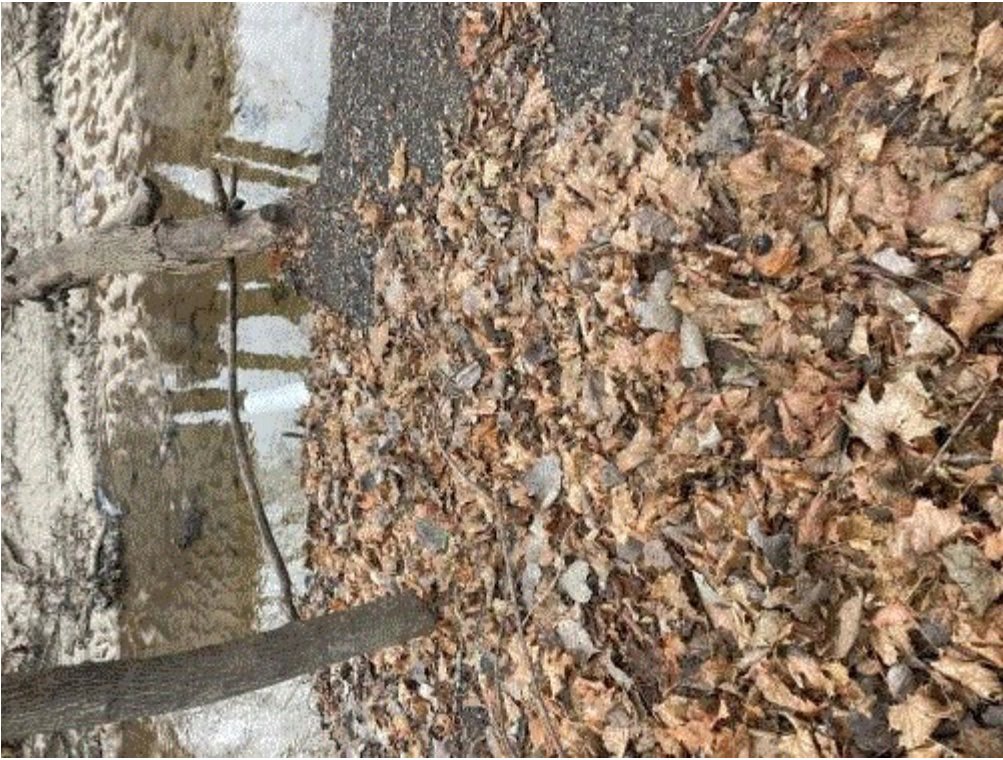
Mr. O'Boyle and I walked to access the site and conducted a visual inspection of the creek adjacent to the entrance drive along the way. As we entered the area to the east of the main site that consisted of a parking lot which housed vehicles with the company logo, a PVC pipe that appeared to be some sort of storm drain was observed. (see attached photo). Previous inspections conducted by department staff had not identified this pipe. No visible debris was observed, and a fence was present as a barrier to the creek in the main "yard" of the facility.

multiple occasions. This unit only operates during the colder times of the year when the asphalt plants are down, but there's no snow on the ground. Typically, this is a few months a year. We briefly discussed the PVC pipe outfall to the creek that was observed. He indicated that they were aware of it, but weren't sure if it was even active. I suggested that they observe the pipe during the next rainfall event to see if there is water flow and discharge to the creek. I indicated that they may be contacted by the Water Resources Division for follow up.

Image 2(PVC outfall) : Discharge point from property into creek.

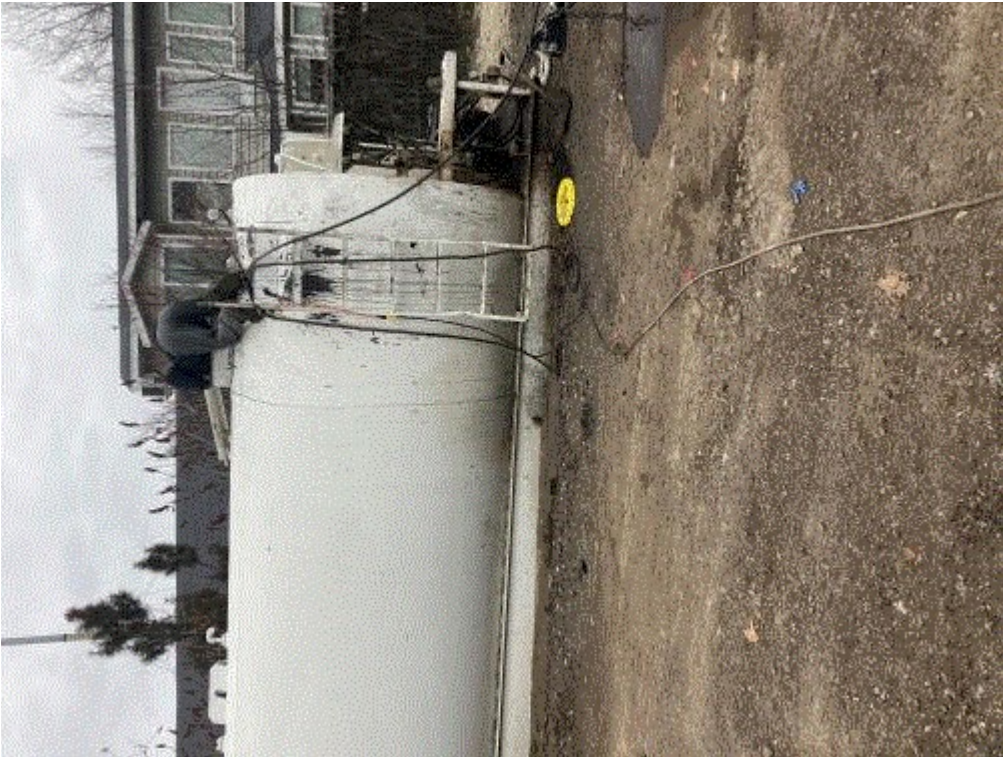
Mr. O'Boyle and I conducted a full site walk around, and he identified several areas that were subject to MMD Rules and Regulations and explained those to Mr. Engleman as items were observed. As we entered the area at the rear of the shop, several oil tanks were observed, as well as a large white tank that is used for storage of sealcoating liquid. At the time of the inspection, it became apparent that someone was inside the tank using a jack/air hammer for cleaning. Mr. Engleman confirmed that there was an employee inside the tank. As we watched, I looked for signs of confined space entry/permit documentation, or a spotter/observer for the employee in the tank. After observing none of those things, I asked Mr. Engleman if any confined space evaluation had been conducted, for example, air monitoring or requiring a spotter/attendant. He responded that they had not done an evaluation but there should be someone watching and there should be a fan inside. No one was present. I informed Mr. Engleman that he needed to remove the employee from the tank until the proper safety measures had been implemented. Mr. O'Boyle reiterated the safety concerns, and we stated that while it is not our jurisdiction, we would not allow the activity to continue. I also stated that I would immediately call the Michigan Occupational and Safety Administration (MIOSHA) if he was not removed.

Mr. Engleman removed the employee from the tank.

Image 3(Sealcoat tank) : An employee is inside the tank, and is not pictured.

Following the inspection, I immediately sent Mr. Buist information via email that included a link to the MIOSHA webpage for confined space entry requirements. Later that day, Mr. O'Boyle also emailed Mr. Buist, and included a link to a confined space entry information video that explained some of the requirements and the reasons for enhanced worker safety requirements within those areas. The following day, I provided a general MIOSHA number to Mr. Buist in case he had additional questions.
