DEPARTMENT OF ENVIRONMENTAL QUALITY  
AIR QUALITY DIVISION  
ACTIVITY REPORT: Complaint Investigation

FACILITY: Hilltop Auto, LLC		SRN / ID: U651904557
LOCATION: 1805 Greenwood Road, Prescott		DISTRICT: Saginaw Bay
CITY: Prescott		COUNTY: OGEMAW
CONTACT: Shane Gamez , Owner		ACTIVITY DATE: 05/23/2019
STAFF: Meg Sheehan	COMPLIANCE STATUS: Compliance	SOURCE CLASS:
SUBJECT: Unannounced site inspection conducted as a result of a complaint that was received on 5/17/19		
RESOLVED COMPLAINTS:

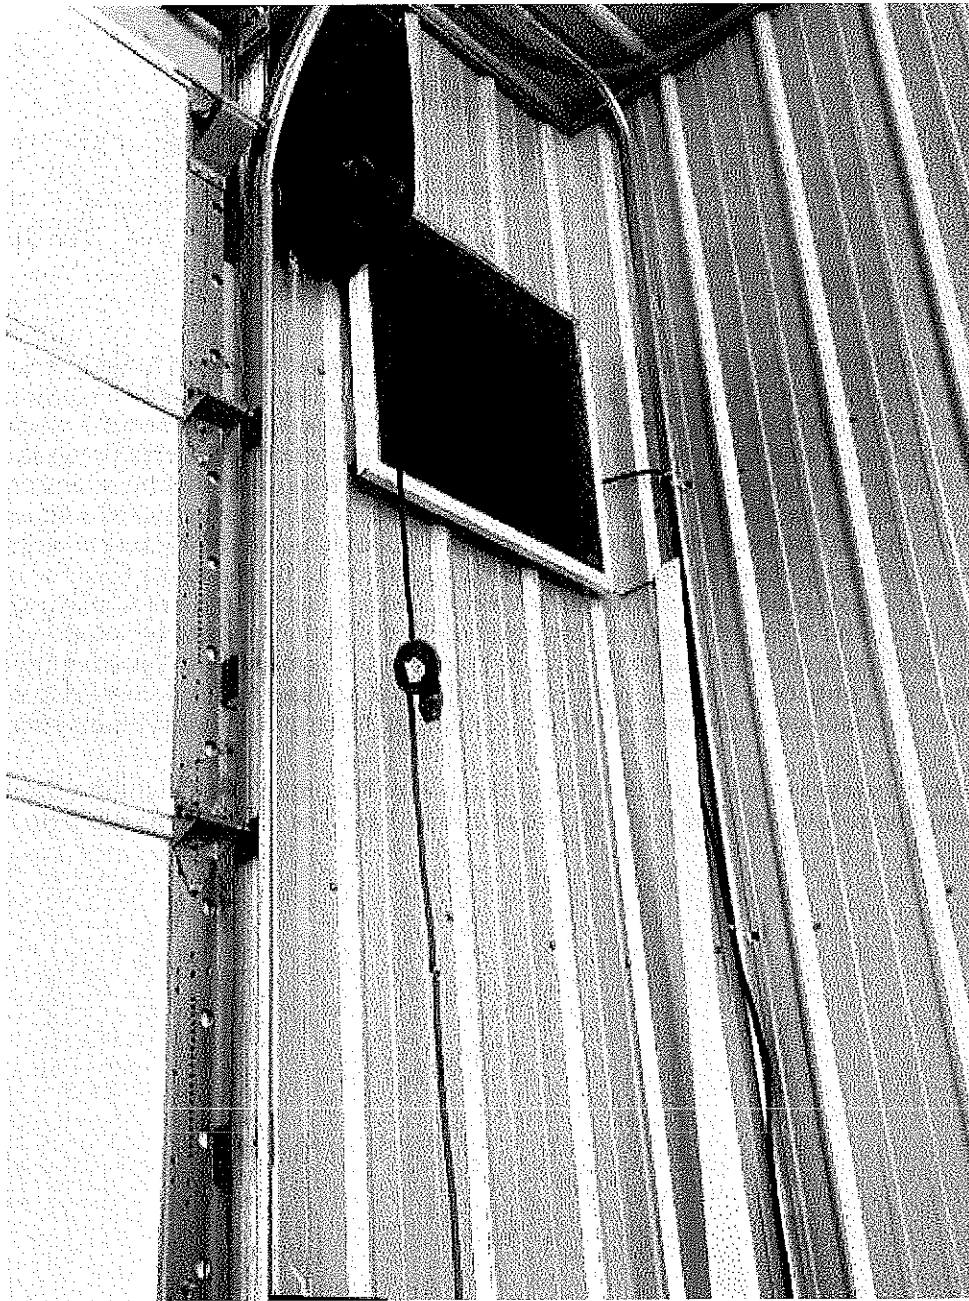
**Image 1(Installed filter)** : View from inside the building.

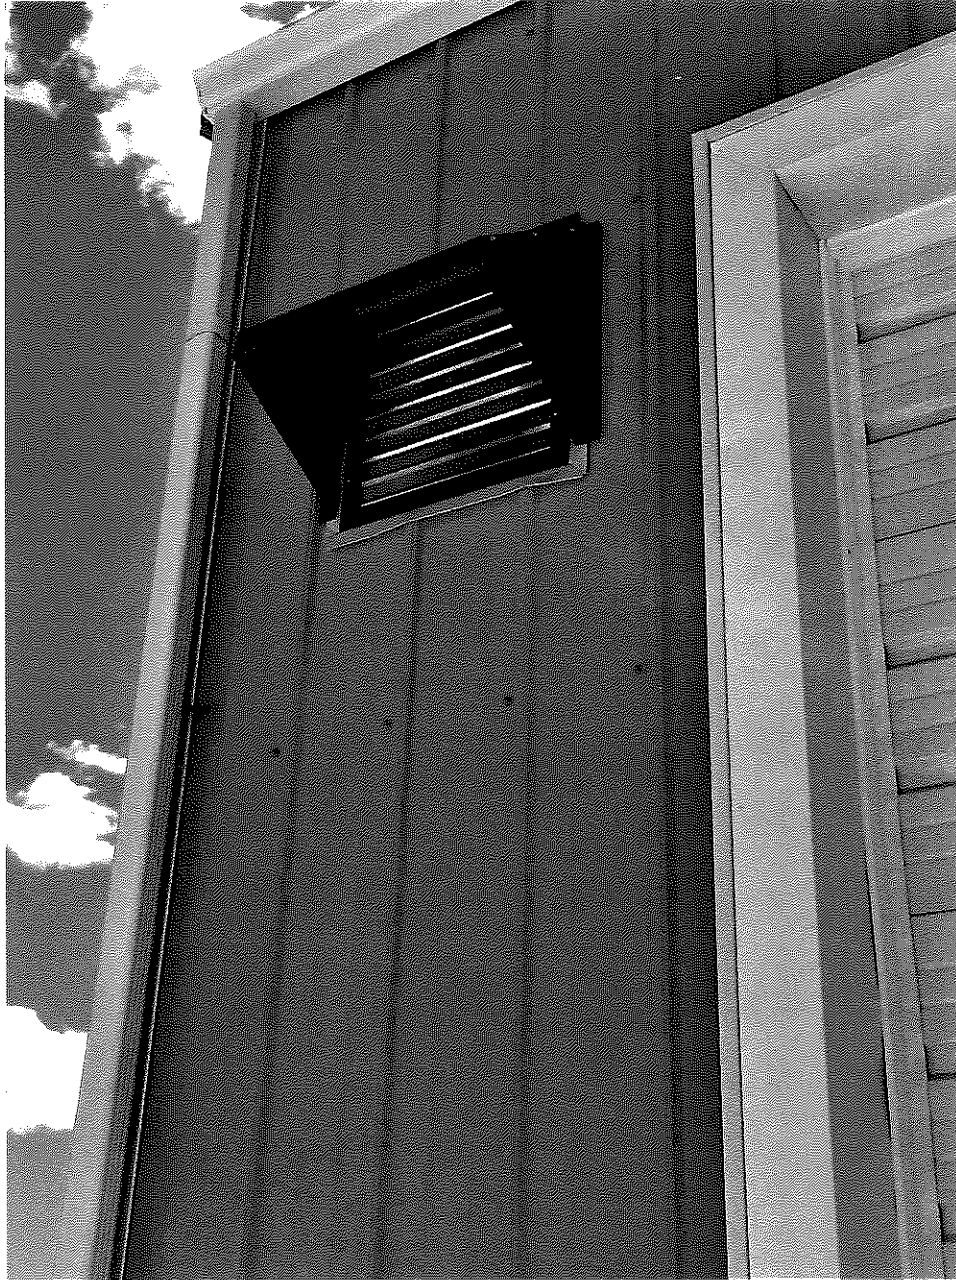
Outside vent - Note red color, not black or silver as complainant described
