## DEPARTMENT OF ENVIRONMENTAL QUALITY AIR QUALITY DIVISION ACTIVITY REPORT: Self Initiated Inspection

U6906009550976		
FACILITY: UNKNOWN		SRN / ID: U69060095
LOCATION: OTSEGO COUNTY, OTSEGO		DISTRICT: Cadillac
CITY: OTSEGO		COUNTY: OTSEGO
CONTACT:		ACTIVITY DATE: 10/15/2019
STAFF: Sharon LeBlanc	COMPLIANCE STATUS: Compliance	SOURCE CLASS:
SUBJECT: Wescoat Pit- Martin Riley Pit. sgl	dale and North Townline Road, Vanderbilt, Otsego Co	ounty, Michigan. Screening operation next to Reith
RESOLVED COMPLAINTS:

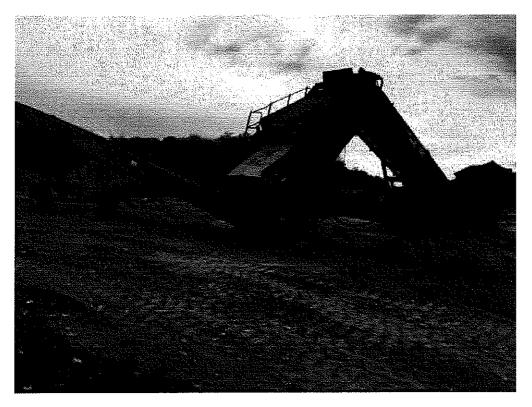
Image 1(screen discharge) : view of screen discharge points. Note that the Finlay 390 screen (Id 4490) discharges into 2 different conveyors. Both have the same ID no. "4501"

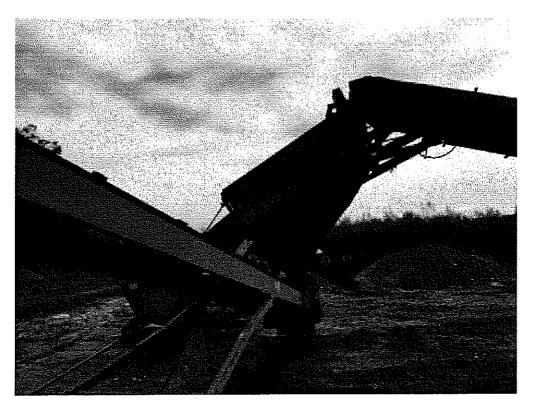
Image 2(sideview of screen) : sideview of finlay390 screen (Id 4490) showing the two discharge points onto conveyors, both finlay conveyors, with the same ID (Id 4501).

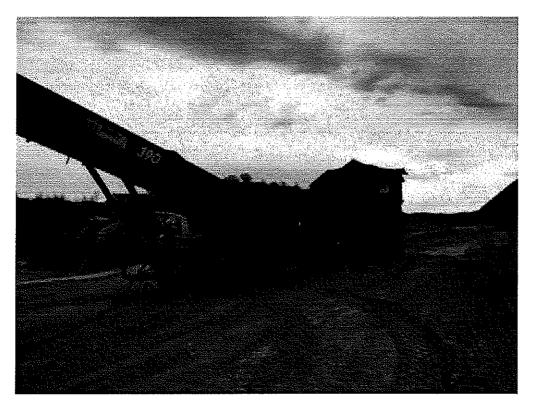
Image 3(feedhopper) : view of feed hopper and prescreen portion of finlay 390 screen (ID 4490)
