Mr. Paul Bujalski, Plant Manager
Revstone Metavation, LLC – Vassar Plant
700 East Huron Avenue
Vassar, MI 48768

SRN: B2043, Tuscola County

VIOLATION NOTICE

On July 23 and 24, 2013, the Department of Environmental Quality (DEQ), Air Quality Division (AQD), observed testing of emissions conducted at the Revstone Metavation Vassar Foundry located at 700 East Huron Avenue, Vassar, Michigan. The purpose of the emission testing was to determine compliance with the requirements of the federal Clean Air Act; Part 55, Air Pollution Control, of the Natural Resources and Environmental Protection Act, 1994 PA 451, as amended (Act 451); the administrative rules and the conditions of Renewable Operating Permit (ROP) MI-ROP-B2043-2009a.

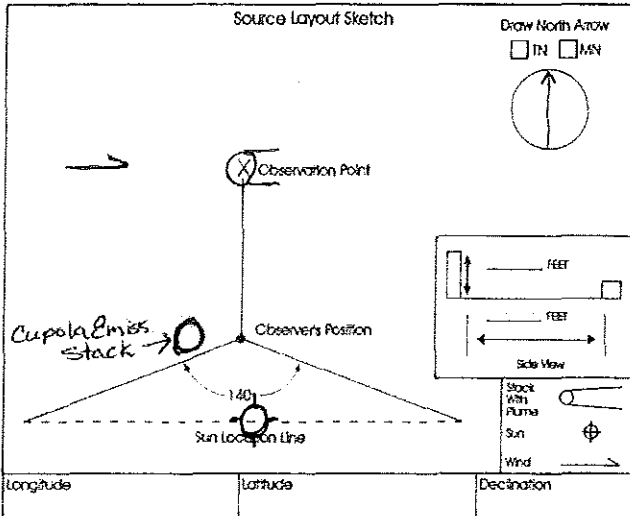
Describe Emission Point: Cupola charge Door
Rigitive emissions
 Height of Emiss. Pt. Start: ~40 ft End: ~40 ft Ret. to Observer: Start equal End equal
 Distance to Emiss. Pt. Start: ~15 ft End: ~15 ft Direction to Emiss. Pt. (Degrees): Start 360° End 360°

Describe Emissions: Start fuming/falling End fuming/falling
 Emission Color: Start blue/white End blue/white
 Water Droplet Plume: Attached Detached None

Describe Plume Background: Start upper cupola End upper cupola
 Background Color: Start brown End brown Sky Conditions: Start overcast End overcast
 Wind Speed: Start 5-10 mph End 5-10 mph Wind Direction: Start W End W
 Ambient Temp.: Start 70 End 70 Wet Bulb Temp.: NA RH Percent: NA
