**DEPARTMENT OF ENVIRONMENTAL QUALITY
AIR QUALITY DIVISION
ACTIVITY REPORT: On-site Inspection**

N173571881

FACILITY: Uniform Color Co		SRN / ID: N1735
LOCATION: 942 Brooks, HOLLAND		DISTRICT: Kalamazoo
CITY: HOLLAND		COUNTY: ALLEGAN
CONTACT: Matt O'Daniels , HSE Specialist		ACTIVITY DATE: 03/14/2024
STAFF: Mariah Scott	COMPLIANCE STATUS: Compliance	SOURCE CLASS:
SUBJECT: Scheduled inspection with Cody Yazzie		
RESOLVED COMPLAINTS:

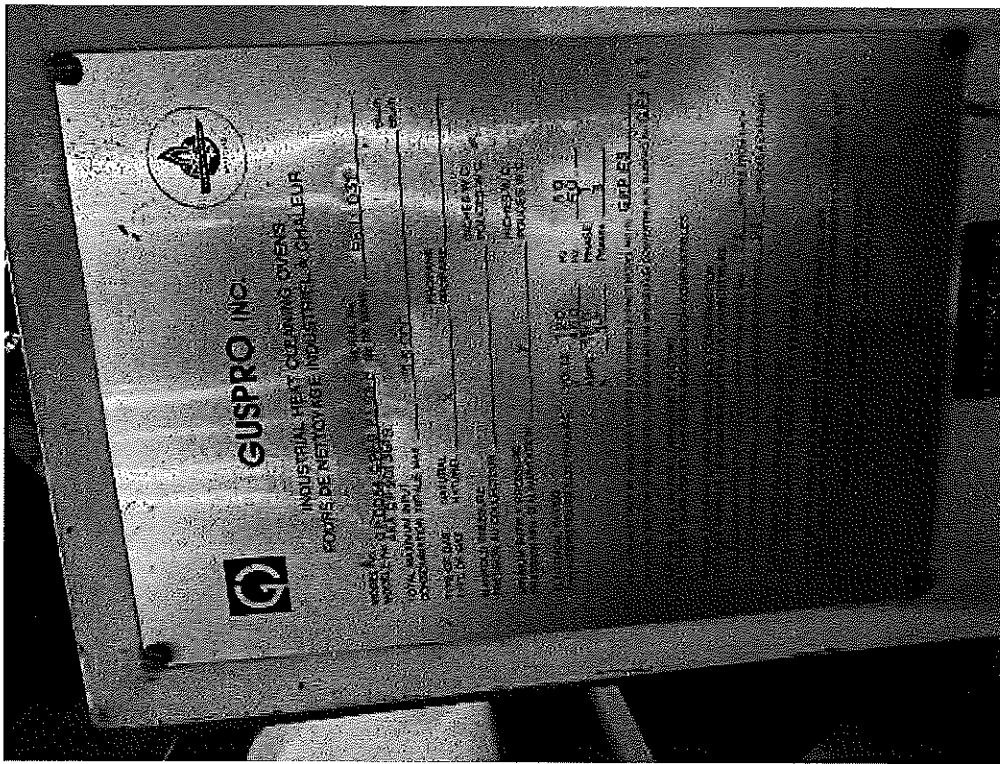
This emission unit was located across the street at the warehouse. A natural gas oven used for industrial cleaning of plastic off metal die plates was observed during the inspection, but did not have an existing PTI. This emission unit exhausts outdoors. UCC informed Staff that the emission unit is fired about 1-2 times per week. The maximum operating temperature of the Oven is 1400 °F, as displayed on the machine's signage. The unit is a GUSPRO Inc. Industrial Heat Cleaning Oven, Model Number GP0054GPP2P3S3N AKA GP2013618, Serial Number 96U031, with total maximum input of 515,000 Btu/h. UCC will be sent a Rule 278a Letter, requesting Uniform Color Co demonstrate either the natural gas oven located at 905 Brooks, Holland, Michigan and used to clean plastic off dies from the plastic extruding process is exempt from the requirements of Rule 201 or submit a PTI application for the subject processes at the facility.

Image 2(Plastic Mold 1 of 2) : 2024_04_11 photograph from Matt O'Daniels of Plastic Mold Cleaning Oven 1 of 2.

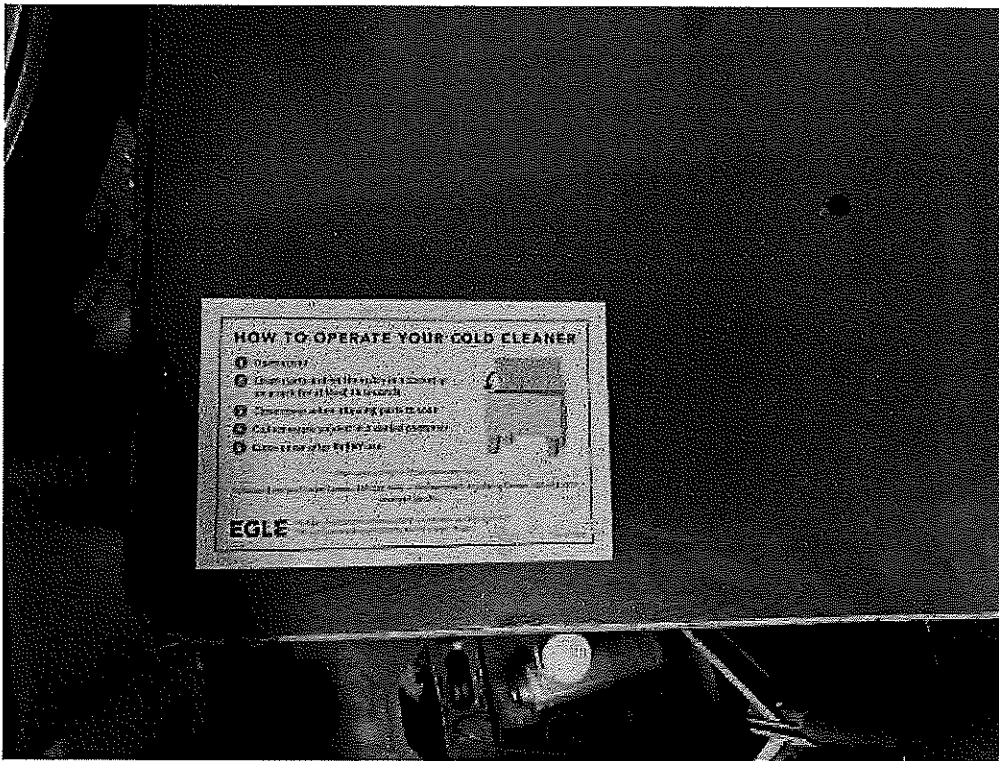
This emission unit was located across the street at the warehouse. Safety-Kleen Premium Solvent is subject to Rule 707. The safety data sheet describes the solvent as 100% hydrotreated light petroleum distillates, lists the safety considerations, and describes the VOC content as 100%. Cold cleaner signage was not posted on the machines, so Staff provided UCC with a copy of the necessary signage stickers. An April 19, 2024 email from Matt O'Daniels included photographs of the installed cold cleaner stickers. The cold cleaner was covered when Staff inspected the facility. UCC informed Staff that Safety Kleen picks up used solvent about once a month.

Image 4(Cold Cleaner 1 of 2) : 2024_04_19 photograph from Matt O'Daniels of Cold Cleaner with compliance sticker photograph 1 of 2

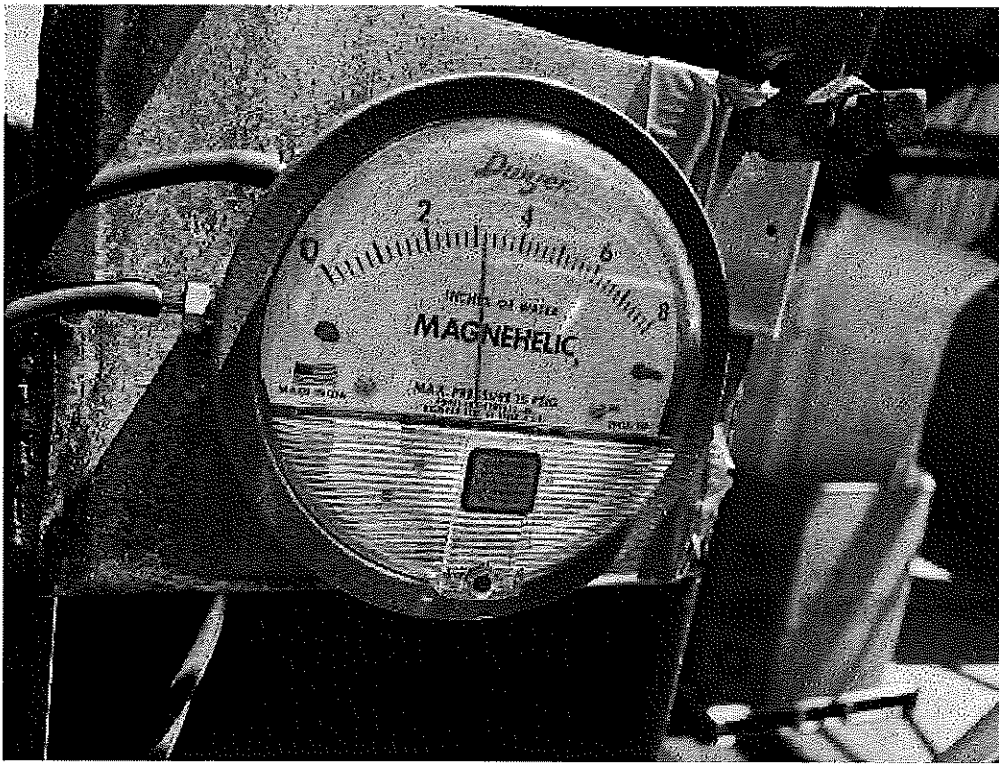
There were no visible emissions from the discharge point. Nevertheless, the differential pressure gauge was reading 8 inches of water at 11:15 am during the inspection, which would appear outside the normal operating range. UCC said it normally is about 4 inches of water. In 2011, a similar situation of a reading 8 inches of water was noted by AQD staff and they were told the normal was 2 inches. This past issue was caused by the drive chain for the rotating arm falling off the sprockets. This was repaired in 2011 and UCC reported that the differential pressure gauge was again reading 2 inches of water. This new high differential pressure gauge issue in 2024 appears to be with the magnehelic gauges. UCC plans to have an annual recalibration program through Waltz Holst. A quote, determined to be confidential, for this repair was sent on April 5, 2024 from Waltz Holst and was provided to AQD Staff. The repair process proceeded over time.

May 13, 2024 email from Matt O'Daniels to AQD Staff included a photo of the baghouse gauges on May 8, 2024, reading 6.2 inches of water, and May 13, 2024, reading 3.1 inches of water.

Image 6(Dustar guage May 8) : 2024_05_08 photograph from Matt O'Daniels of Dustar magnehelic gauge

May 14, 2024 phone call with Matt O'Daniels informed AQD Staff the gauge lines were cleaned, creating a backlog of dust into the cone. This backlog of dust was removed and the gauge was reading about 3 to 6 inches of water. UCC claimed no visible emissions occurred during this maintenance.
