December 21, 2022

Re: Response to AQD Dec 8, 2022 Violation Notice (SRN: N2688)

Figure 1 - Times and Dates with >40 ppm CH4 Readings at Perimeter Monitors

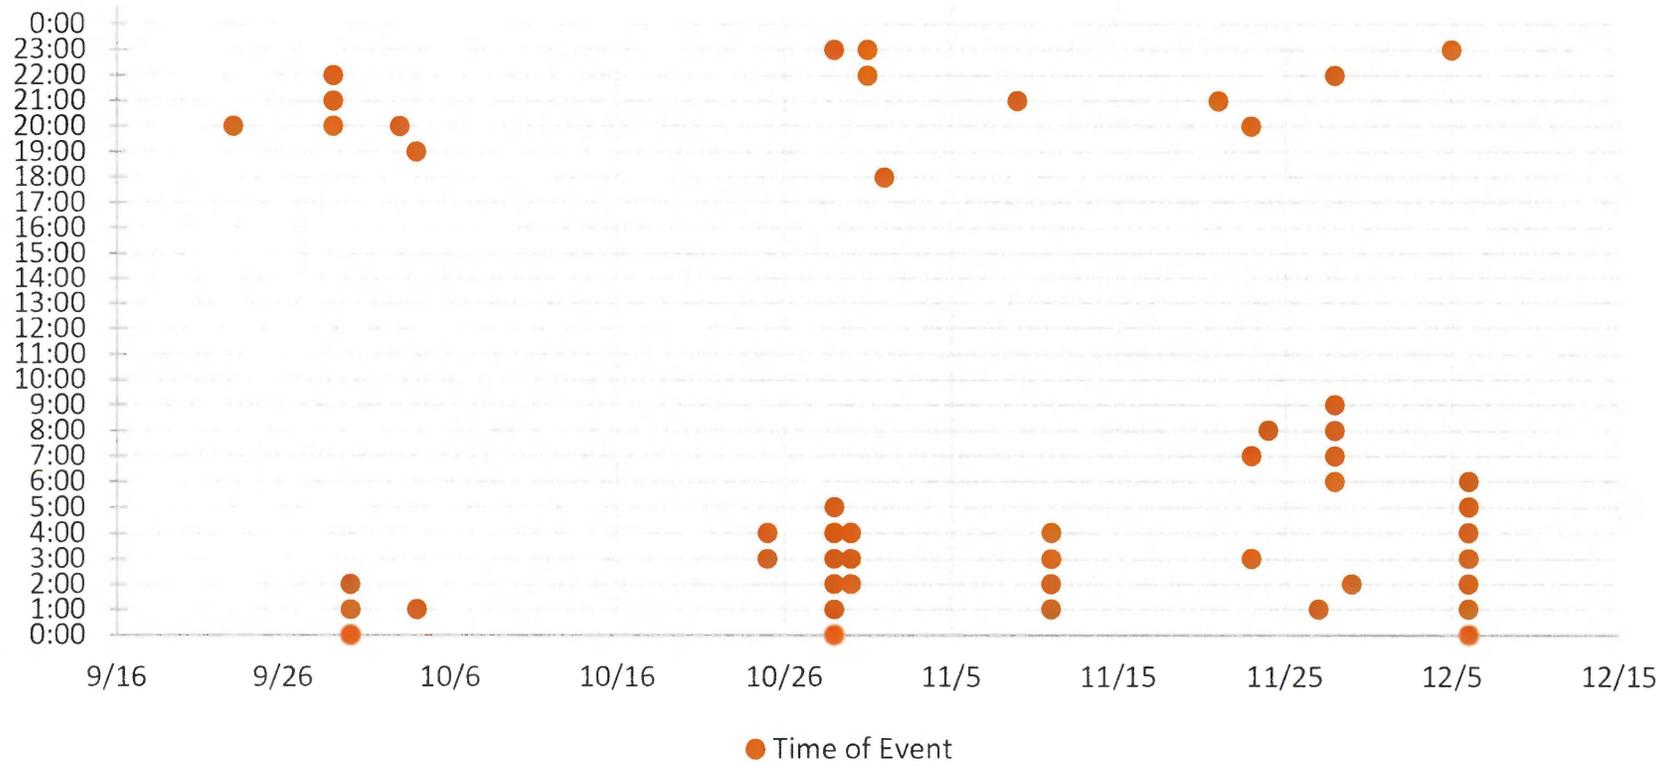
Each of the exceedances occurred during low wind speeds, and most of them occurred during the nighttime.¹ Occasionally, the wind was not even blowing toward the nearby community.

¹ See figure 1 that charts the time and date of each of these action level events that clearly shows that the events predominantly occurred during the evening hours.

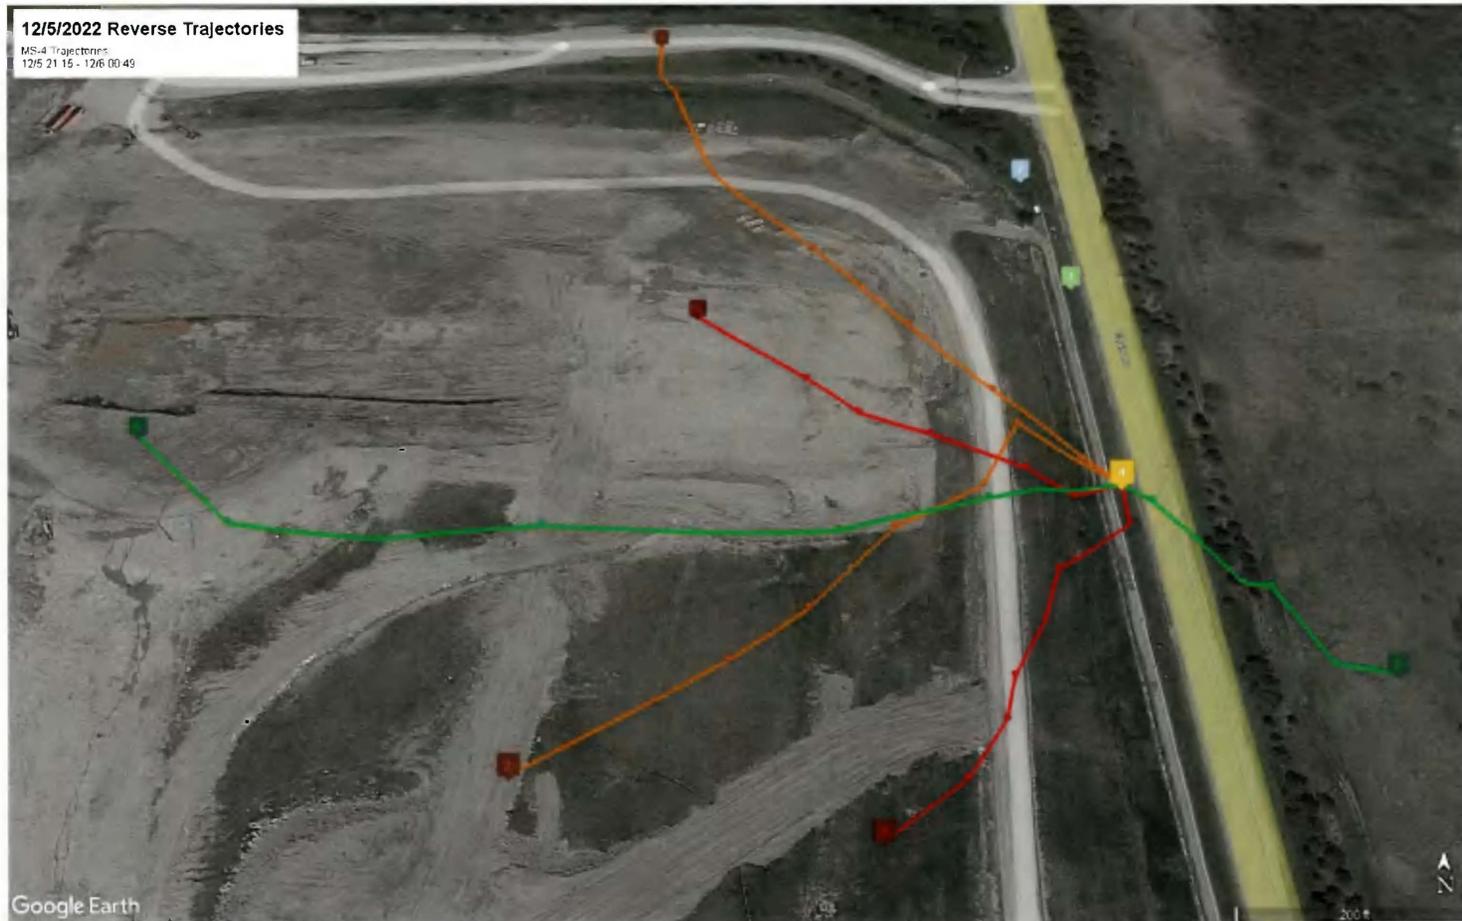
Figure 2 - 12/5/2022 Reverse Trajectories, MS-4

Figure 2 shows 10-minute reverse trajectories for the measured action level concentrations that occurred on December 5 and 6, 2022 at MS-4. Each node of the trajectory represents each minute of the 10-minute interval, working backwards in time from the monitor location. The trajectory numbers are chronological, with trajectory #1 (prior to the start of the elevated levels) at the earliest start time (21:07), and trajectory #6 (at the end of the elevated levels) starting at 00:40 on December 6, 2022. The trajectories are also color coded, with red representing the highest measured values and green representing measured values below the action level.

Figure 2 shows that wind direction at MS-4 started from the southeast (T #1) and shifted from the northwest (T #5). Maximum CH₄ levels were observed during the middle periods (T#3 and T#4). These reverse trajectories indicate that elevated CH₄ levels could have originated anywhere from the east, west to the northwest of MS-4. The figure clearly shows that wind direction is too variable to identify a culpable emission source.

As previously listed, Arbor Hills is recommending adjustment of the 40 ppm CH₄ concentration action level threshold to occur at a perimeter monitor as well as at the relocated MS-1 to the east of Napier Road. This recommended revision could be documented in an odor operations plan that would focus efforts on meaningful events that results in corrective actions. If needed, these recommendations could be addressed in an addendum to the Consent Judgment.
