**DEPARTMENT OF ENVIRONMENTAL QUALITY
AIR QUALITY DIVISION
ACTIVITY REPORT: On-site Inspection**

FACILITY: Great Lakes Cremation Service, Inc.		SRN / ID: N8339
LOCATION: 29547 Costello Dr, NEW HUDSON		DISTRICT: Warren
CITY: NEW HUDSON		COUNTY: OAKLAND
CONTACT: Gil Pietrandrea , Facility Manager		ACTIVITY DATE: 02/10/2021
STAFF: Robert Elmouchi	COMPLIANCE STATUS: Non Compliance	SOURCE CLASS: MINOR
SUBJECT: Complaint investigation and targeted inspection.		
RESOLVED COMPLAINTS: C-20-04233, C-20-04253, C-20-04264, C-20-04382, C-20-04390, C-21-00223, C-21-00383

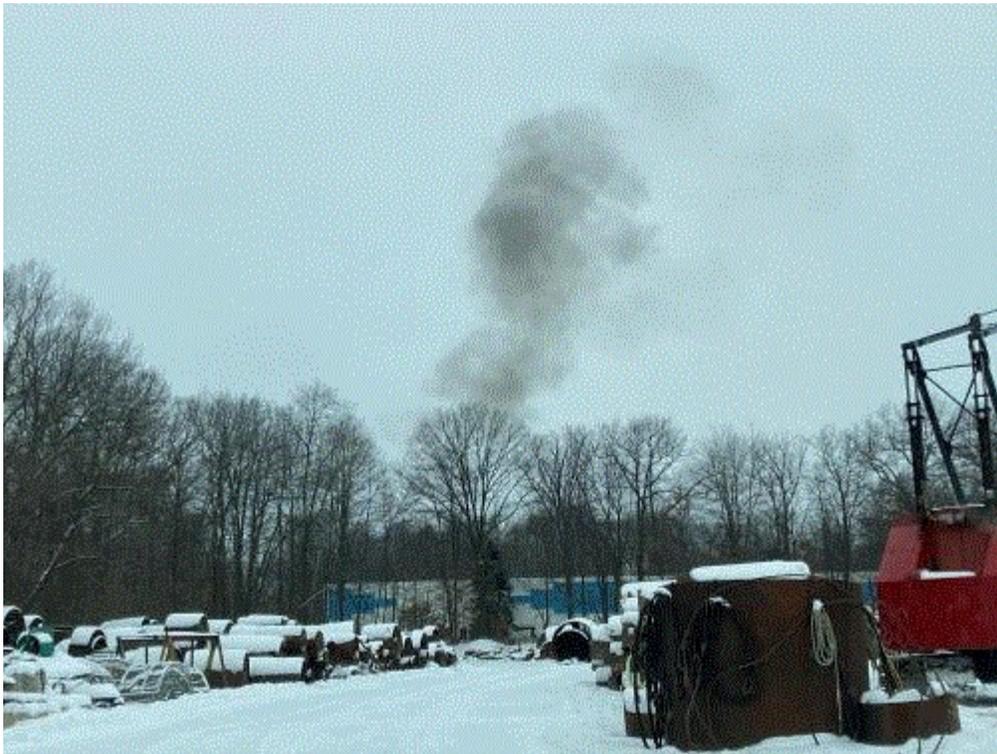
Because of the low ambient temperature, I observed multiple white plumes, which appeared to be generated by water in the exhausts from multiple businesses' building heaters. I observed multiple intermittent black smoke plumes from the general direction of the GLC exhaust stacks (photo attached). I did not smell a foul odor. The black smoke did not appear to be in violation of R 336.1301 because of plume durations, which were less than 1-minute and less than about 75 percent. A valid Method 9 reading could not be taken because the exhaust stacks are not visible from ground level and the permittee cannot provide safe access to the roof or a suitably elevated position.

We also discussed the black smoke plumes I observed during the complaint investigation. Mr. Pietrandrea stated that crematorium operators are not allowed to open the delivered containers, therefore they cannot remove any inappropriate materials placed in the container by relatives. Furthermore, with the recent high-volume of COVID-19 deaths, bodies may come wrapped in two or three black plastic body bags that create black smoke, which appears to be what I observed during the complaint investigation.

Image 1(IMG_0116.JPG) : View of black smoke plume from Great Lakes Cremation Service from the east. Image taken on February 10, 2020.

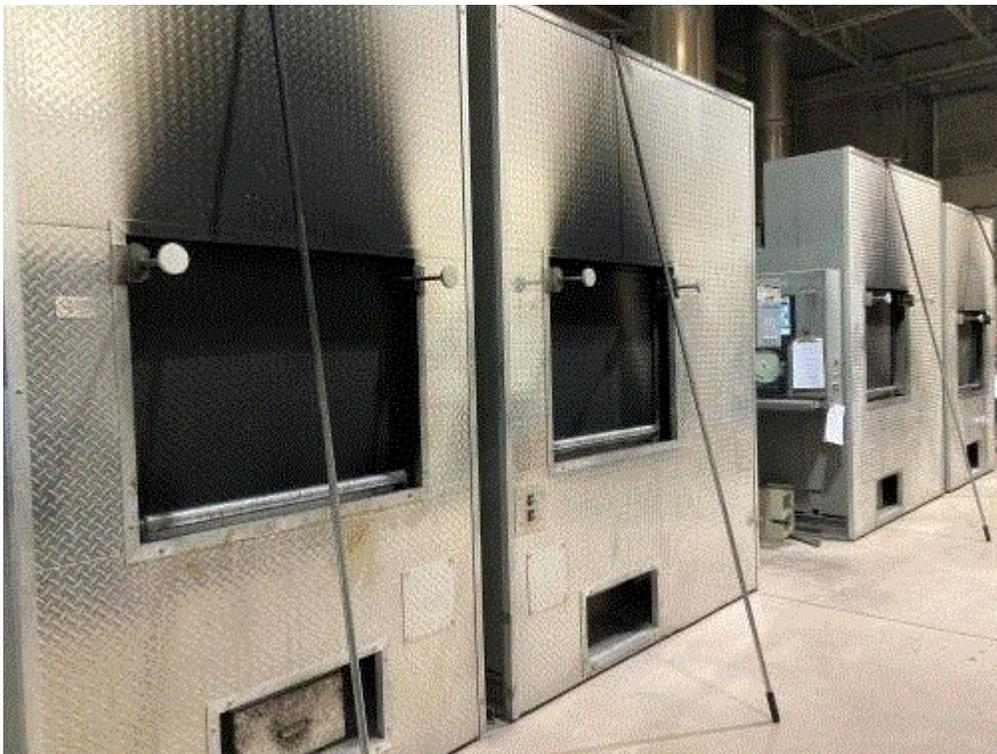
I entered the office building and identified myself. I met with Mr. Gil Pietrandrea, Facility Manager, and Ms. Danielle Hall, Manager. I observed the condition of the cremation units. All four human crematories were operating. The single animal crematorium was not operating. I observed that the charge doors of the four human crematories were darkened with soot deposits, which was noticeably different compared to what I had observed during previous inspections. I was told that the soot deposits were caused by charges beginning to combust during insertion and before the primary combustion chamber charge door can be closed. The soot deposits do not appear to indicate a violation of permit conditions.

Image 2(IMG_0135.JPG IMG_0135) : View of soot deposits on the crematory doors. Image taken on February 10, 2020.

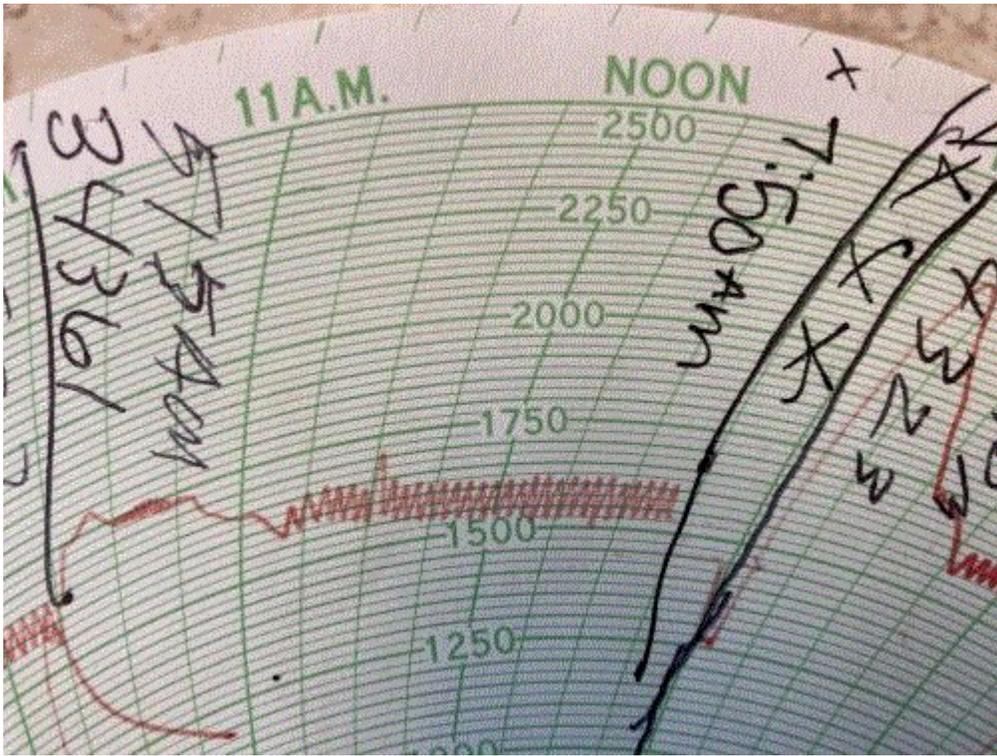
I reviewed the permit-required secondary combustion chamber temperature records. Temperature records for EUCREMATORY1 indicate that on February 3, 2021, the permittee failed to maintain a minimum secondary combustion chamber temperature of 1600°F. The actual minimum temperature that was maintained was approximately 1525°F. This appears to be a violation of PTI No. 232-09B, EUCREMATORY1, Special Condition III.1, which states in part, "The permittee shall not combust waste in EUCREMATORY1 unless a minimum temperature of 1600°F and a minimum retention time of 1.0 seconds in the secondary combustion chamber are maintained." This noncompliance shall be cited in a violation notice.

Image 3(IMG_0152 rotated.jpg) : Close-up photo of EUCREMATORY1, February 3, 2021, temperature chart. Temperature record indicates the PTI No 232-09B, EUCREMATORY1, III.1 minimum temperature of 1600F was not maintained.

I did not perform a Method 9 opacity observation. I did observe a failure to maintain a minimum secondary combustion chamber temperature of 1600°F, which shall be cited in a violation notice.
