DEPARTMENT OF ENVIRONMENTAL QUALITY
AIR QUALITY DIVISION
ACTIVITY REPORT: On-site Inspection

P056973078

FACILITY: PADNOS GRANDVILLE RECYCLING		SRN / ID: P0569
LOCATION: 3485 VIADUCT STREET SW, GRANDVILLE		DISTRICT: Grand Rapids
CITY: GRANDVILLE		COUNTY: KENT
CONTACT: Todd Jousma , Environmental Manager		ACTIVITY DATE: 07/23/2024
STAFF: April Lazzaro	COMPLIANCE STATUS: Compliance	SOURCE CLASS: MINOR
SUBJECT: Unannounced, scheduled inspection.		
RESOLVED COMPLAINTS:

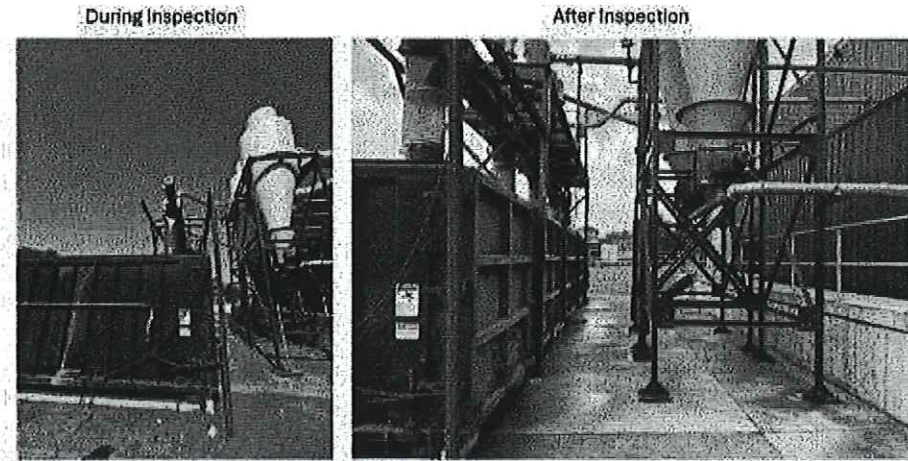
The new wire chop system, referred to as wire chop 2.0, has been installed and is operating on the south end of the eddy current building. As we observed the process from inside the facility, I noted that the air was filled with debris that was also landing and accumulating on my notepad. We quickly exited the area to observe the outdoor collection system that consists of cyclones that deposit solids into one of five roll off bins and return the air back into the building. The area showed material accumulation, and one of the corrugated flex tube connectors used to put solids into a roll off was damaged, with materials escaping into the ambient air. We discussed how the debris, and the damaged corrugated tube were not acceptable. By the end of the day, Padnos had emailed pictures showing that the corrugated tube had been replaced and the area by the roll offs had been cleaned of all debris. The emission unit exemption documentation for the wire chop 2.0 was received and indicates that the process is exempt from permitting pursuant to Rule 285(2)(l)(vi)(B).

At this time, I discussed the indoor air and particulate observed with Chad Ignatoski from an employee safety perspective. I noted that the dust in the air and the amount that landed on my notepad seemed excessive. Padnos noted that they have been working to improve the collection system for the process. During a follow up discussion with Todd Jousma, AQD learned that at the

Image 1(Before and after) : Photo during inspection taken by AQD, photo after provided by Padnos.

time of the inspection, the system was being operated in an unapproved manner and was shut down immediately, and employees were retrained on proper operation.

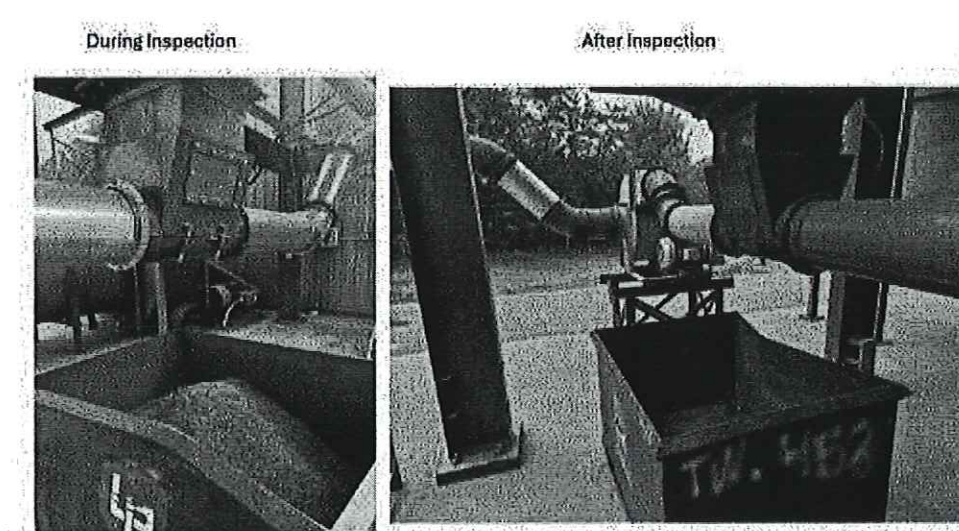
Image 2(Before and after) : Photo during inspection taken by AQD, photo after provided by Padnos.
