December 1, 2021

Re: Response to Violation Notice dated November 8, 2021  
Ferrous Processing & Trading Company (FPT) – Schlafer Division (N7683)  
1350 Medbury Street, Detroit, MI

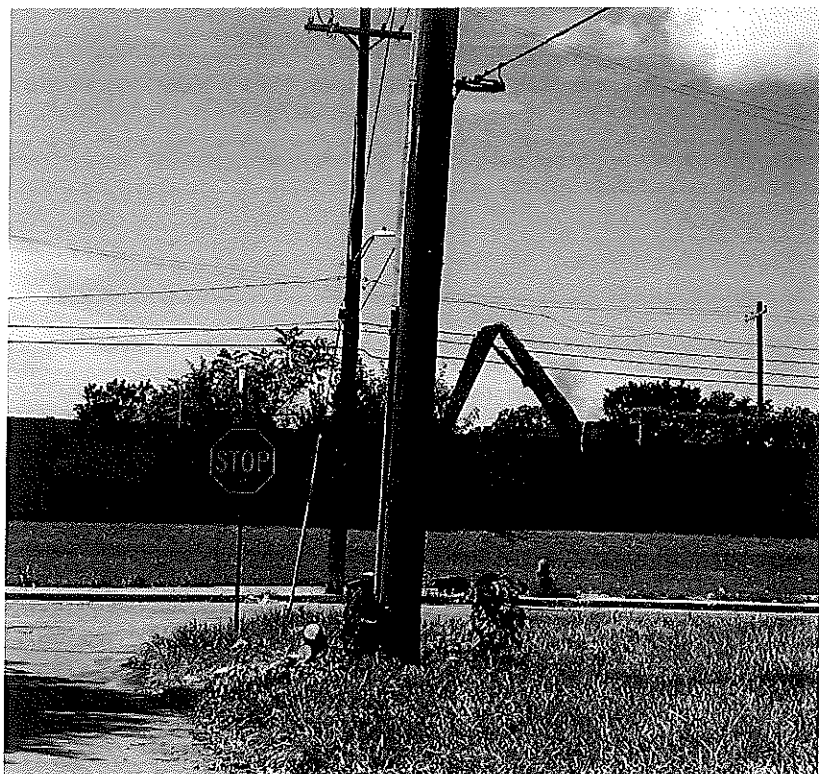
Photograph 1. Photo taken by EGLE on September 3, 2021

The VEOF also indicates that the visible emission observations were taken from outside of FPT's fence line. The specific operations producing the visible emissions cannot be seen from this location. The view over this fence is not clear.
