DEPARTMENT OF ENVIRONMENTAL QUALITY  
 AIR QUALITY DIVISION  
 ACTIVITY REPORT: Scheduled Inspection

FACILITY: INDUSTRIAL STEEL TREAT CO		SRN / ID: A1864
LOCATION: 613 CARROLL ST, JACKSON		DISTRICT: Jackson
CITY: JACKSON		COUNTY: JACKSON
CONTACT: Jim Matthews , Facilities Manager/Environmental		ACTIVITY DATE: 02/28/2018
STAFF: Mike Kovalchick	COMPLIANCE STATUS: Non Compliance	SOURCE CLASS: MINOR
SUBJECT: Inspection of a heat treat facility.		
RESOLVED COMPLAINTS:

**Minor Source: Inspection of Industrial Steel Treating located at 613 Carroll Street, Jackson, Michigan.**

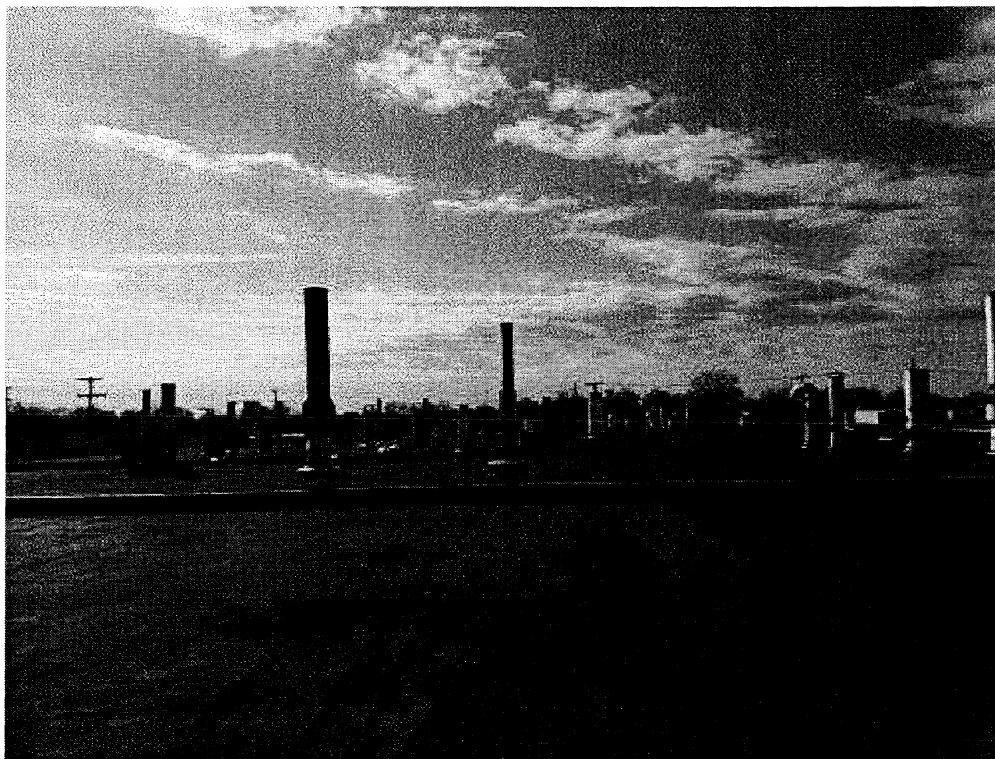
**Image 5(Roof-East)** : Part of roof of the East Building.

PTI 394-07A- FG-BELTLINES & FG-BATCHPUSHER VIII. STACK/VENT RESTRICTIONS. A number of stacks d not discharge unobstructed vertically upwards.

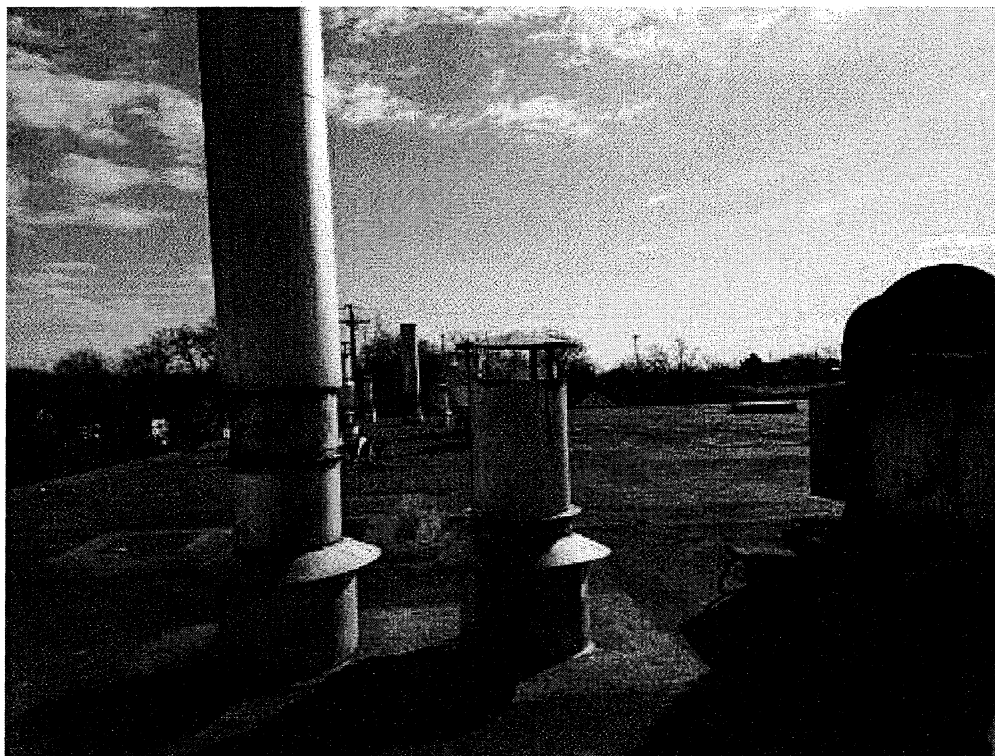
EU ID	Observations / Comments
EU1CHARDENTEMPER	Not operating.
EU2CHARDENTEMPER	Observed operation. It was properly equipped with 2 operating flares. No smoke observed.
EU4CHARDENTEMPER	Observed operation. It was properly equipped with 2 operating flares. Note. The roof inspection showed white smoke estimated at 30% opacity was coming from this process. The smoke would last for about a minute then restart several minutes. It wasn't clear why.
EU5KHARDENTEMPER	Observed operation. It was properly equipped with 2 operating flares. No smoke observed.
EU1KTEMPER	Not observed.
EU7AHARDEN	Not in operation.
EU8AHARDEN	Not in operation.
EU9AHARDEN	Not in operation.
EU1ATEMPER	Not in operation.
EU2ATEMPER	Not in operation.
EU4ATEMPER	Not in operation.
EU11ATEMPER	Not in operation.
EU1HHARDENTEMPER	Observed operation. It was properly equipped with 3 operating flares. No smoke observed.
EU2HHARDENTEMPER	Not in operation but appeared to be about ready to operate as 3 flares were operating.

We had a brief post-inspection meeting as I was leaving. I informed JM that my only concerns included the permi status of the ammonia tanks, the numerous stacks that had rain caps on them and the one stack that was sent emitting white smoke. I thanked JM for his excellent cooperation and assistance, and I departed the facility at approximately 11:00 am.

**Image 6(Smoke)** : Smoke coming from stack with rain cap.

A Violation Notice (VN) will be sent to the Company and they will have 21 days to respond.

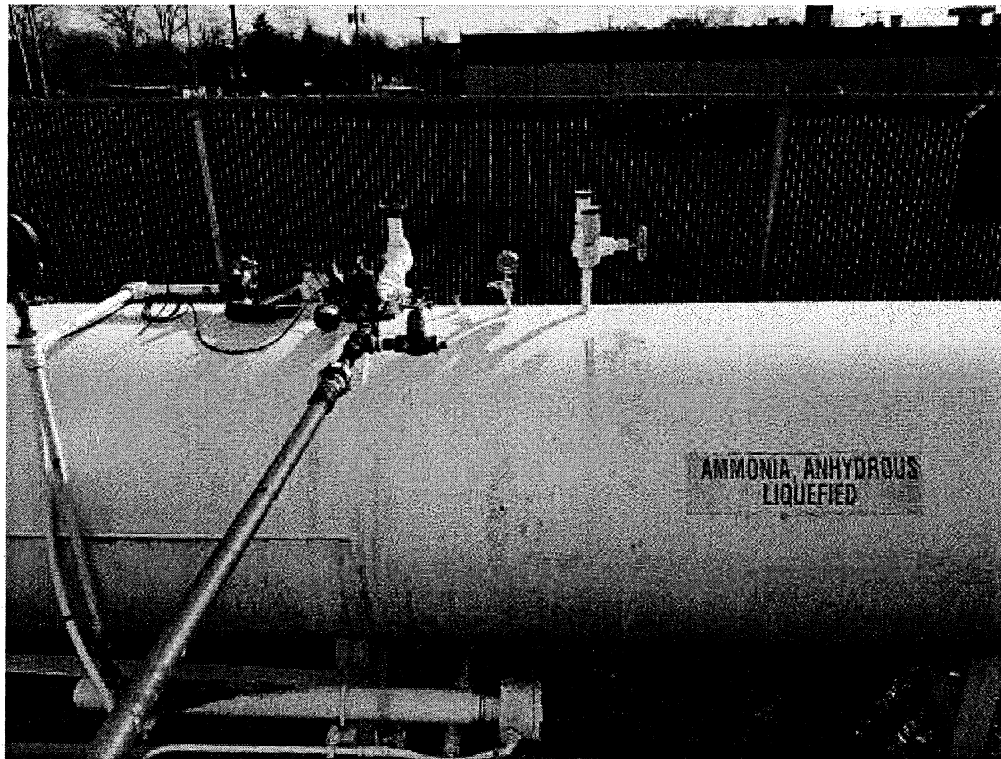
One ammonia tank is located just outside the West Building with a storage capacity of 1000 gallons with a fill capacity of 85%. It was installed in the 2006-2007 time frame. Another 2300 gallon tank is located adjacent to the East Building. It has a fill capacity of 50%. In 2017, IST used 24,000 pounds of ammonia.

Rule 201-No Permit to Install. A 1000 gallon and a 2300 gallon ammonia storage tank each require a separate PTI permit. The 1000 gallon tank maybe eligible for a General Permit. The 2300 gallon tank likely is ineligible for a perr as it does not meet the required setup distances.

**Image 7(Ammonia)** : 1000 gallon Ammonia storage tank adjacent to West building.

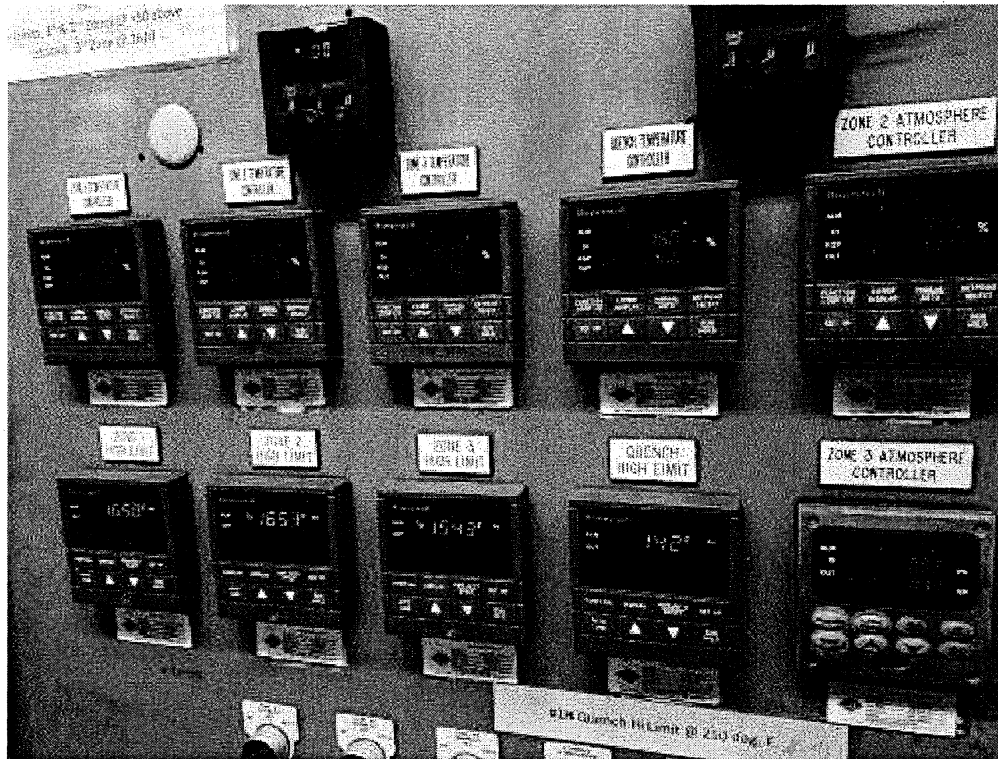
**Image 9(Temp controls) :** Temp control panels of one of the furnaces.

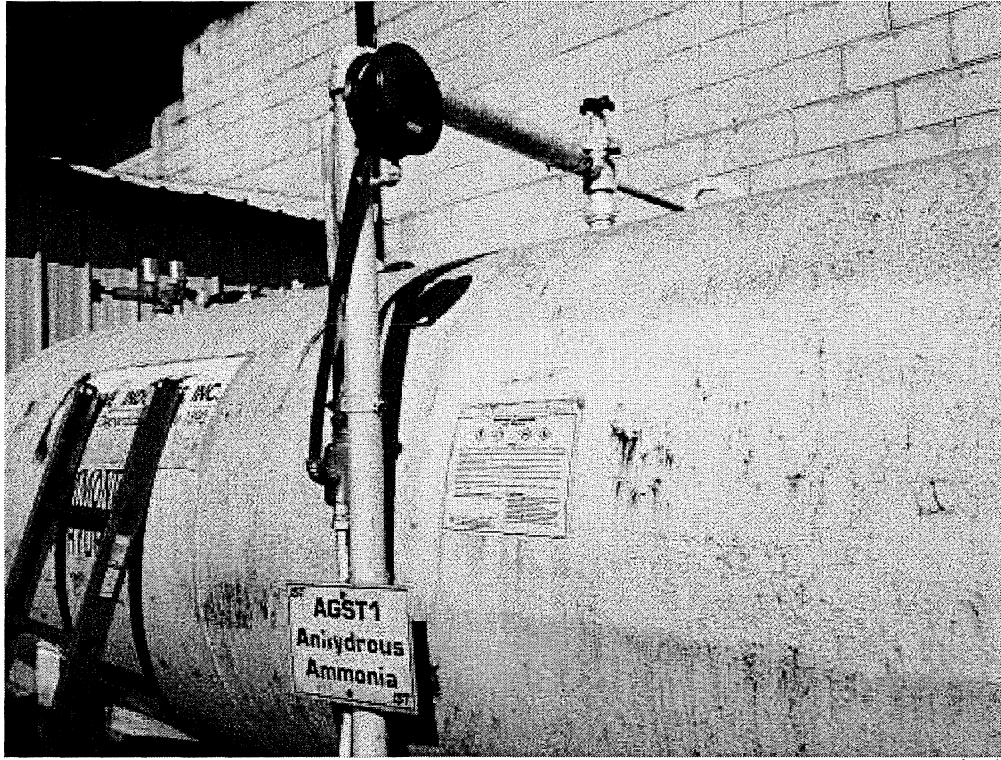
**Image 11(Ammonia tank) :** 2300 gallon ammonia tank adjacent to East building.
