**DEPARTMENT OF ENVIRONMENTAL QUALITY
AIR QUALITY DIVISION
ACTIVITY REPORT: On-site Inspection**

FACILITY: Louis Padnos Iron & Metal		SRN / ID: A2457
LOCATION: 2001 TURNER ST, GRAND RAPIDS		DISTRICT: Grand Rapids
CITY: GRAND RAPIDS		COUNTY: KENT
CONTACT: Robert McCormick , Safety & Environmental Coordinator		ACTIVITY DATE: 08/22/2023
STAFF: April Lazzaro	COMPLIANCE STATUS: Non Compliance	SOURCE CLASS: MINOR
SUBJECT: Unannounced, scheduled inspection.		
RESOLVED COMPLAINTS:

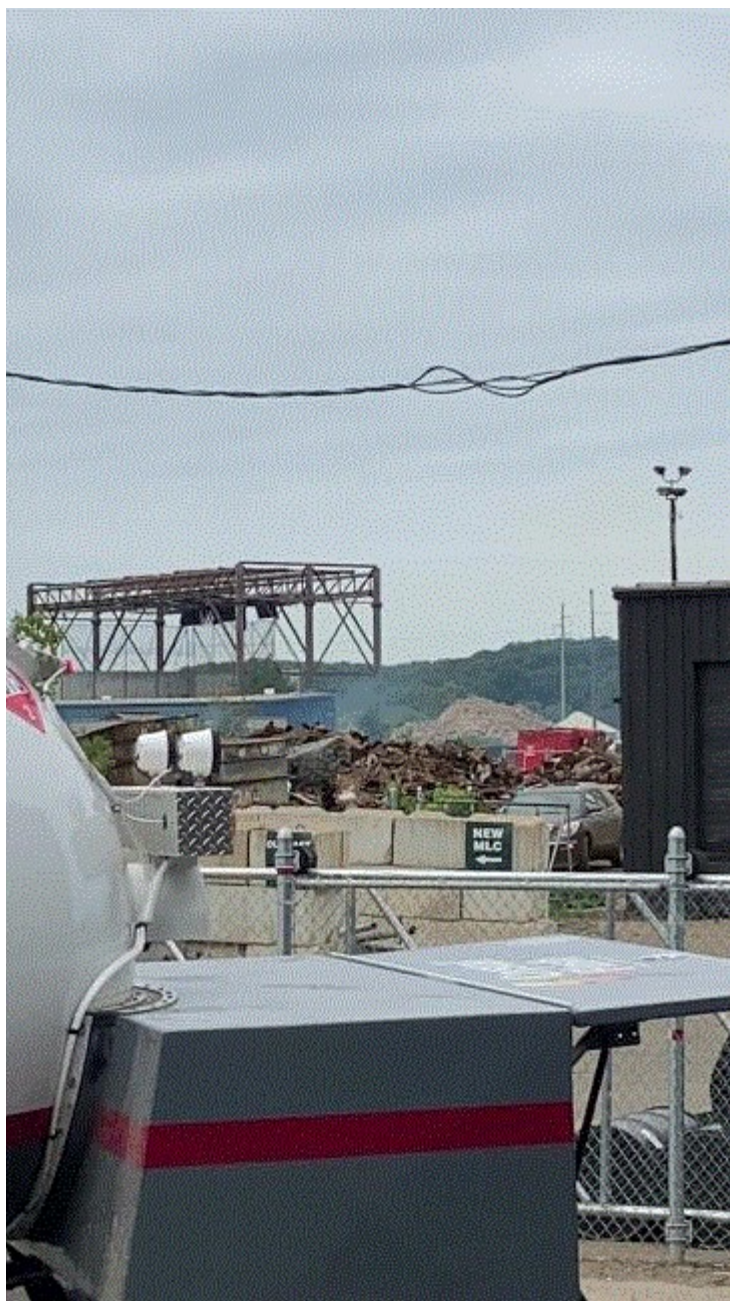
Image 1(Torching smoke) : Smoke observed from torching 8/23/23.

Since smoke was observed from the torching area, this was inspected first. Upon arriving in the area, a large press was in the process of disassembly via torching by Canyon Torching staff. Attached photos show that the part was leaking oil, was grease covered and rubber hoses had been torched. I referred to the AQD file copy of the Padnos Best Management Practices (BMP) for torching, which I had brought with me and we discussed the fact that it appeared several of the BMP's were not being

At the end of the inspection, we returned to the torching pad again after being joined by Rob McCormick Safety & Environmental Coordinator and Kyle Daneff, Environmental Manager. I explained that my observations are that the torching company employed by Padnos is not following the BMP for torching that has been established practice for many years. At that time, it was noted that no action had been taken to address the oil leaking from the press.

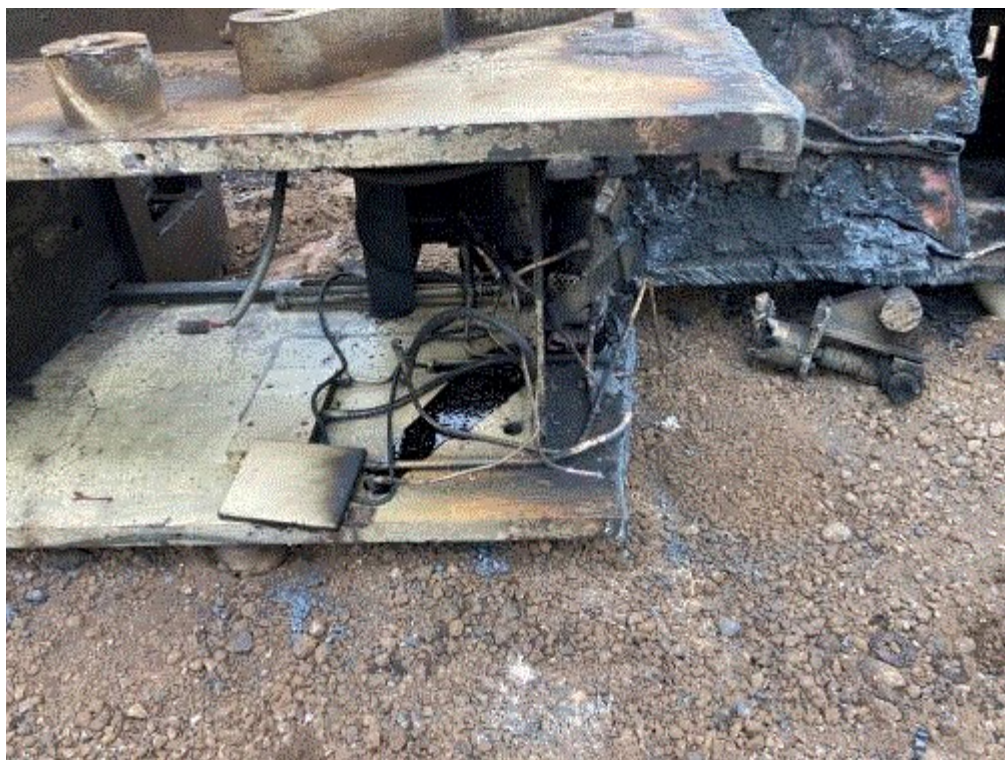
Image 2(Torched press) : Oil leaking from press being torched. 8/23/23

followed. Specifically, the BMP states that machinery or presses may be torched under special circumstances, and that they can present multiple problems. The BMP states that all non-metallic elements should be removed, all oil/grease/fluids should be drained and appropriately recycled. The plan refers to a procedure named "Receiving Unclean Machinery or Equipment". This part of the BMP states that any oil or grease that is coating these items needs to be pressure-washed at a cleaning station prior to torching. As stated above, these items of the BMP were not followed prior to torching the press. Discussion ensued whereby Padnos indicated that they do their best to eliminate the items noted, but that sometimes they don't know where the oil is stored, and hoses are located until they get 'into' the large presses. It is noted that no effort to clean or drain the oil had taken place.

The AQD will request a formal Malfunction Abatement Plan pursuant to Rule 911 for the torching operations. It is noted that in an email communication, Padnos intends to conduct a trial operation of a hydrogen torching system that is touted as a lower smoke and emissions approach. The AQD informed Padnos that they must identify whether a permit exemption would apply to this process. A Rule 278 Exemption Demonstration will be requested.

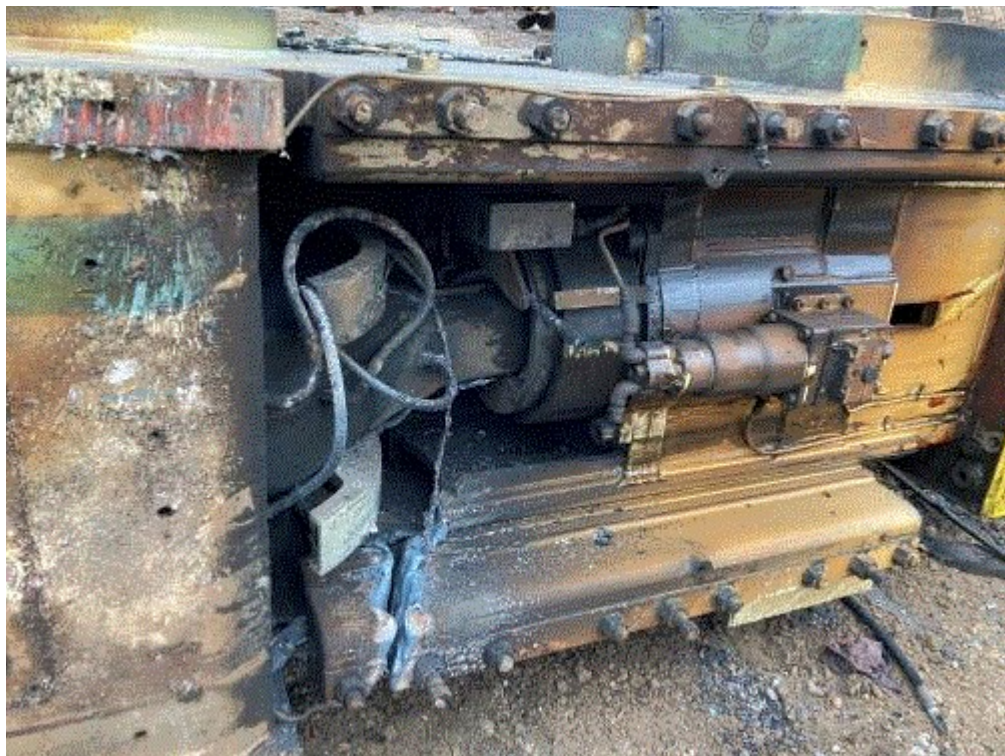
Image 3(Torched hoses) : Hoses being torched on press. 8/23/23

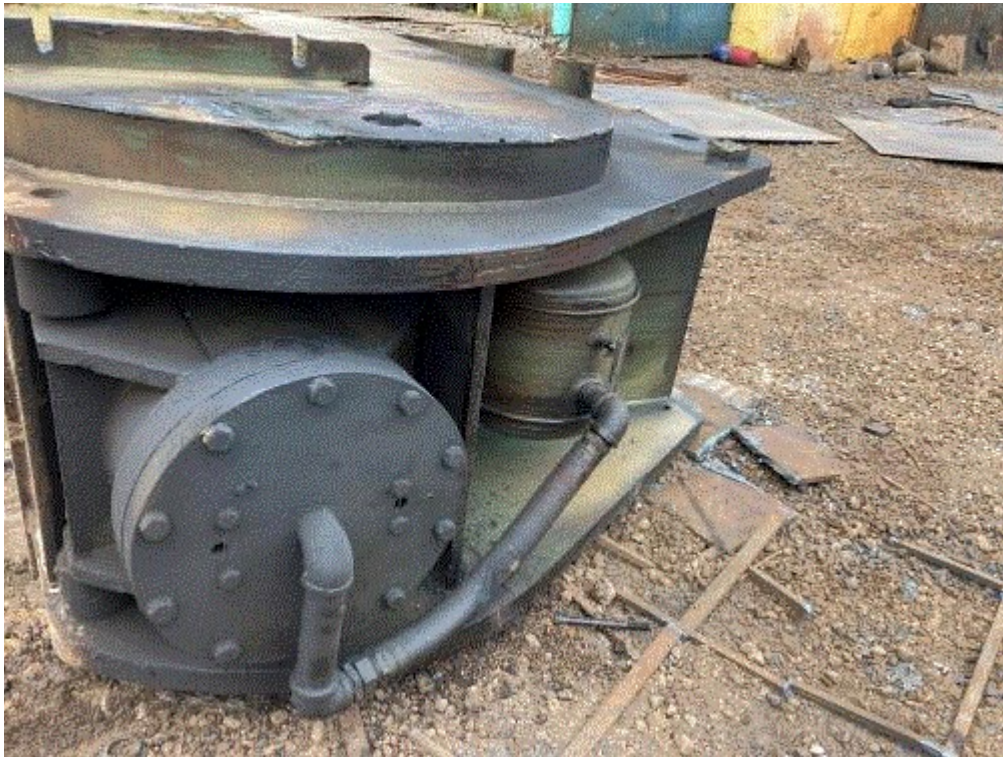
Image 4(Torched press) : Grease on press being torched. 8/23/23

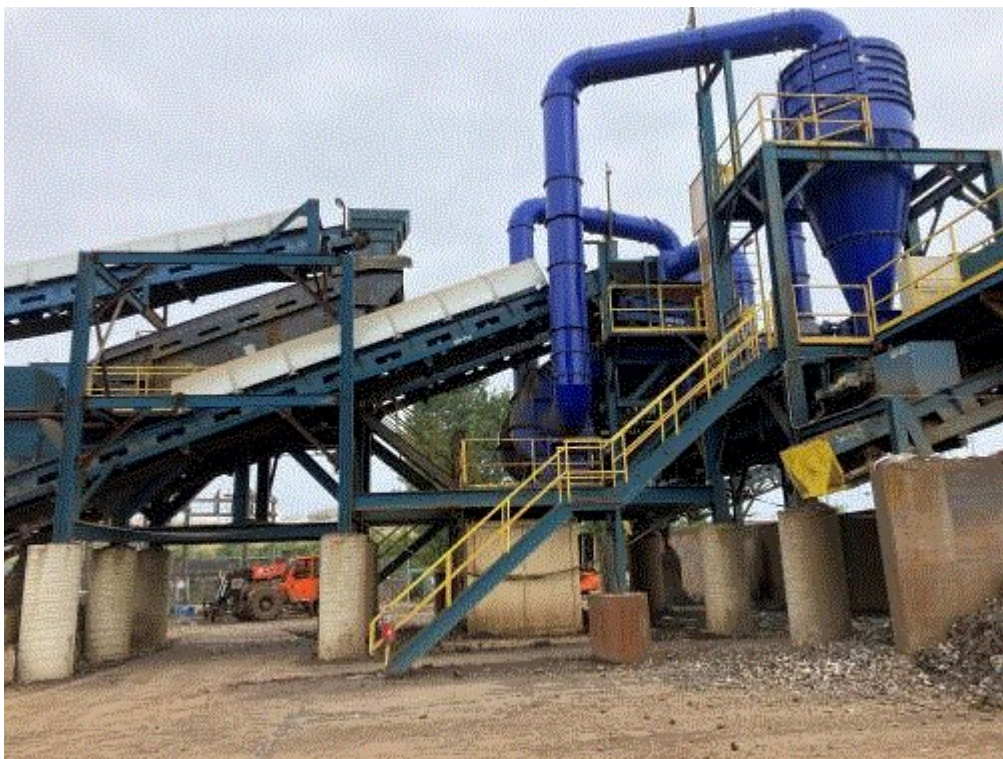
During the inspection, AQD found that the original EU-NONFERROUS emission unit had been removed and replaced with an entirely new system. The new system consists of a screen and sorting equipment and two cyclones that discharge different materials to the two sides of the material storage area. Padnos asserted that this is a closed loop system with no stack. Both cyclones are equipped with discharge chutes. However, as noted previously, in this area was a significant amount of non-ferrous materials flying around in the air and landing on and around us during the first inspection.

Image 5(New emission unit) : New non-ferrous material separation system. 8/23/23

The replacement of an emission unit, without obtaining a Permit to Install, is a violation of Rule 201. A Violation Notice will be issued.

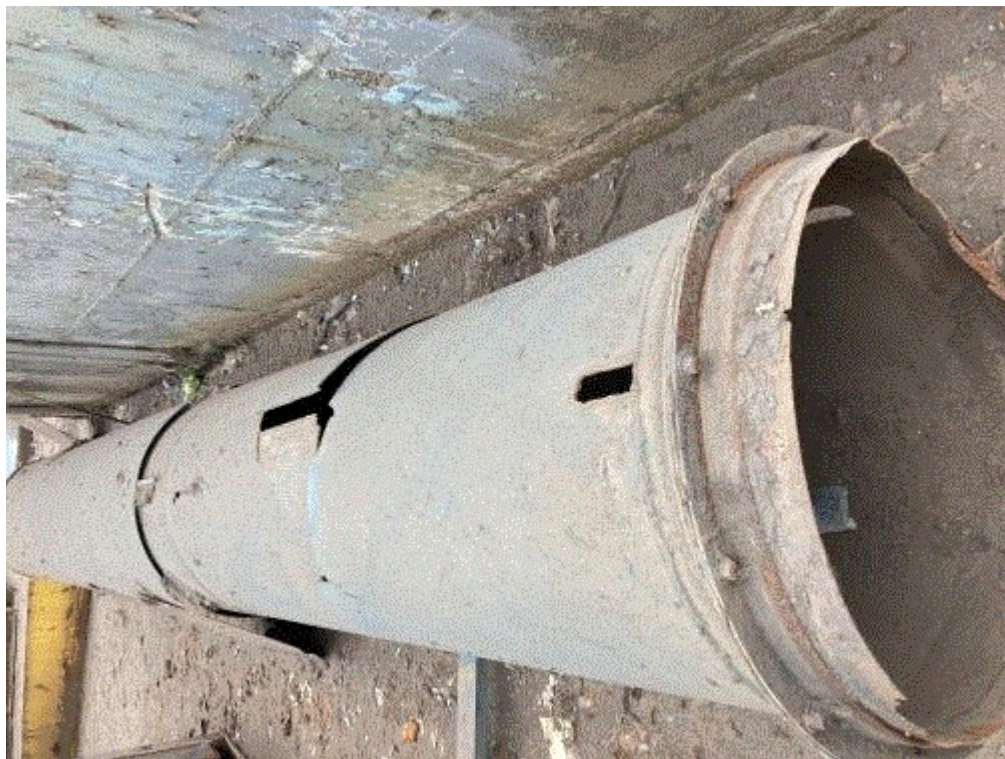
During the inspection, the unit was observed, and a stack height measurement was going to be taken. The stack on this emission unit had broken and fell over approximately one month ago. The remaining stack was also partially covered. (see attached photos) This is a violation of PTI No. 278-06A for failure to meet the stack height requirement. A Violation Notice will be issued. It is noted that Padnos had repaired and reinstalled the stack by August 29, 2023.

Image 6(Broken stack) : EU-FERROUSZBOX stack broken and on the ground. 8/23/23

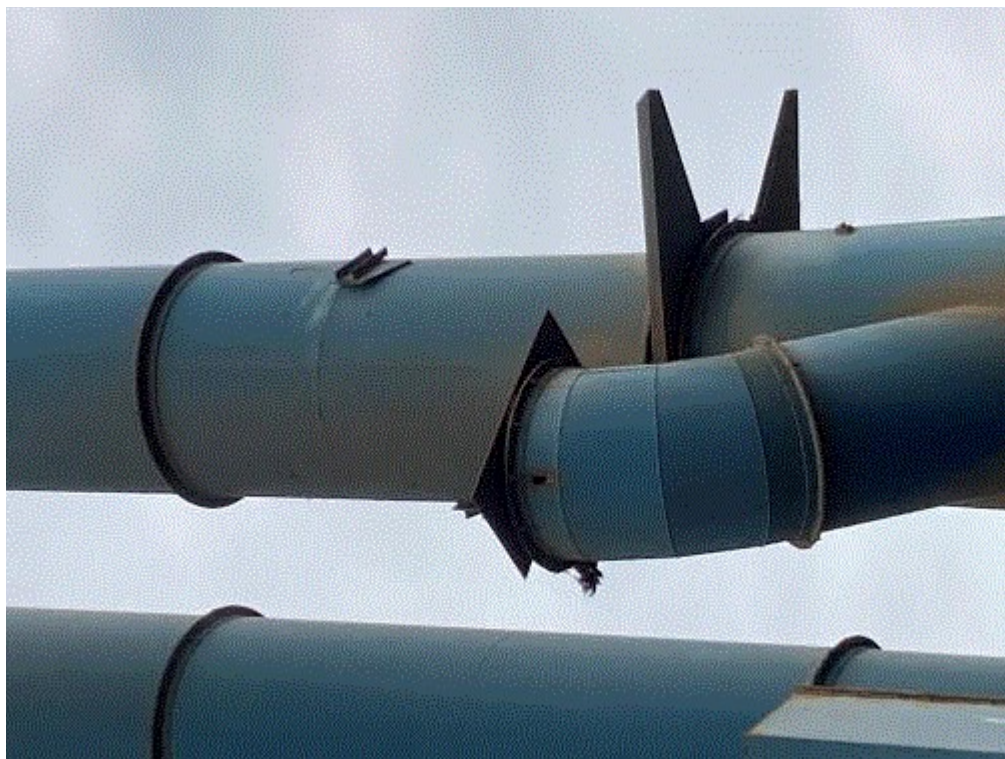
Image 7(Missing stack) : Remaining portion of stack, obstructed partially. Please view this image one turn

clockwise. 8/23/23

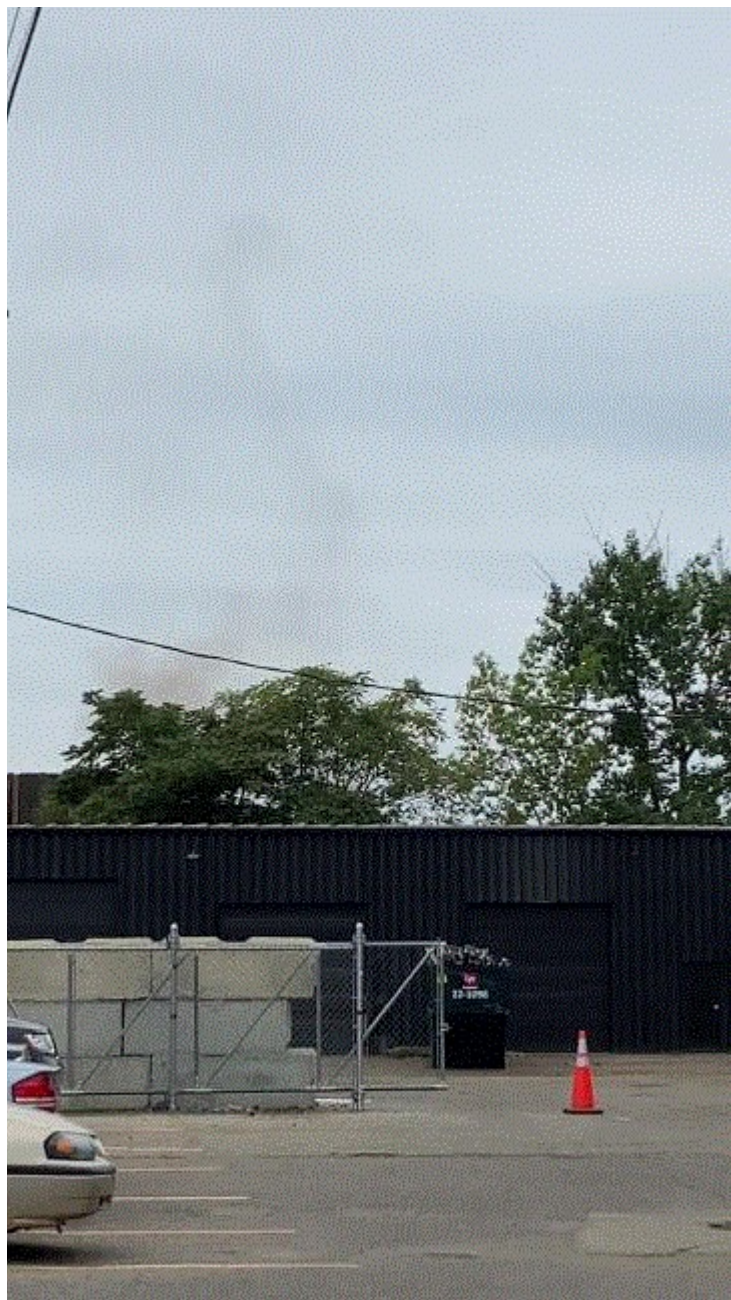
Emission limits for PM10, PM, Mercury and hexavalent chromium are included, and 2018 stack testing determined compliance with those limits. Opacity was observed from the shredder when I arrived on site for the first day of the inspection. (see attached photo) Additionally, opacity around the enclosure hood portion have been observed by AQD staff while driving past the facility on personal time, however a specific opacity/emission limit exceedance has not been documented to date. During times when excessive smoke has been observed, Padnos has been contacted via email. Opacity readings taken during the stack test indicated compliance with the 10% limit.

Image 8(Shredder opacity) : Opacity observed from shredder 8/23/23.

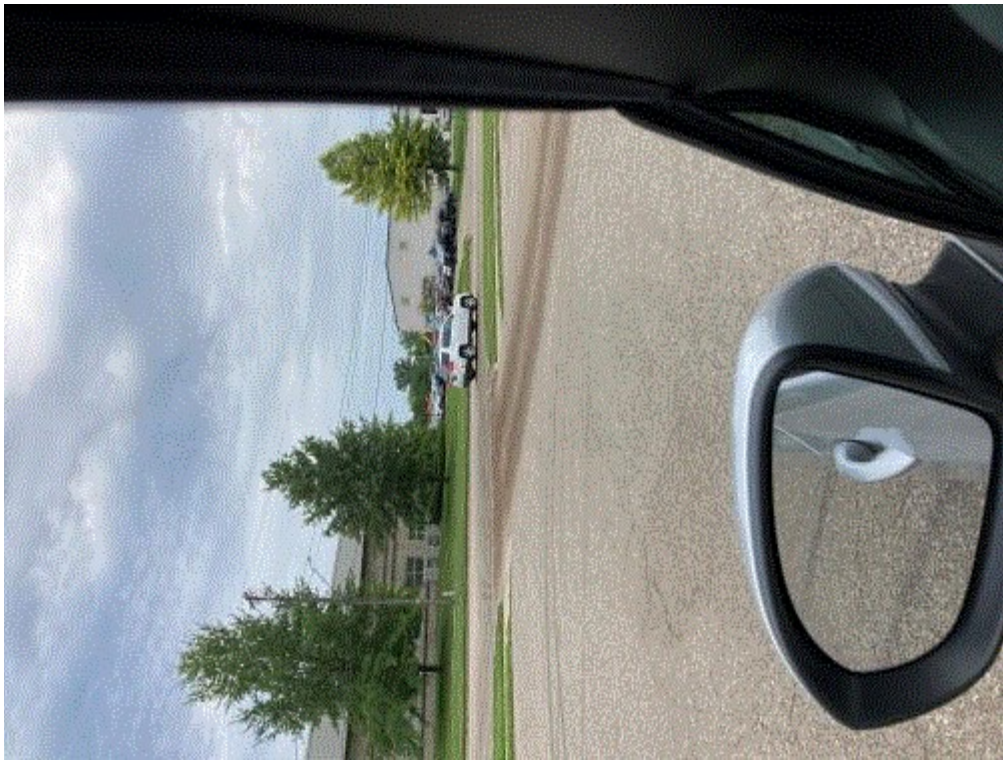
Records pursuant to the fugitive dust plan specified in Appendix A were requested and received. It is noted that this facility has a full-time employee position dedicated to water application. It is noted that track out was identified from the northernmost facility exit. This was discussed with Padnos during the inspection.

Image 9(Track out) : Track out observed from truck traffic exiting the northernmost roadway. 8/23/23

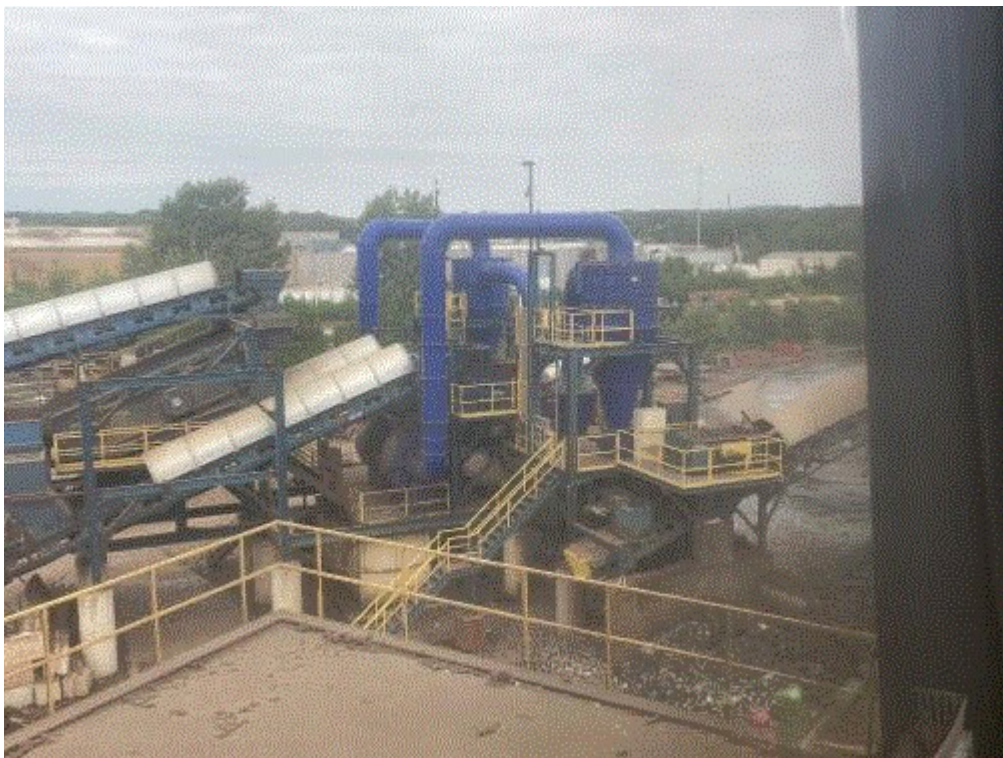
Image 10(Non ferrous system) : New non ferrous separation system, from shredder operator tower view.
