DEPARTMENT OF ENVIRONMENTAL QUALITY
AIR QUALITY DIVISION
ACTIVITY REPORT: On-site Inspection

FACILITY: FLINT WATER POLLUTION CONTROL FACILITY		SRN / ID: B1598
LOCATION: G-4652 BEECHER RD, FLINT		DISTRICT: Lansing
CITY: FLINT		COUNTY: GENESEE
CONTACT: John Florshinger , Plant Foreman		ACTIVITY DATE: 06/17/2020
STAFF: Daniel McGeen	COMPLIANCE STATUS: Compliance	SOURCE CLASS: MINOR
SUBJECT: Unannounced, scheduled inspection of facility.		
RESOLVED COMPLAINTS:

On 6/17/2020, the Michigan Department of Environment, Great Lakes, and Energy (EGLE), Air Quality Division (AQD) conducted an unannounced, scheduled inspection of Flint Water Pollution Control (WPC).

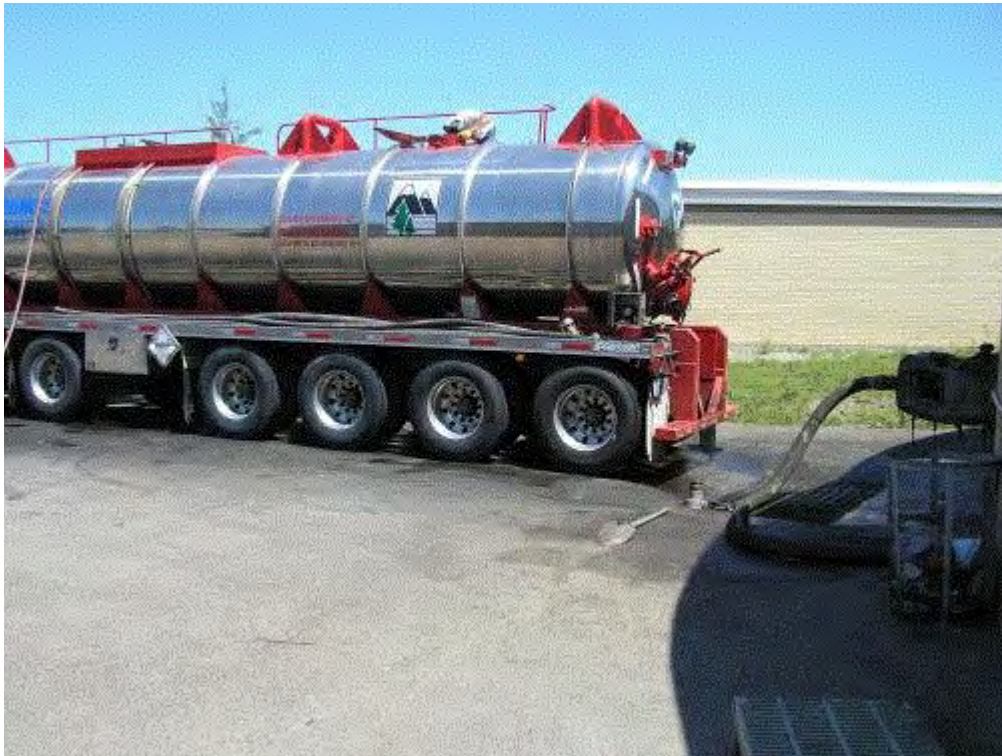
Image 1(001) : Truck washing after substrate delivery.

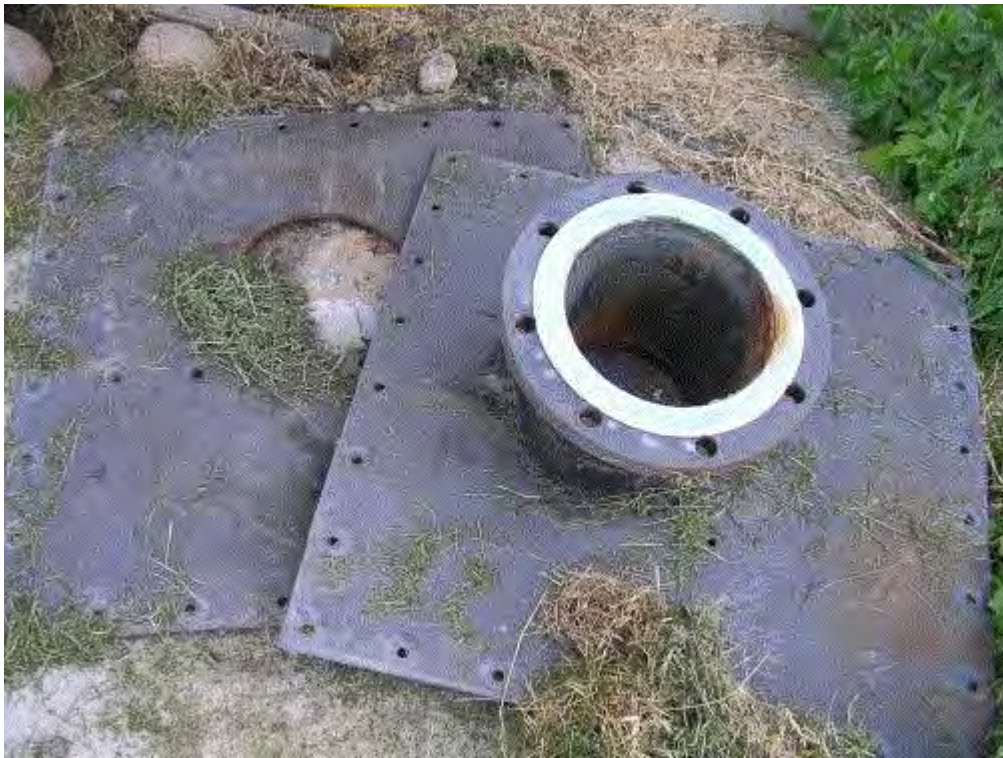
Mr. Floreshinger showed me the areas where they made repairs and upgrades following rupture of a seal this spring. It is my understanding that a mixer or agitator had broken free from its base, and torn a seal on the side of the tank, releasing digestate onto the ground. When they repaired the tank, they replaced the original carbon steel plate with a stainless steel plate, with gussets for reinforcement. There was a similar mixer on the other side of the tank, with a carbon steel plate, I was told, and they likewise replaced it with a stainless steel, gusseted plate. Mr. Florshinger showed me the removed carbon steel plates; please see photo No. 002.

Image 2(002) : Carbon steel plates from digestate tank.

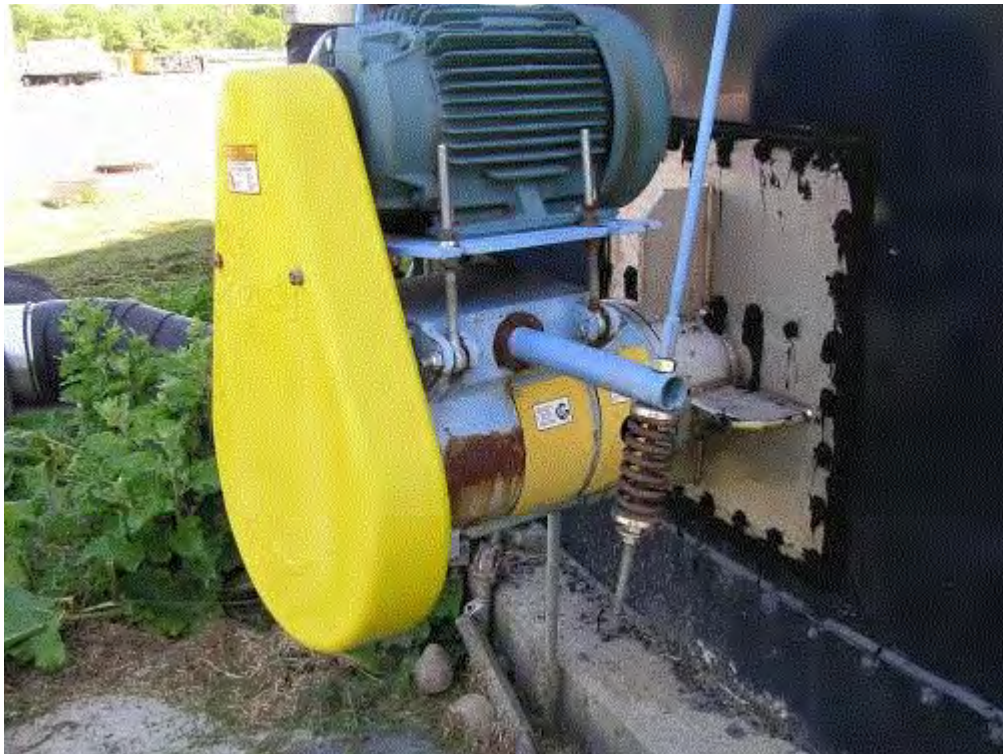
Image 3(003) : New stainless steel plate with gussets.

I was shown the new, gusseted stainless steel plates, each of which had a shock mount to support the electric motor, pulley, and shaft of their respective mixers. Please see attached photos Nos. 003 and 004.

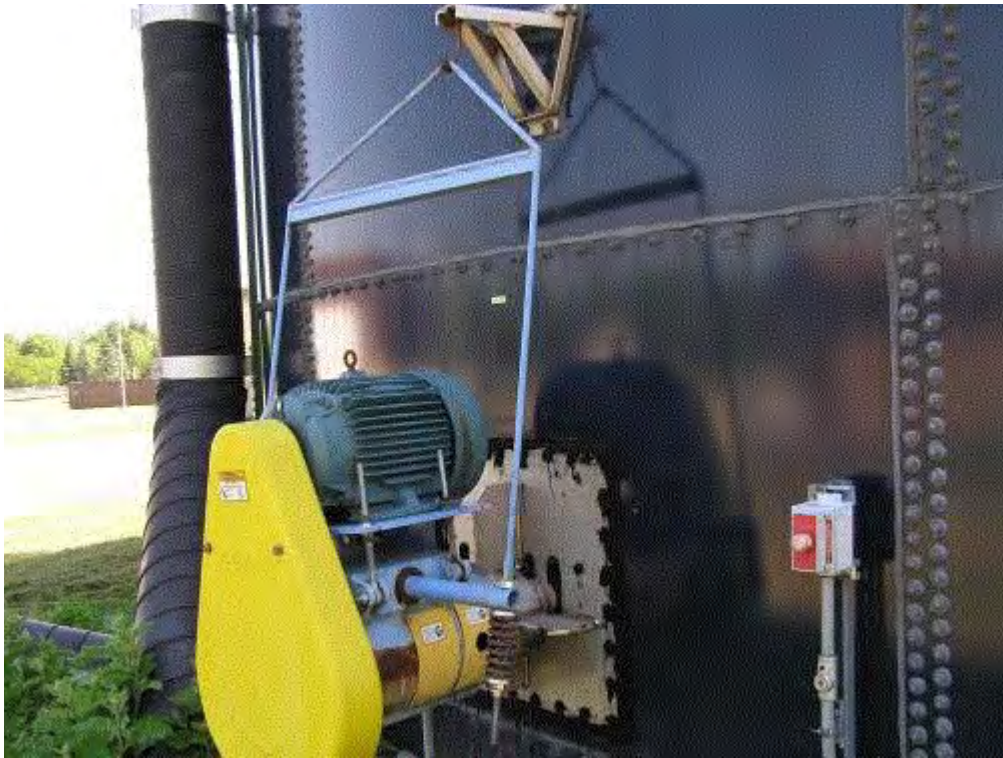
Image 4(004) : New shock mount for electric motor, pulley, and shaft of mixer.

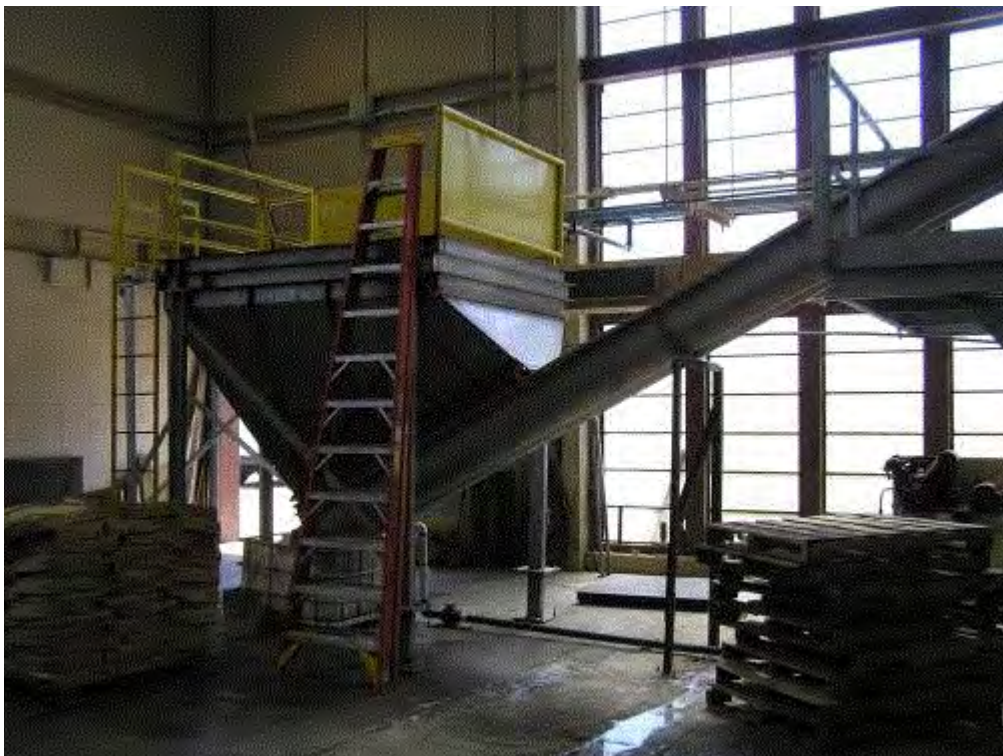
The loading hopper for food packages was at the left or east end of the room. Please see photo No. 005. An auger, or screw conveyor, takes the food packages to the right, to the depackager or "opener," please see photo No. 006. The opener, I was told, is a drum with paddles. The slurry of waste food goes to a feed line, while the shredded food packaging goes into a bin, below. The feed line goes to either the east sludge tank or to the south digester. The process was not running, at the moment. The odor of spoiled food in the room was sharp, but not overly strong, at this time.

Image 5(005) : Feed hopper and auger.

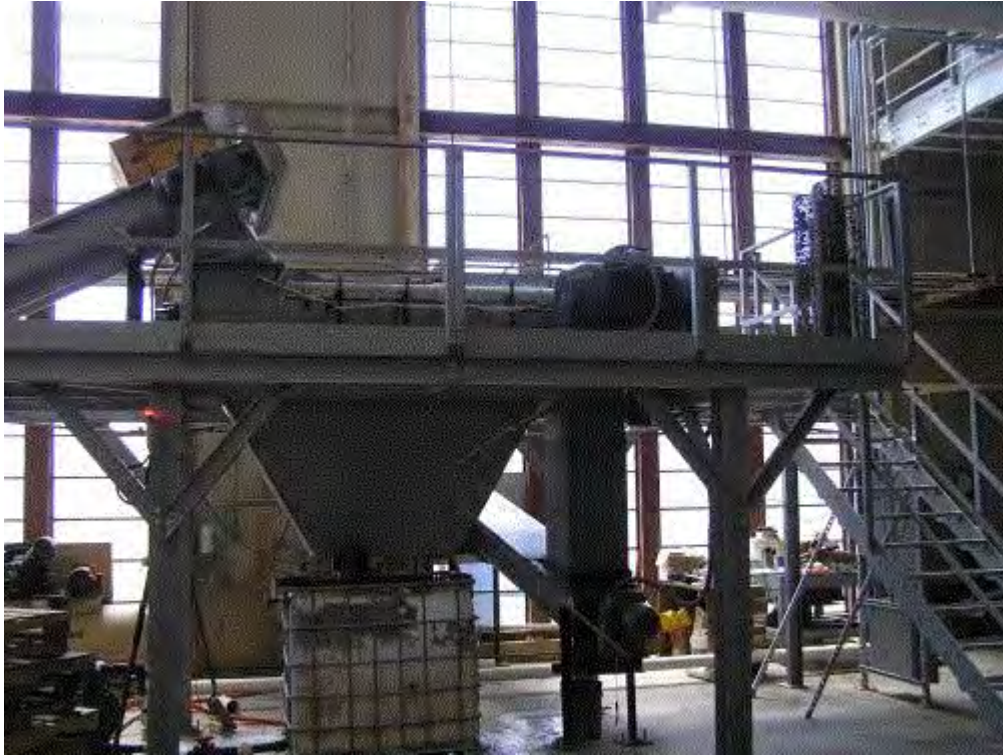
Image 6(006) : Depackager or opener.

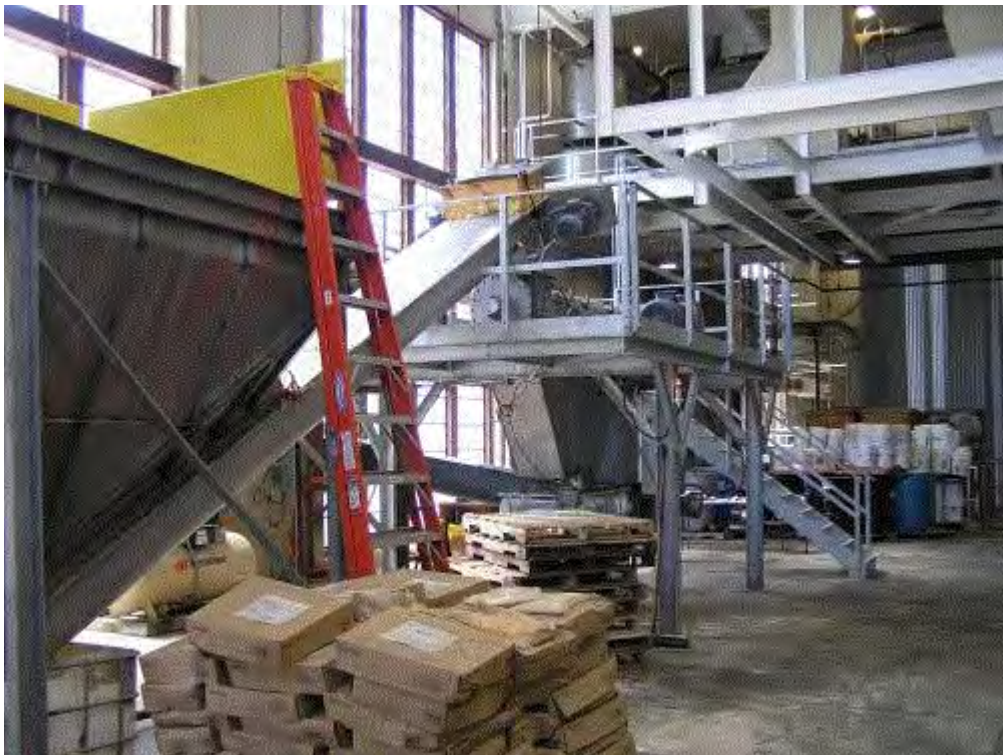
Photo No. 007 shows the feed hopper and depackager in relation to one another. ~~Photo No. 008 shows the bin for baled packaging. Photo 009-8 shows the depackager at center, with the waste packaging bin underneath it. Photo no. 009-010 shows a stainless steel tank which stores the slurry prior to it being routed to the south digester or east sludge storage tank, as I understand it.~~

Image 7(007) : Hopper at left, and depackager at center of photo.

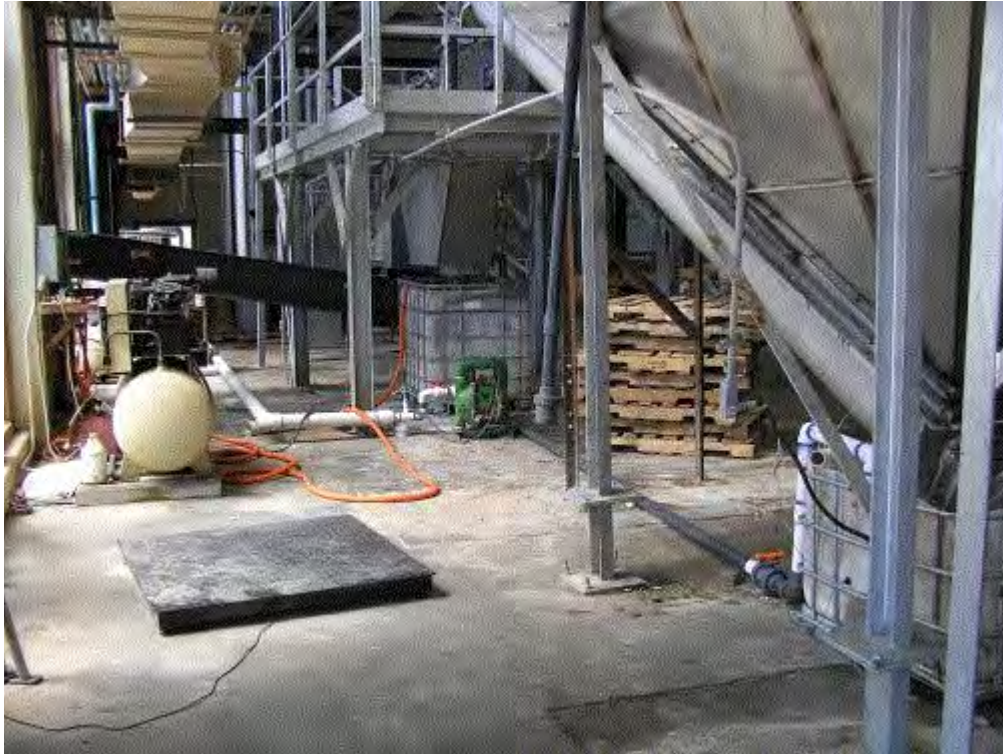
Image 8(008) : Depackager at center, with bin for waste packaging underneath.
