**DEPARTMENT OF ENVIRONMENTAL QUALITY
AIR QUALITY DIVISION
ACTIVITY REPORT: On-site Inspection**

FACILITY: Ervin Amasteel Division		SRN / ID: B1754
LOCATION: 915 TABOR ST., ADRIAN		DISTRICT: Jackson
CITY: ADRIAN		COUNTY: LENAWEE
CONTACT: Richard Payne , Plant Engineer		ACTIVITY DATE: 06/09/2021
STAFF: Mike Kovalchick	COMPLIANCE STATUS: Compliance	SOURCE CLASS: MAJOR
SUBJECT: Inspection of a secondary steel mill. One compliance concern regarding opacity from vent on south wall of roof vent.		
RESOLVED COMPLAINTS:

Major Source for CO-Area Source for HAPs-Full Compliance Evaluation (FCE)

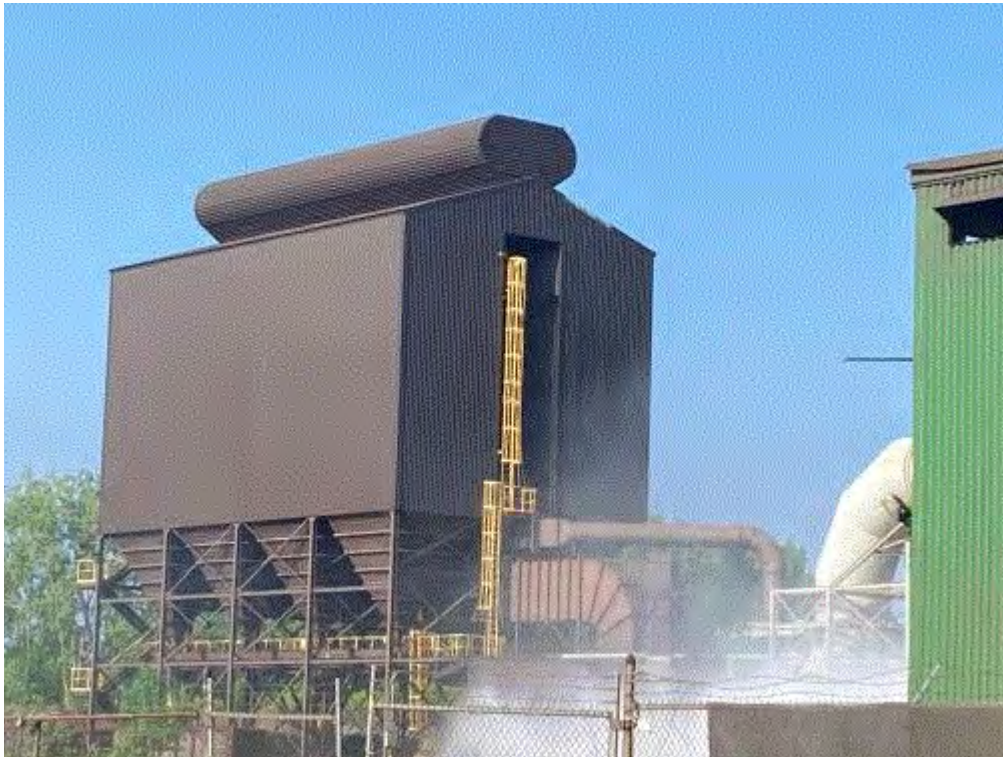
RP took me to look at EAF baghouse. Just outside the 8-section positive pressure-reverse jet baghouse is where a large ventilation duct was coming in from the Northside of the facility where the EAF is located. A smaller auxiliary fan has been added siting directly adjacent to the original fan. This auxiliary fan is used when the EAF is not in operation. RP indicated that all approximately 1300 bags had been replaced about 6 weeks prior. The last time they had been changed was about 8 years ago. RP indicated that the bags were still in good condition although they were getting "heavy". No opacity was visible coming from the baghouse. Next, we entered the baghouse control room. See attached photo of the control panel and pressure drop meters for each section of the baghouse. The readings were generally close to 6" of inches of water. This was in sharp contrast to previous visit when the pressure drop readings averaged about 11".

Image 1(EAF Baghouse) : EAF Baghouse

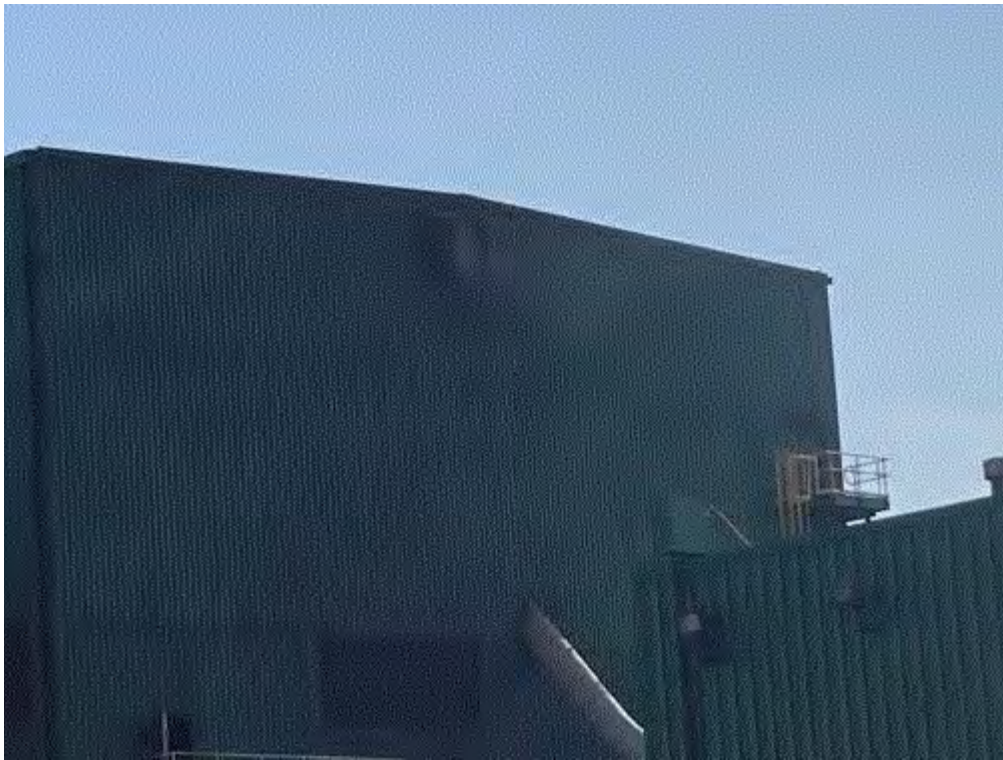
Visible emissions were observed upon my approach to the Company's facility. I arrived at 8:50 am in the parking lot and observed opacity coming from an open louver vent near the top of the south wall of the Melt Shop. I took photos/video of the opacity and then proceeded to the Company's front office to request access for an inspection, provided my identification and spoke with Rick Payne (RP) Plant Engineer.

Despite the fan not being on, this is where I noted opacity upon arrival of the facility. I estimated the opacity at 10 to 20% over a ten-minute. The sun angle was directly behind the source of the opacity so a proper Method 9 reading could not be taken from where the smoke could be read on the ground.

The opacity limit is 6%. (Discussion with RP after the inspection and another Ervin employee concluded that I observed opacity during the tapping part of the Melt cycle which may have been the result of an operator pouring the melt too fast or not in a steady fashion which results in excess smoke that lingers near the ceiling of Melt Shop for quite some time.) We observed the EAF for a while from the control room. I witnessed the 3 electrodes already emplaced into the scrap. I took several photos of all the process parameters being displayed on the control room screens. See attached.

Image 2(South wall-Melt Shop) : South wall-Melt Shop showing roof vent with louver stuck open resulting in opacity.

1. I was unable to determine compliance with the 6% opacity limit for fugitive dust emissions coming from the EAF building. The Company is required to:
 - a) Investigate what methods/procedures that they can implement that would reduce opacity coming from the vent on the upper south wall of the EAF building. Acceptable options include sealing off the vent permanently or otherwise completely redesigning the vent louvers so that they are not prone to sticking in the open position.
 - b) Conduct Method 9 readings to show compliance during the tapping part of the Melt cycle after modifications to the vent have been completed.
 - c) Provide an update by the end of July to AQD.

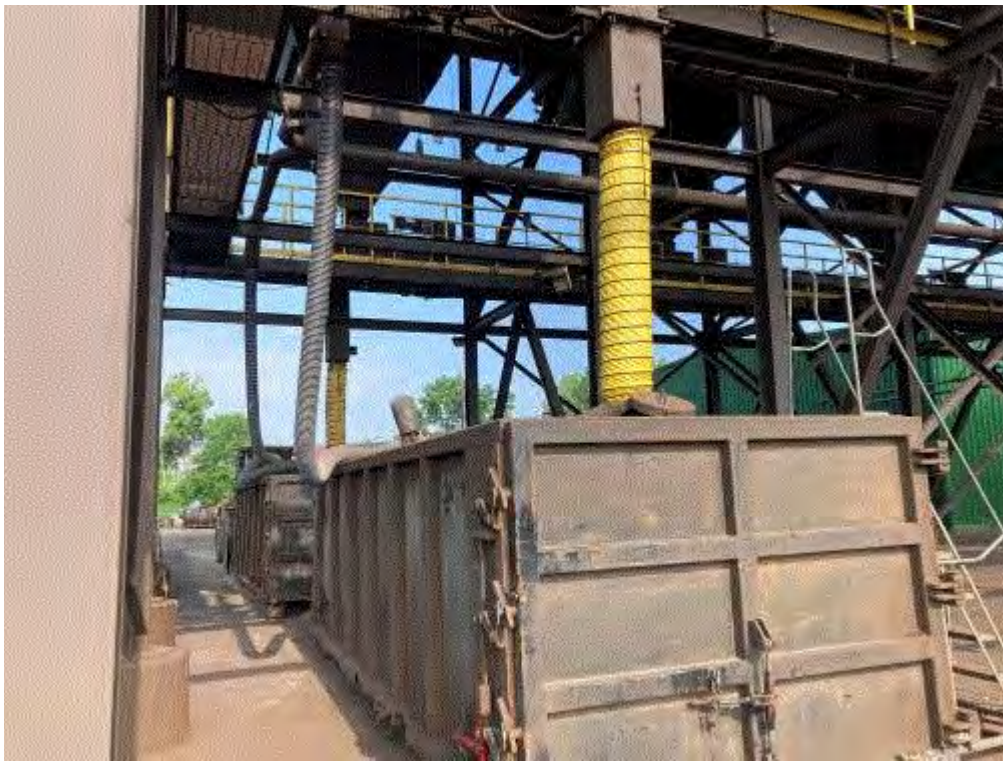
Next, we went outside to look at the 2 dust boxes located underneath the baghouse. Collected solids from the baghouse are routed into 1 of 2 dust boxes for collection. No collected fines were visible on or near the dust boxes and also no opacity. (See attached photo.)

Image 3(EAF Baghouse) : EAG Baghouse boxes where fines are disposed of.

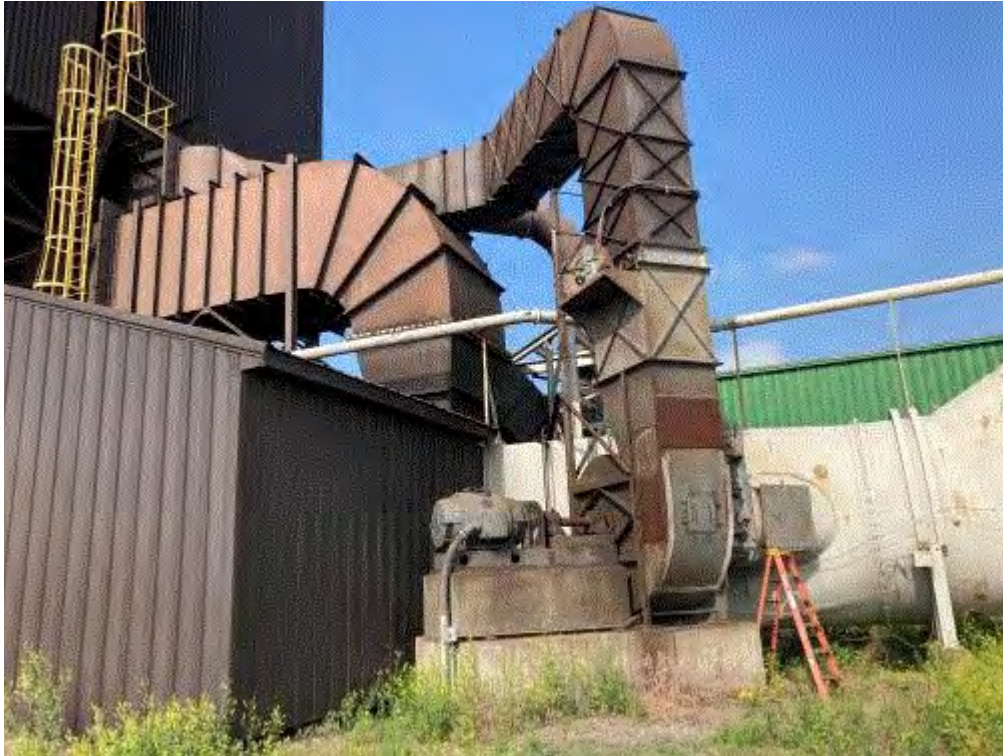
Image 4(EAF Baghouse) : EAG Baghouse elbow area.

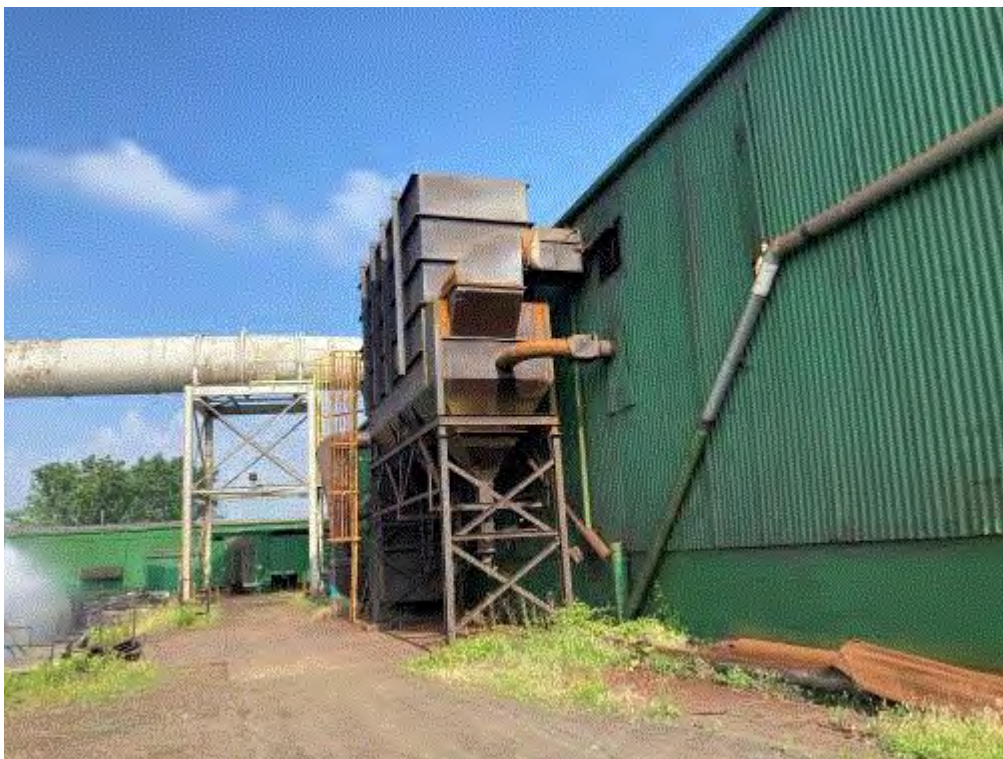
We stopped to look at the Grit dust collector associated with EU-0007. No opacity was observed, and the collector appeared to be operating properly. (See attached photo.)

Note: Observation of the baghouse exhaust during the inspection showed no visible emissions. Observation of the area around the baghouse showed good housekeeping practices.

Image 5(EU-0007) : EU-0007 baghouse

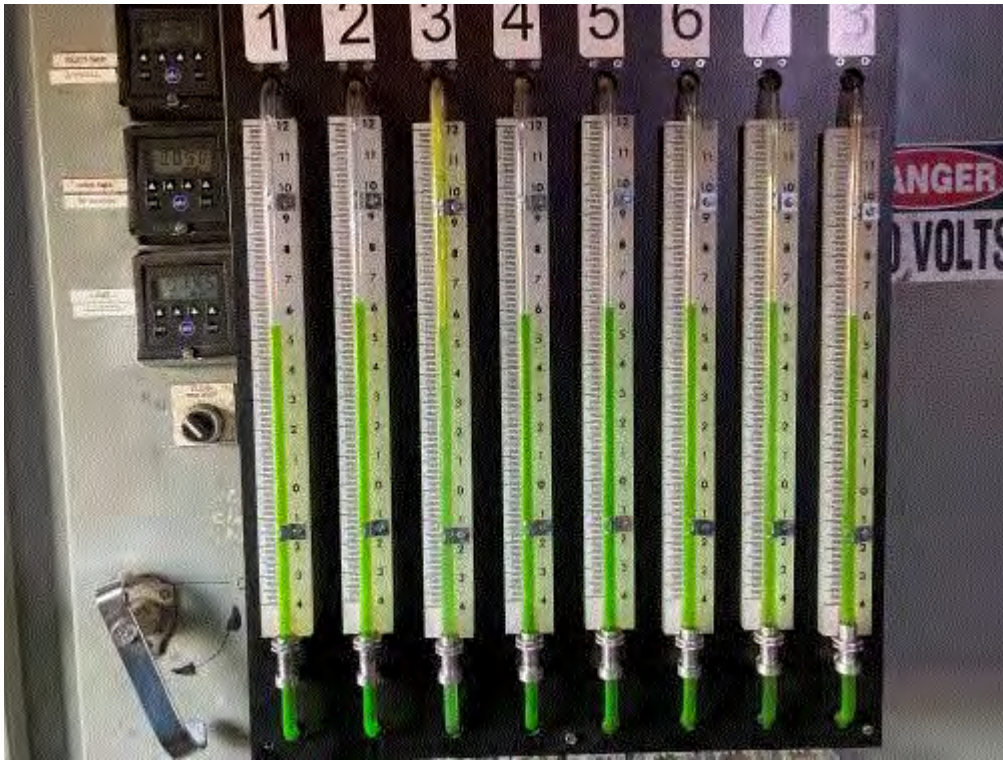
Image 6(EAF Baghouse) : EAG baghouse pressure drop readings for each baghouse section.

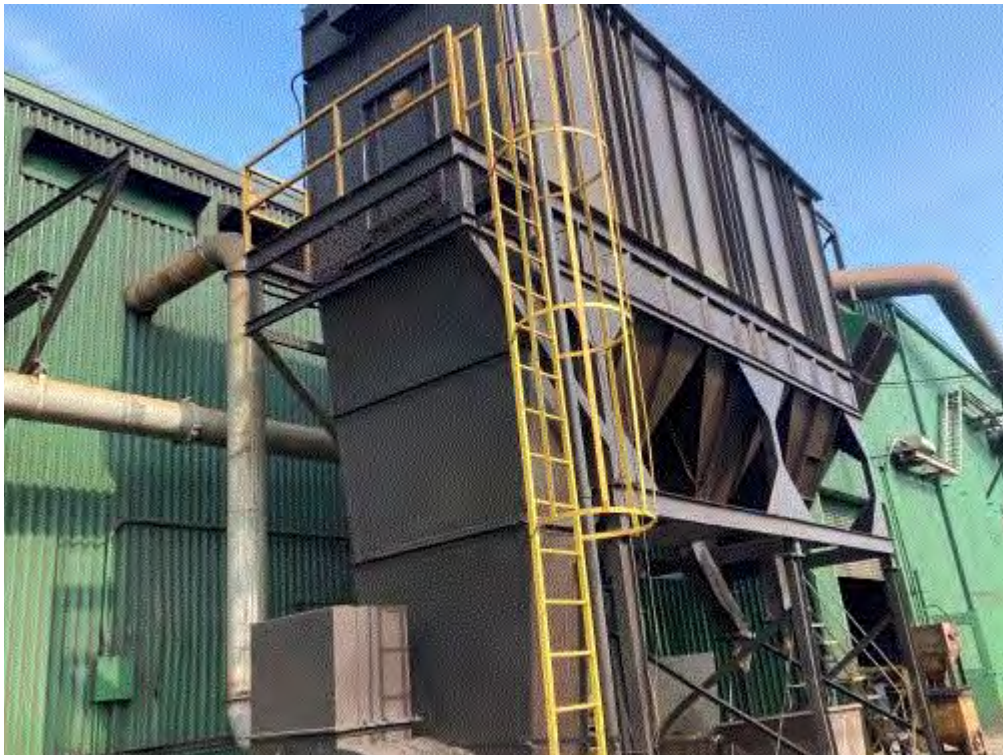
We stopped to look at a dust collector associated with EU-0005. No opacity was observed, and the collector appeared to be operating properly. (See attached photo.)

Note: Observation of the baghouse exhaust showed no visible emissions.

Image 7(EU-0005) : EU-0005 baghouse

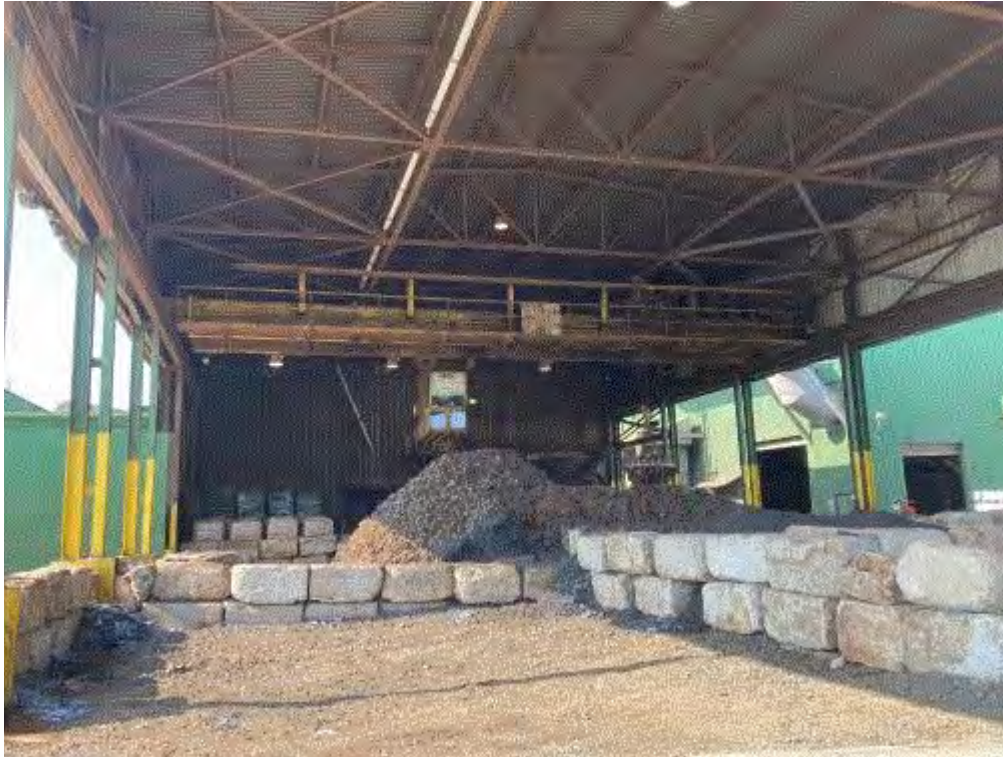
We walled by the scrap yard. (Open sided building with roof-see attached photo.) It handles 300 to 400 tons of scrap per day. 90% of the scrap comes from Omnisource with some coming from Padnos and other scrap dealers. The scrap includes sheet metal stampings, bushings, frag, plate and structural pieces, manganese pieces etc. They use the paint filter test method to verify purchase specifications that appear to be oily etc. The material is collected using a magnetic grabber that fills the charge ladle. The non-metallic materials/chucks are loaded by front end loader. No oil or dust was noted. A small train car (electric powered) like set up takes the filled ladle from the scrap yard building to the Melt shop.

Image 8(Scrap yard building) : Scrap yard building

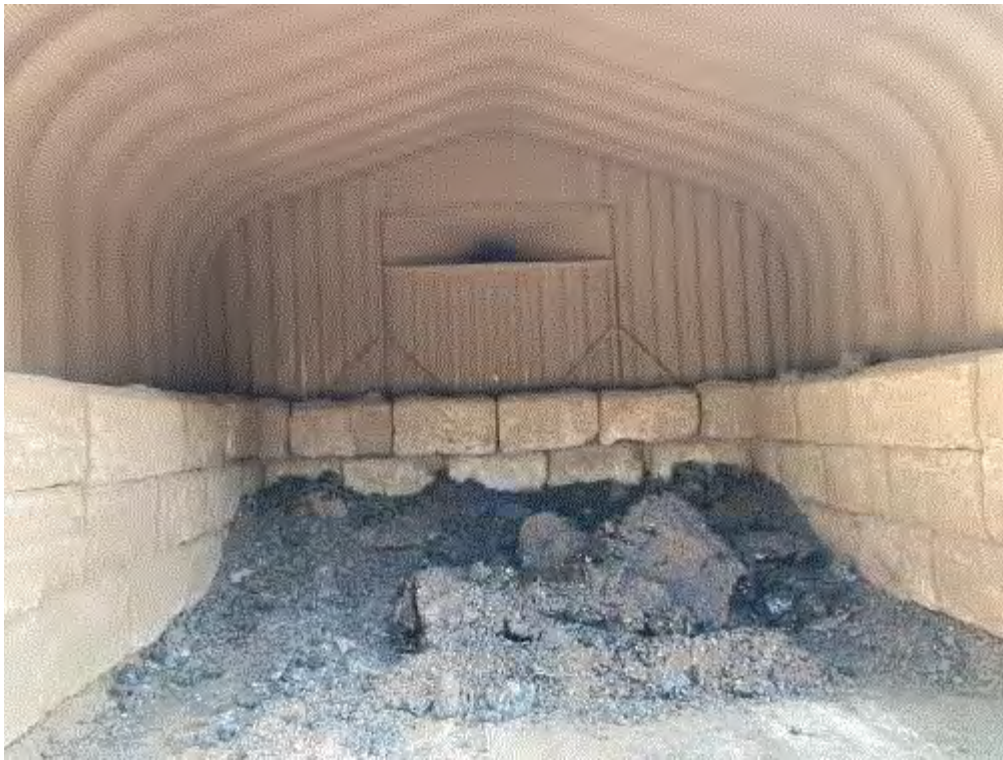
RP showed me the North slag building. This is a small building open on one side located near the scrap yard. Slag from the furnace is placed inside the building to cool. When the front-end loader enters the building, it triggers a motion sensor that turns on a baghouse located behind the building.

Image 9(North scrap) : North scrap pile building with vent in back

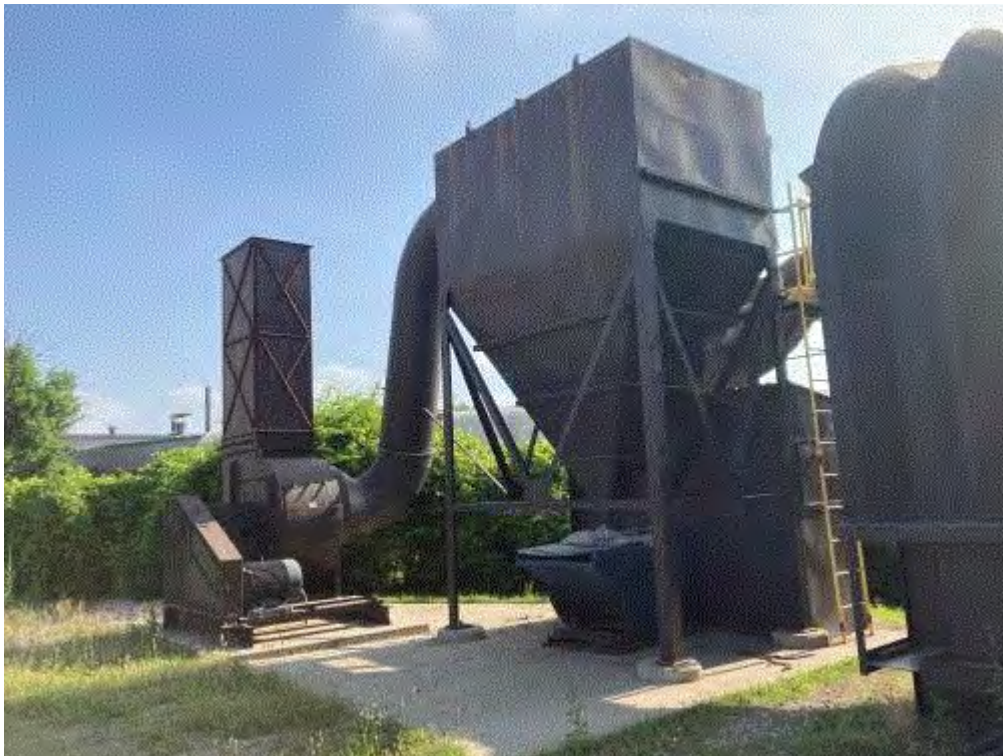
There was some slag in the building during the inspection, but the baghouse was not running since nothing had been deposited in the building recently. The baghouse appeared to be in good shape. See attached photos. After it cools, the slag is removed from the building and brought to the South side of the plant.

Image 10(Slag baghouse) : North slag building baghouse. (not operating)

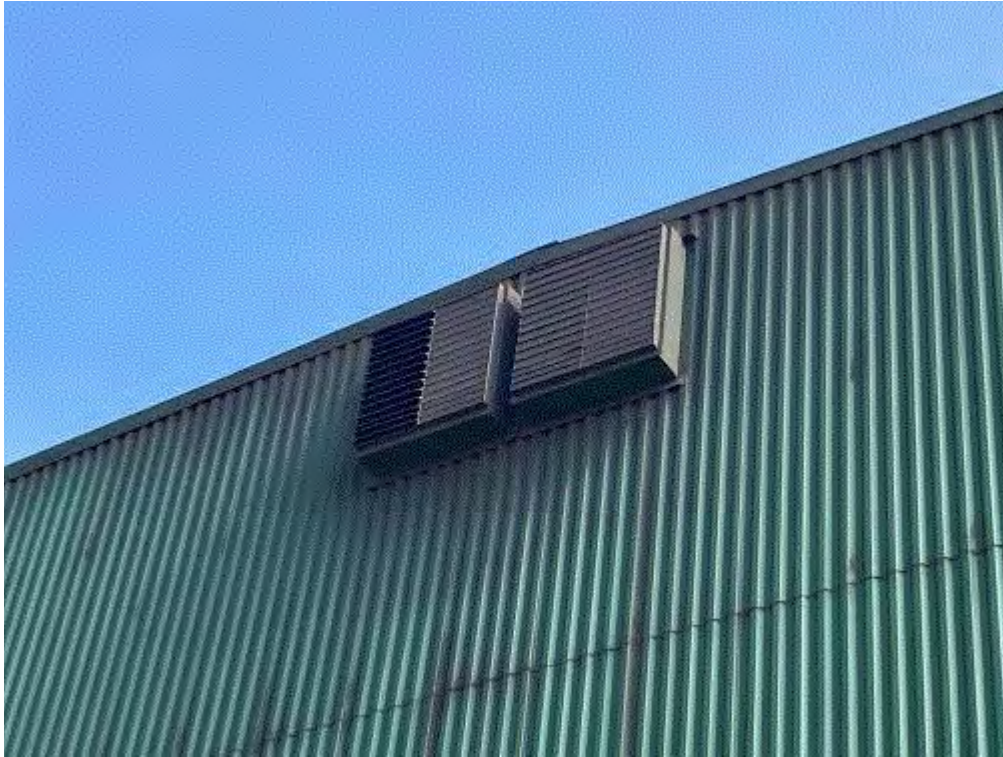
occurring. Generally, no smoke was observed exiting the building except through the ventilation system. There are 2 vents on the south side of the Melt shop and one on the east side of it near the roof line. These are the vents that EPA was interested in during their previous inspections and concluded an administrative consent order with the Company regarding this issue. As a result, the Company has altered the fans associated with the side vents so that they are not turned on when the EAF is in operation. The east vent was closed but the west part of south vent appeared to be stuck open. No opacity was visible while on the roof. (No fallout was visible anywhere on the roof either.)

Image 11(South Vent) : Vent on southside of Melt Shop. Louver stuck open on the left(west) side of it.

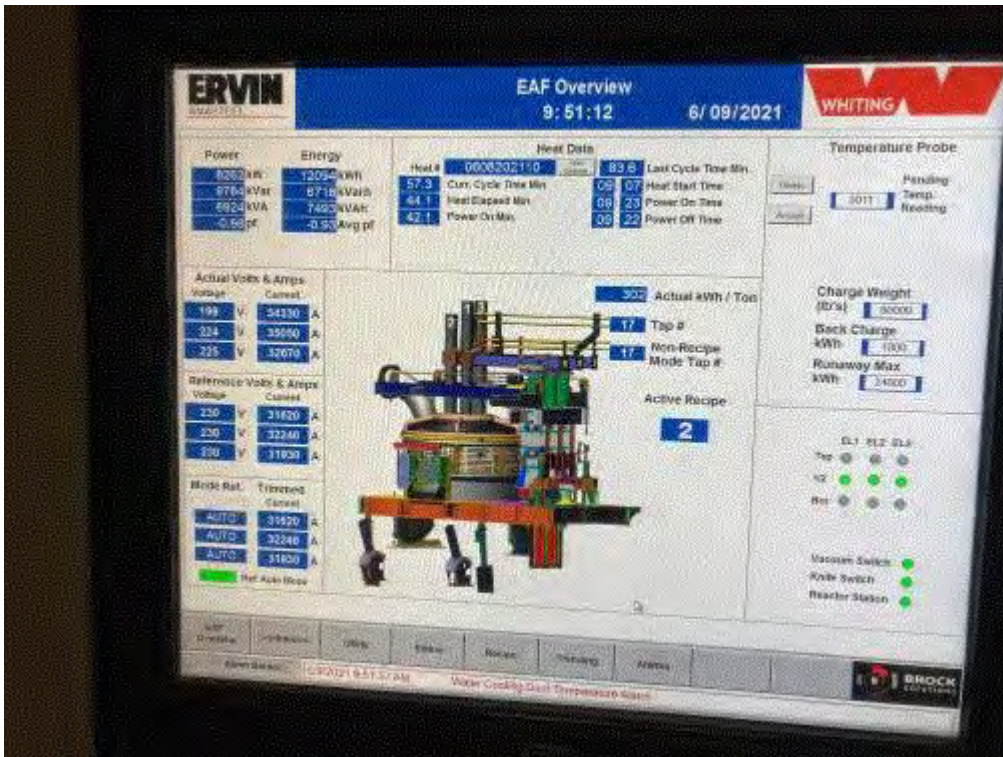
Image 12(EAF Control Room) : EAF Control Room view

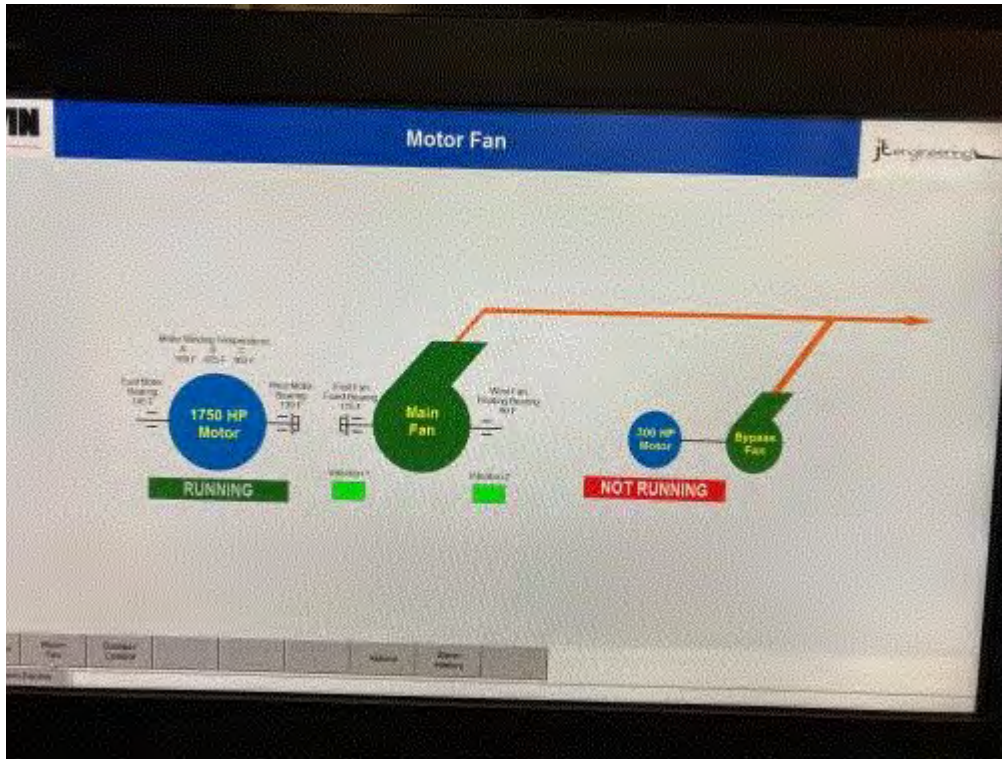
The Melt shop has a HMI system to allow for the automated operation of the Melt shop hood dampers. This includes the furnace control damper, the furnace monitor damper, the caster monitor damper, the box and ladle collection damper, the fly swatter collection damper and the atomizing tank collection damper. The automated system allows for the control of damper openings, as well as the percentage that an individual damper is opened. Damper openings are controlled based on the stage of the process (melting, pouring, and casting) to optimize the use of the 300,000 scfm of airflow available to draw off emissions.

Image 13(EAF Control Room) : EAF Control screen view.

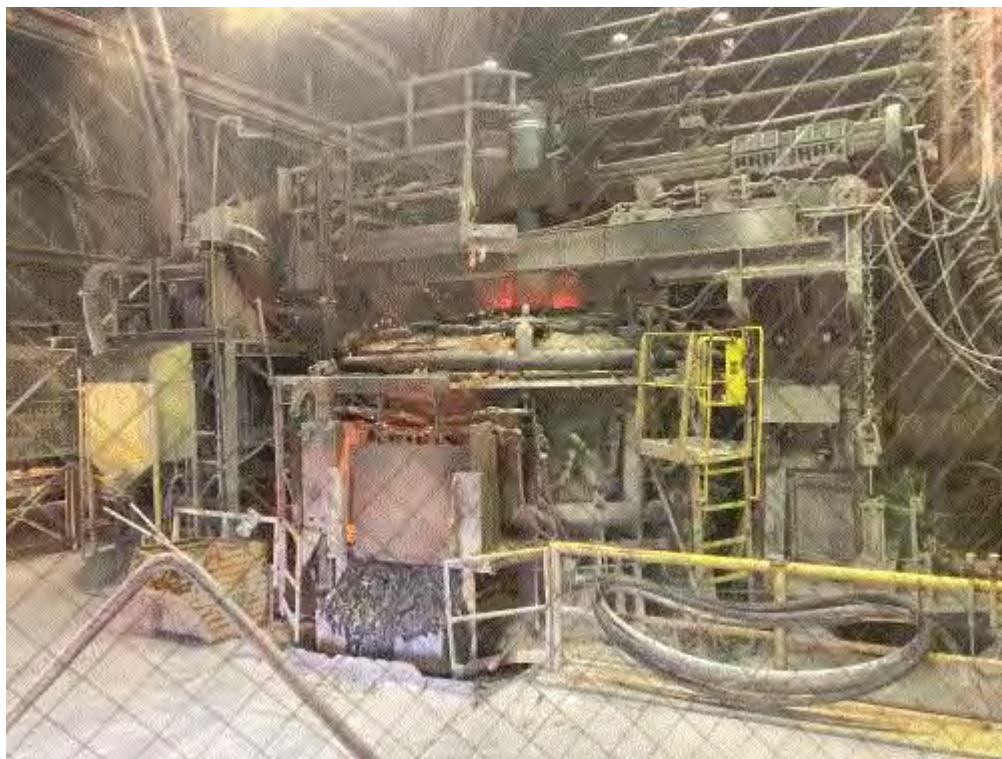
We visited the EAF building and a roof adjacent to it. The EAF was in the middle of a melt. A small amount of smoke was being generated. It appeared to be captured by the roof canopy hood located near the ceiling of the 100-foot-high building. (The roof of the building has no openings.) Some of the emissions were being captured by the “fly swatter” hood located close to where tapping occurs.

Image 14(EAF) : EAF half way through melt cycle.
