DEPARTMENT OF ENVIRONMENTAL QUALITY
AIR QUALITY DIVISION
ACTIVITY REPORT: Scheduled Inspection

FACILITY: Gerdau Special Steel North America - Jackson Mill		SRN / ID: B4306
LOCATION: 3100 BROOKLYN RD, JACKSON		DISTRICT: Jackson
CITY: JACKSON		COUNTY: JACKSON
CONTACT: Craig Metzger, Regional Environmental Manager		ACTIVITY DATE: 01/24/2018
STAFF: Mike Kovalchick	COMPLIANCE STATUS: Non Compliance	SOURCE CLASS: MAJOR
SUBJECT: Inspection of Gerdau and adjacent TMI International Corporation slag handling facility.		
RESOLVED COMPLAINTS:

Major / ROP Source. Full Compliance Evaluation (FCE) and Inspection (PCE)

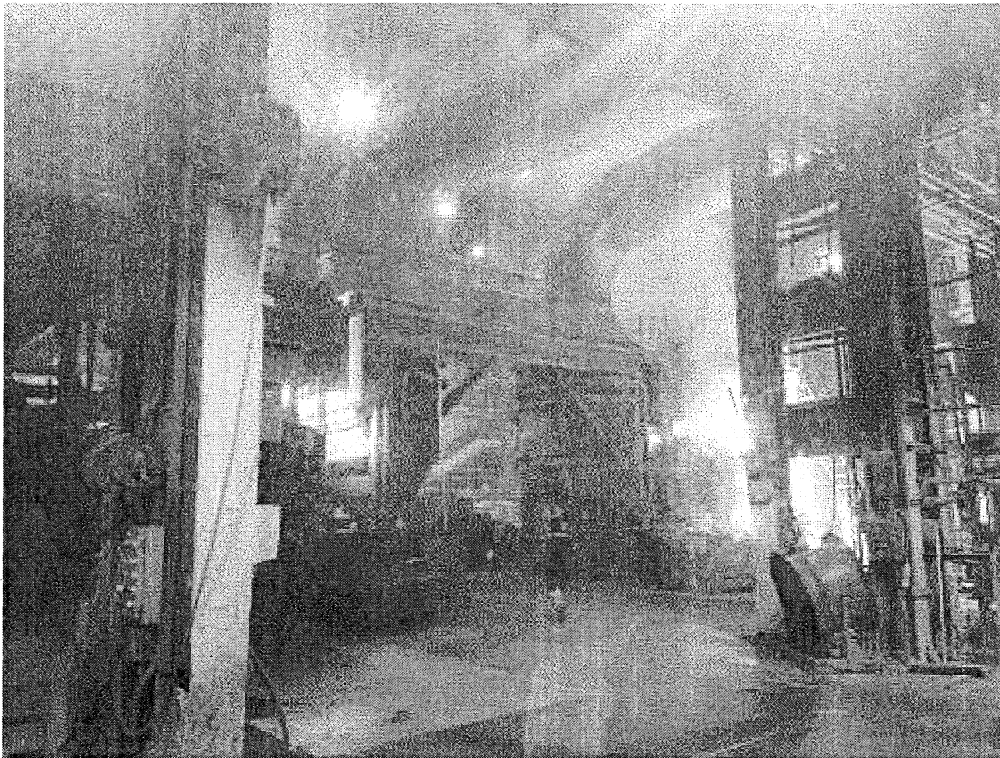
Most of the emissions were captured by the overhead canopy. GJ operates 2 individual EAFs with a 50-ton capacity. Each is equipped with 3 electrodes and additional oxy-fuel burners. Scrap is charged 2 times per heat. GJ does alternate the front (1st) and the back (2nd) charge. We then observed the LMF, followed by the

Image 2(EAF) : Looks towards EAFs from behind window.

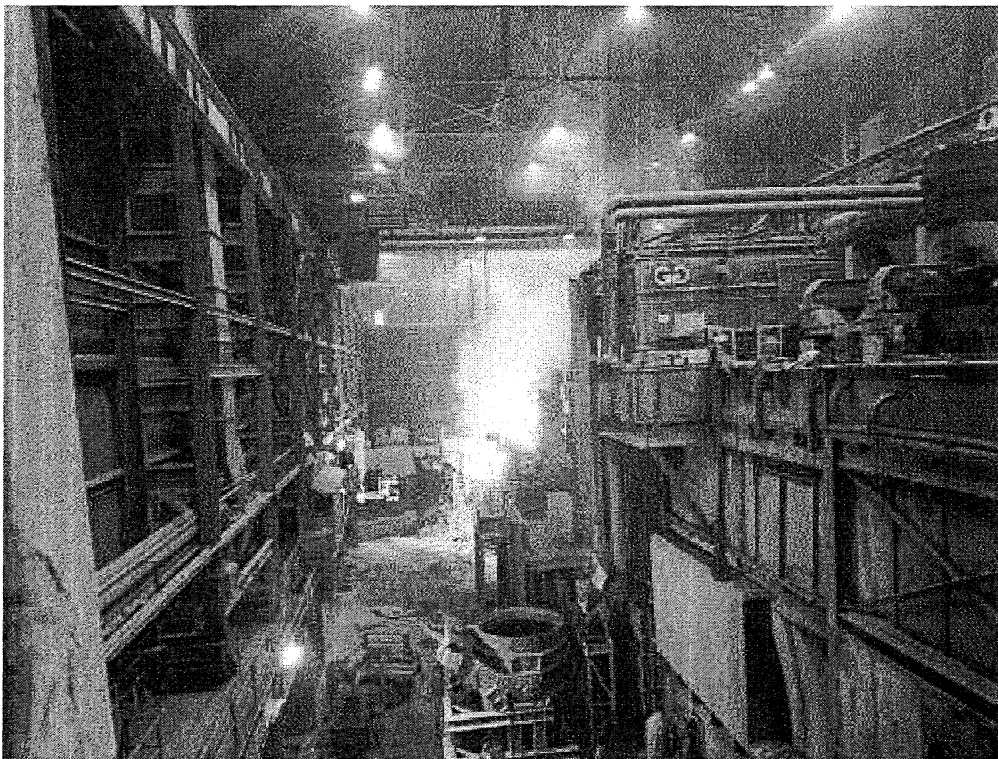
VAD. A ladle is transported by an overhead crane from the EAF to the LMF, then to the VAD, and finally to the caster and the caster roof monitor.

Image 3(EAF) : Distant view of ladle pouring.

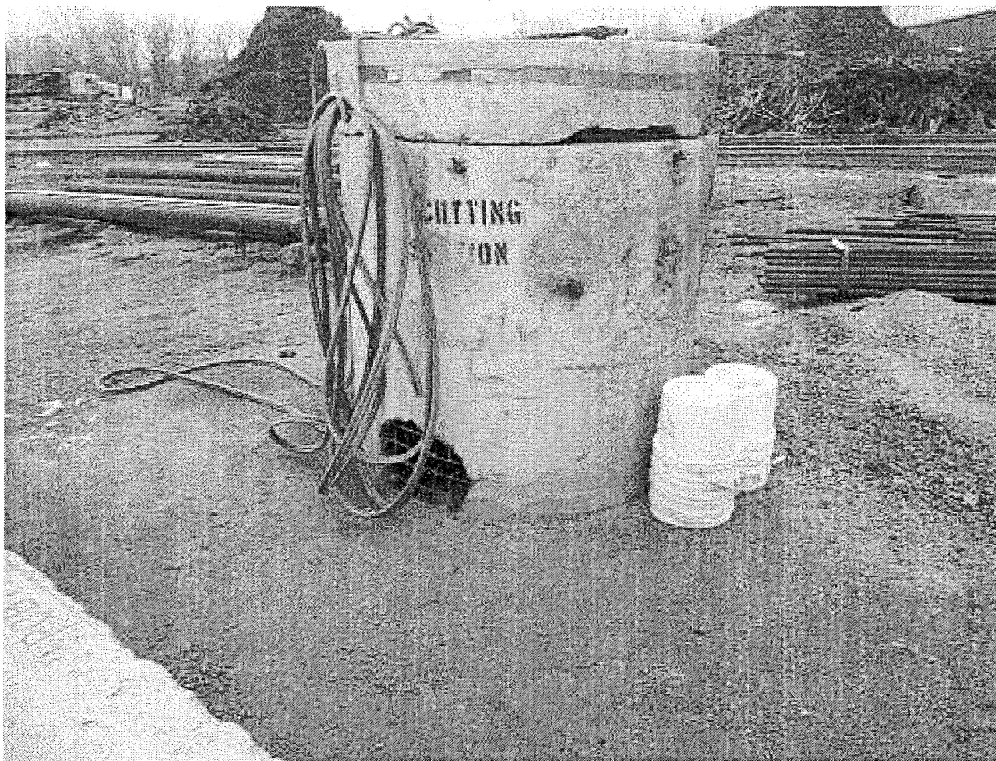
Next, we went outside to observe the torch cutting area. There appeared to be 3 separate torch cutting stations; each station equipped with multiple torches. There was a both a large pile of off-spec steel rods that were waiting to be torched and metal that had already been torched. PB explained that the steel needs to be cut into 4-foot sections so that he can be placed back in the ladle to be re-heated. They were not torching during the plant tour but PB explained that torching is done daily.

Image 5(Torch Cutting) : One of three torch cutting stations.

- Torch Cutting operation may not be in compliance with 20% opacity and Rule 201. This issue will be revisited during an upcoming scheduled inspection when the torch cutting operation is active.
- Slag handling operation needs to be included in upcoming ROP renewal. It may need to be added as a separate section of the ROP.

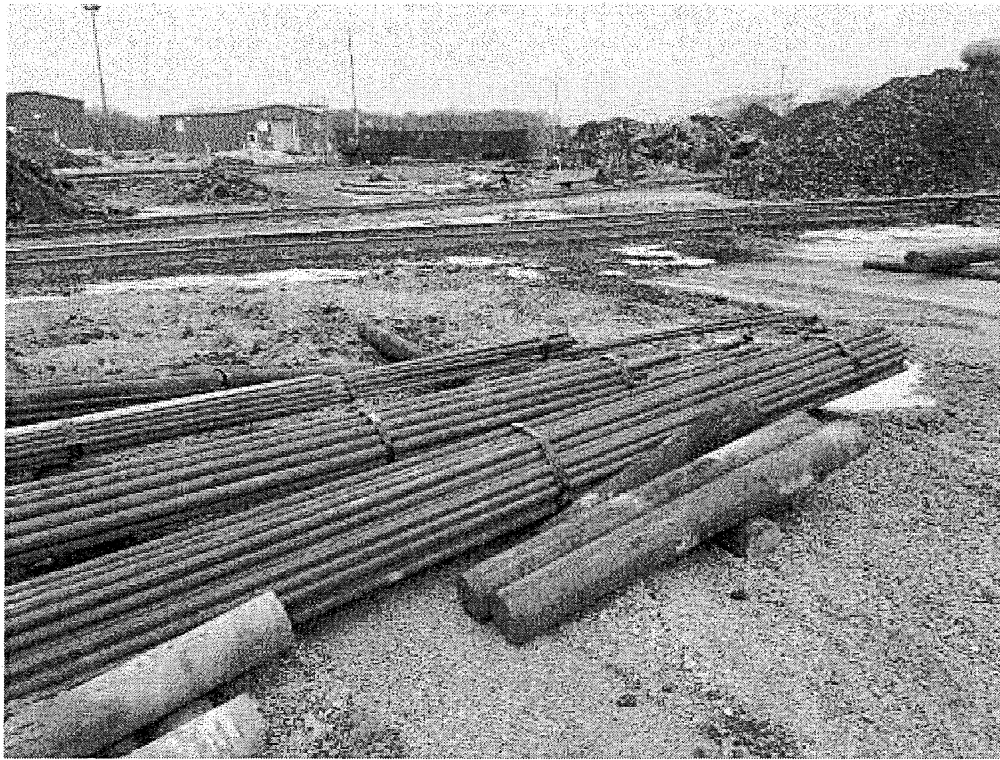
Image 6(Torch Cutting) : Recycled material ready to be torch cut.

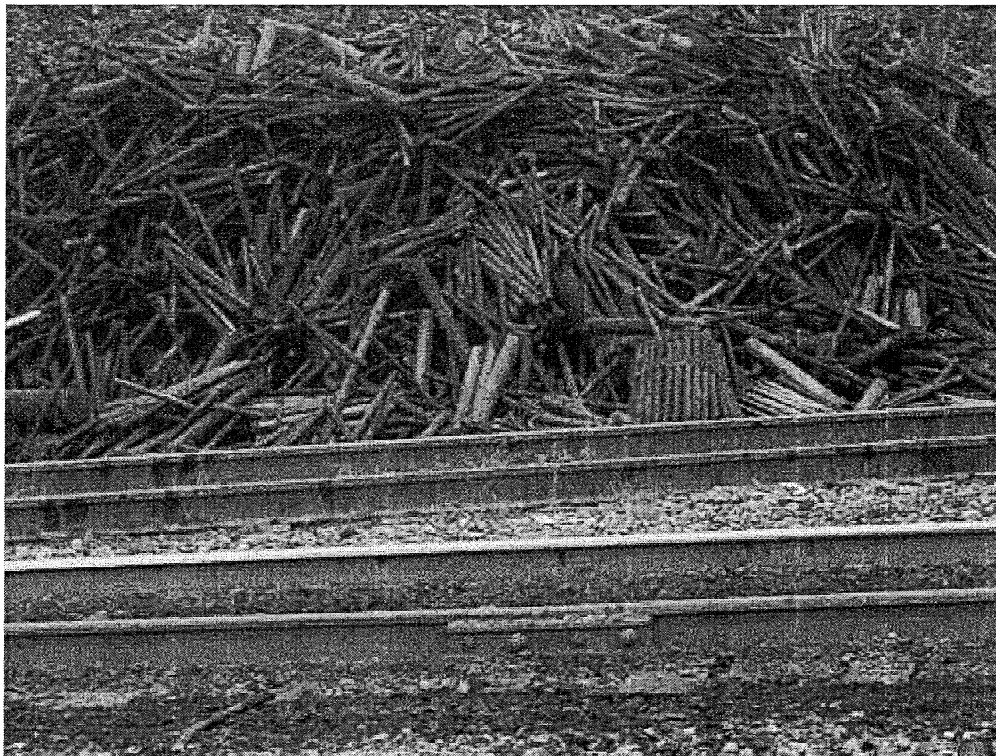
Image 7(Torch Cutting) : Material already cut via torch cutting.

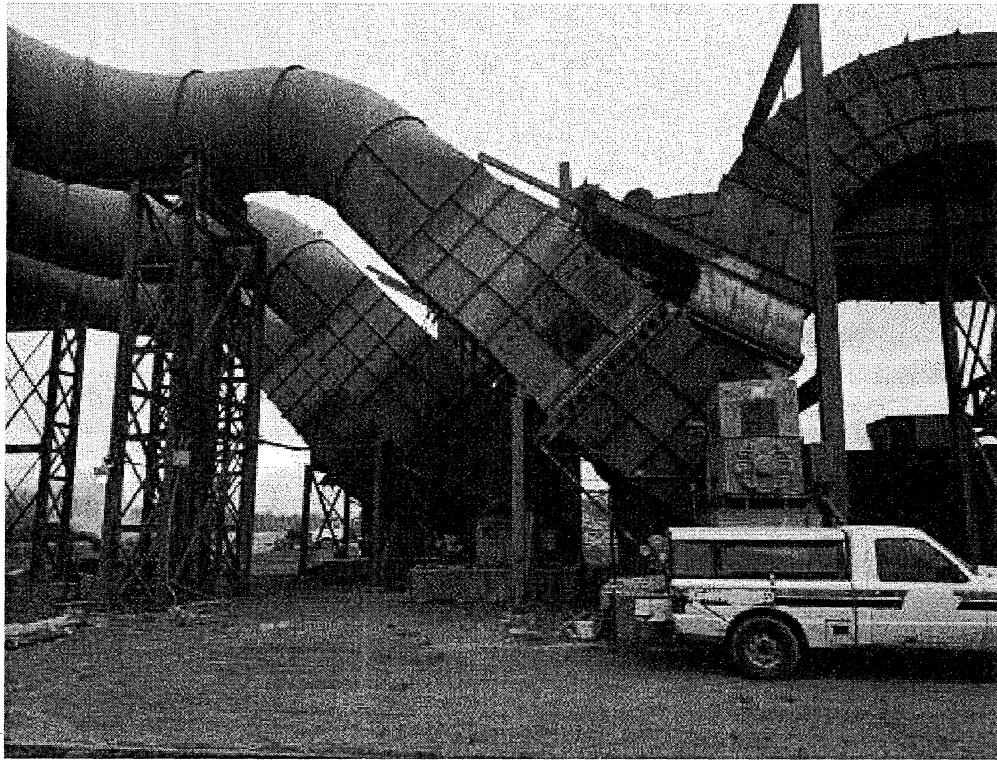
Next, we observed the baghouse duct work and no VE were observed. Behind the baghouse, the facility operates equipment to crush slag into smaller pieces that is sold. This facility is owned and operated by TMS International although it is on GJ's property. We observed VE from the equipment and piles of crushed slag. Most of the VE was from losses from conveyors dropping to material piles below being caught in the wind. Next, we observed the facility's positive pressure baghouse (DV-BH03). It is a positive pressure baghouse which places a fan in-duct prior to the baghouse compartments, where the actual bags are located. Prior to the fan's location, the ductwork is under negative pressure, while the baghouse compartment is under positive pressure. Operation of the baghouse is required for FG-EAF/LMF/VAD's operation, per SC IV.1 and to comply with NESHAP Subpart YYYYYY PM emission limits (SCs I.1 and I.3). There was no collected dust spilled on the ground near the baghouse.

Image 8(Baghouse ducts) : Ducts to Baghouse

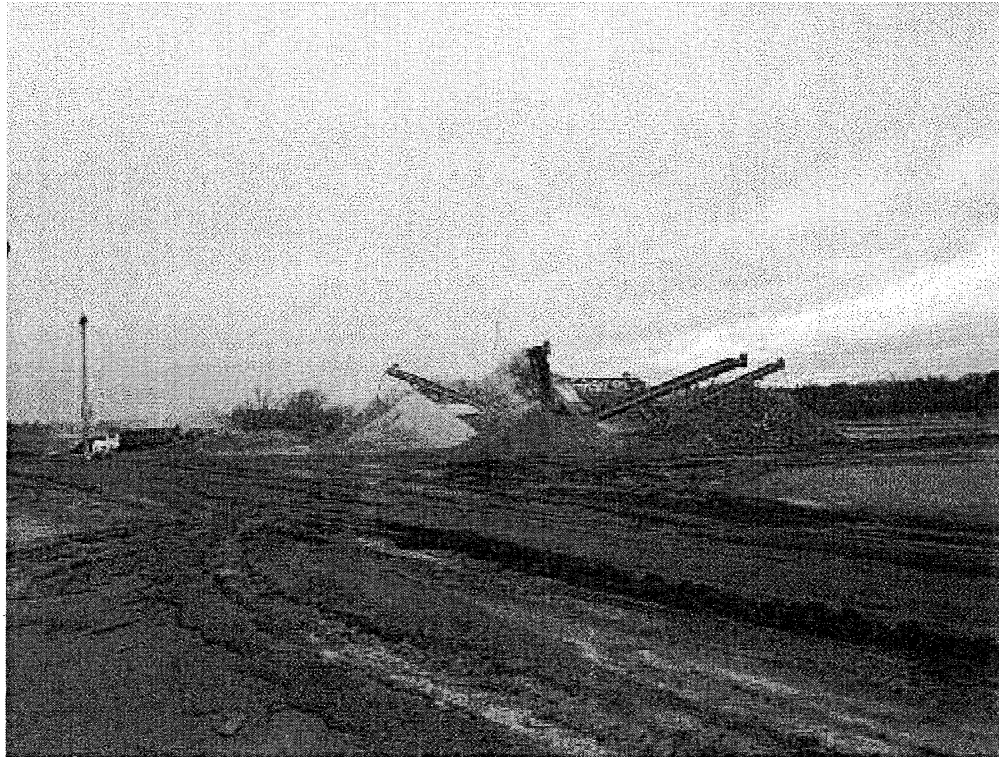
operation. It wasn't clear from the diagram provided in the demonstration whether the process contains crushers or not. They used emission factors that were based on crushed stone processing and pulverized mineral processing. Slag is neither. Also, the demonstration didn't look at air toxics such as manganese oxide compounds, and other trace metals compounds like thallium, chromium, vanadium, cadmium, lead, and nickel. Depending on the specific compound, the TMI would need to show that either the toxic compound isn't present or that it is being emitted less than 20 pounds per month in order to be eligible to use Rule 290 to be exempt from PTI requirements. Furthermore, there is no fugitive dust plan in place to minimize particulate emissions and significant opacity was noted during the inspection. This process is in violation of Rule 201-No Permit to Install.

Image 10(Slag handling) : Slag handling facility.

Furthermore, the slag handling operation that is owned/operated by TMI International is in violation of Rule 201-No Permit to Install. A Violation Notice will be sent to TMI and they will be given 21 days to respond.
