DEPARTMENT OF ENVIRONMENTAL QUALITY
AIR QUALITY DIVISION
ACTIVITY REPORT: On-site Inspection

FACILITY: Gavilon Grain LLC		SRN / ID: B7117
LOCATION: 3274 CARROLLTON ROAD, CARROLLTON		DISTRICT: Bay City
CITY: CARROLLTON		COUNTY: SAGINAW
CONTACT: Peter Jones , Location Manager		ACTIVITY DATE: 10/23/2023
STAFF: Gina McCann	COMPLIANCE STATUS: Compliance	SOURCE CLASS: MINOR
SUBJECT: Inspection of PTI 124-14, 94-80 and NSPS DD. PTI 94-80 was voided after this inspection.		
RESOLVED COMPLAINTS:

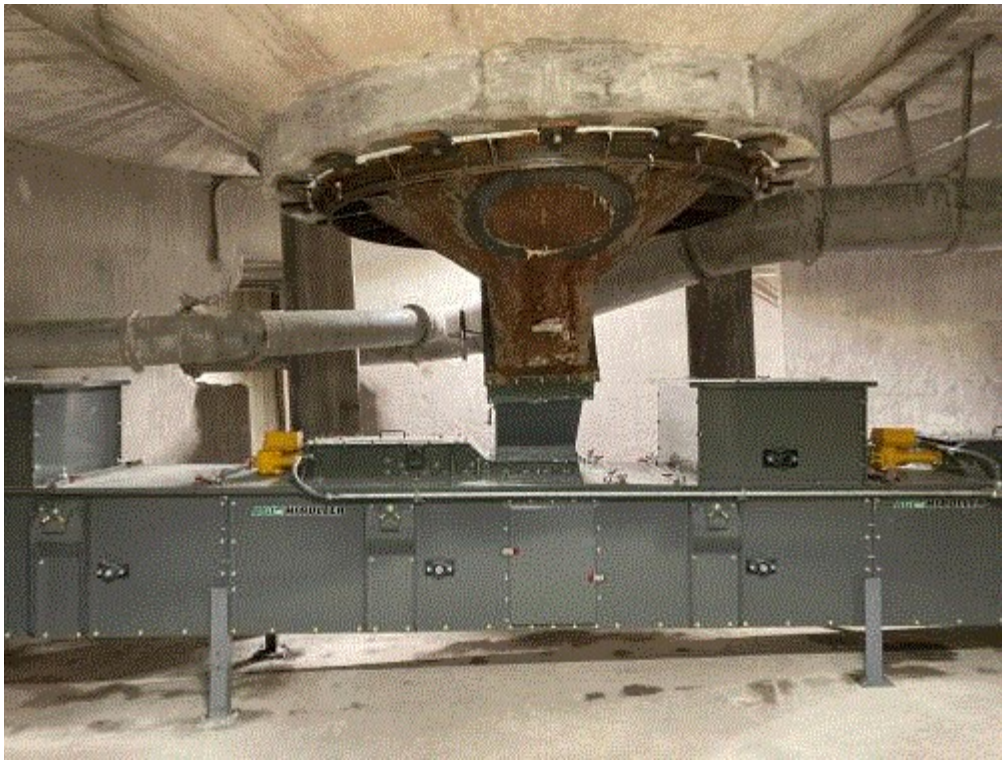
Image 1(Basement Conveyor) : Summer 2023 project enclosing conveyor vents in basement to improve dust handling. Shows how one of the silos connects to the conveyor system.

Associated pictures demonstrate the enclosure of the conveyor belt system. The project also included automating the switch from bin to bin. Previously this was done manually. A control room has been set up for the operators which houses the PLC units and control screens. The

facility was asked about adding the baghouse pressure differentials to the PLC so trends can be observed, and operators can mitigate situations prior to baghouse malfunctions. This has been discussed internally but is not slated as part of this project. It was advised there is value in adding this type of monitoring to the screens.

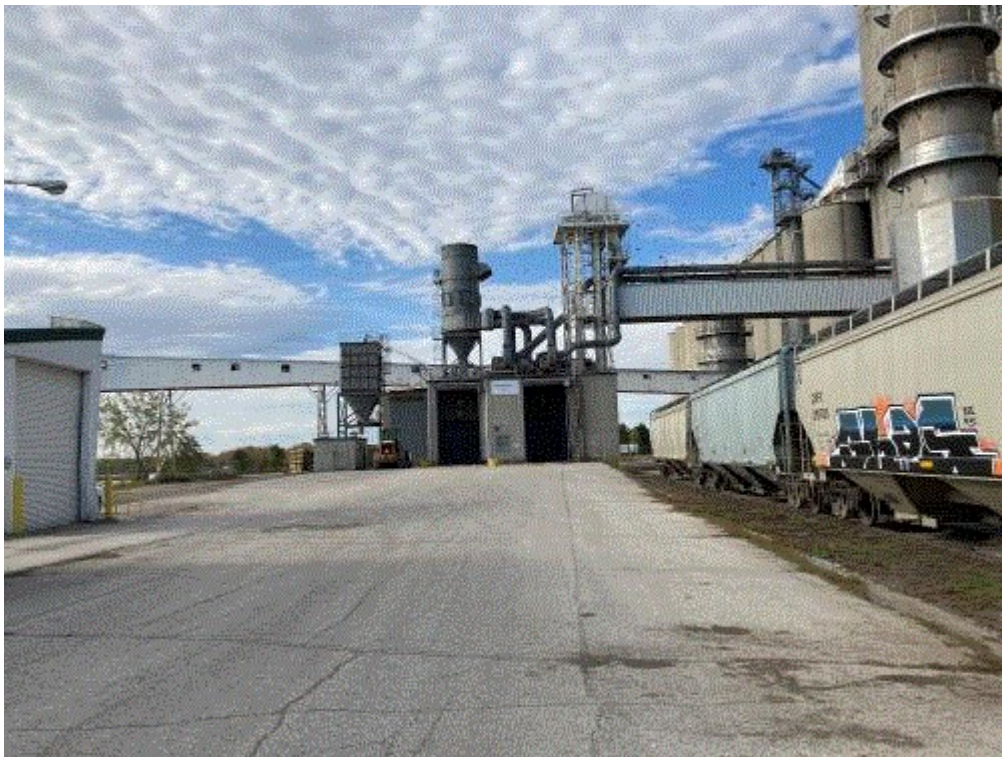
Image 2(EU-TRKREC/UNLOAD) : View of receiving/unloading stations.

There are three loadouts for the train one of which can also unload trucks. There are three dump pits for truck unloading. The truck receiving/unloading grain handling system is controlled by a baghouse. The baghouse receives quarterly inspections which include visually inspecting bags, fans, air locks, etc. The facility does document daily pressure differential readings. However, the desired operating range of the pressure differential was unknown as well as the values that trigger corrective action. A MAP was requested as follow-up to this inspection. A picture of this emission unit is below.

At the time of the inspection the pressure differential on the magnehics was -0.04 inches of water column (" W.C.). Readings are taken at least once per day. Mr. Jones said the normal pressure differential operating range of the truck receiving is between 4.0-5.0 " W.C.

At the time of the inspection, I viewed a couple of trucks unload. Trucks pull through the bay and unload in dump pits. The door at the end of the bay closes as the truck noses out the one end. I did not perform a certified VE reading, though the opacity was limited and appeared to be below the 5% limit in special condition I.3.

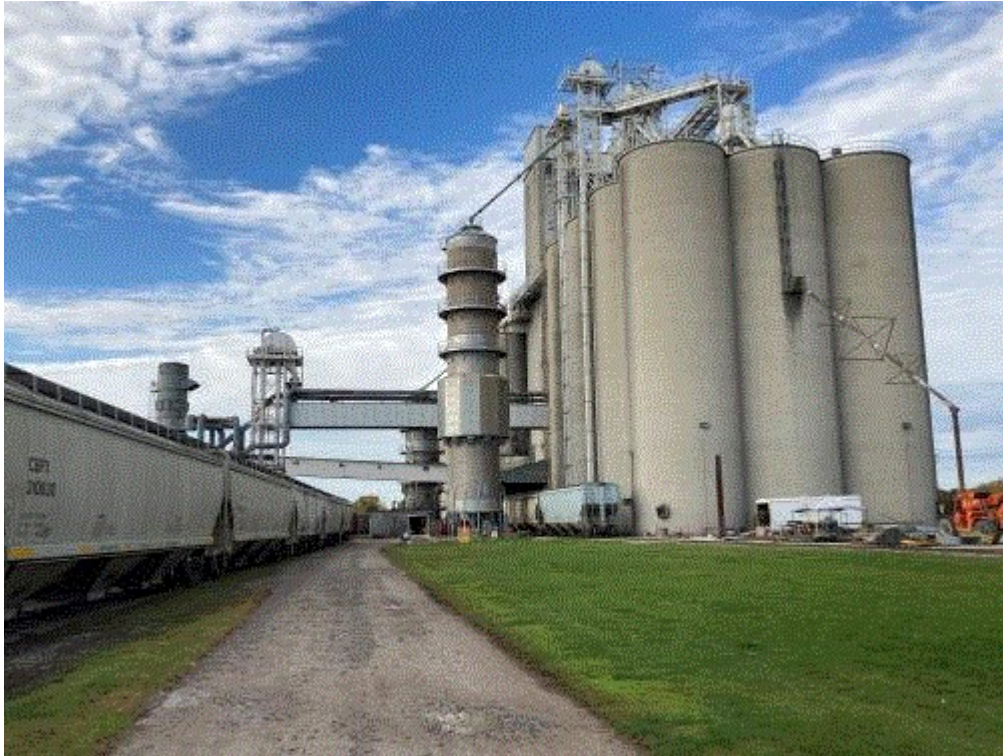
Image 3(Column Dryer) : View of 5,000 bushel per hour Zimmerman column dryer that replaced Berico from PTI #94-80.

This permit is for a Berico dryer. This permit is vintage and has minimal requirements. Special condition 12 restricted visible opacity from the dryer to 0% opacity. The facility replaced this equipment with a Zimmerman column dryer, see photos. The request to void the permit will be submitted.

The NSPS DD requires column dryers with column plate perforations exceeding 2.4 mm diameter to perform testing to comply with emission standards. The perforation size is 0.078 inches and therefore not subject to the particulate standards.

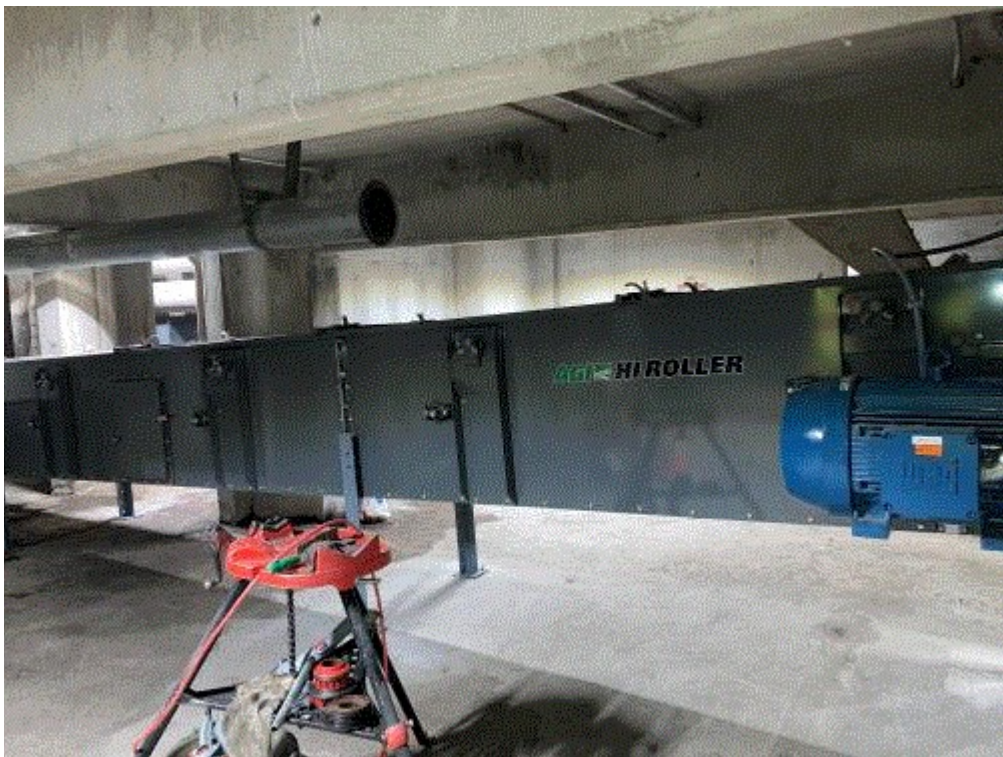
Image 4(Enclosed Conveyor) : View of enclosed conveyor project from summer of 2023. Previous ductwork seen above, which has been disconnected.

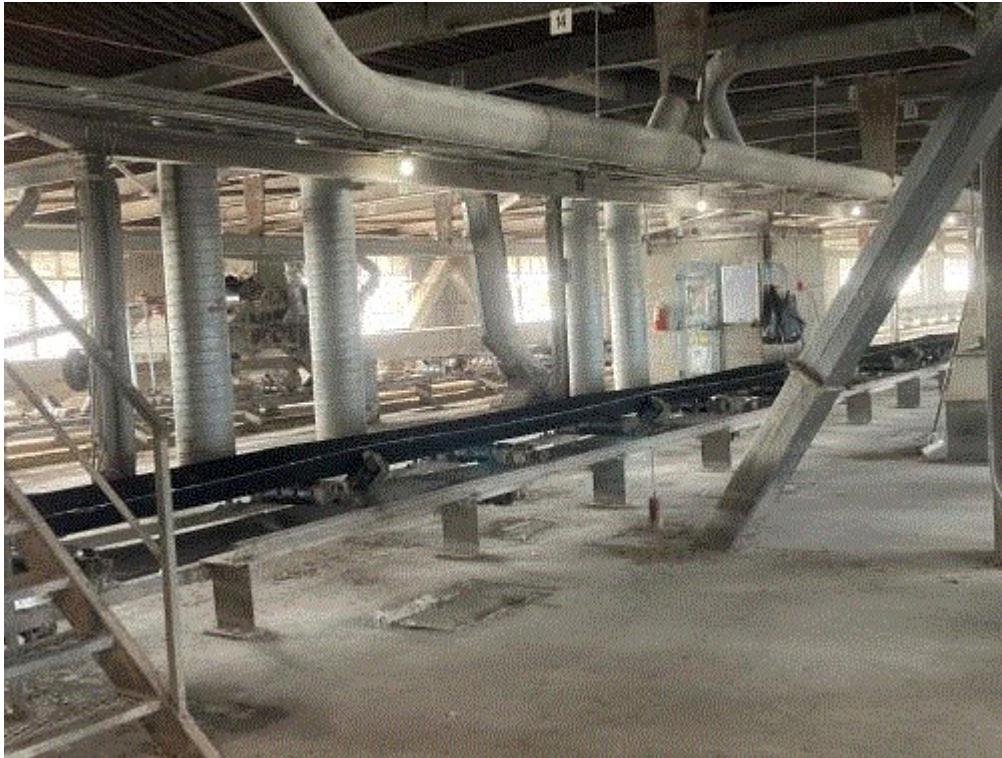
Image 5(Open Conveyor) : Open conveyor system on bin floor demonstrates how the basement conveyor system was prior to 2023.

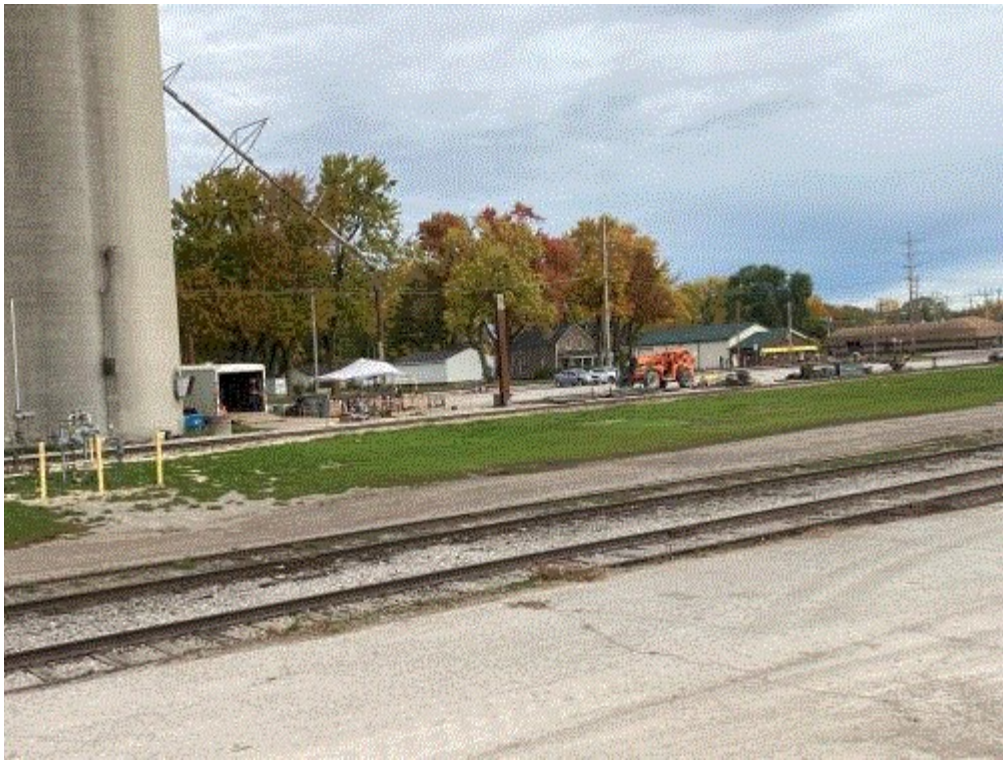
Image 6(Overflow Pad) : This area has historically been the overflow pad for grain when the silos became full the facility would put grain to the ground. Wall surrounding pad removed. Plan to discontinue going to the ground.

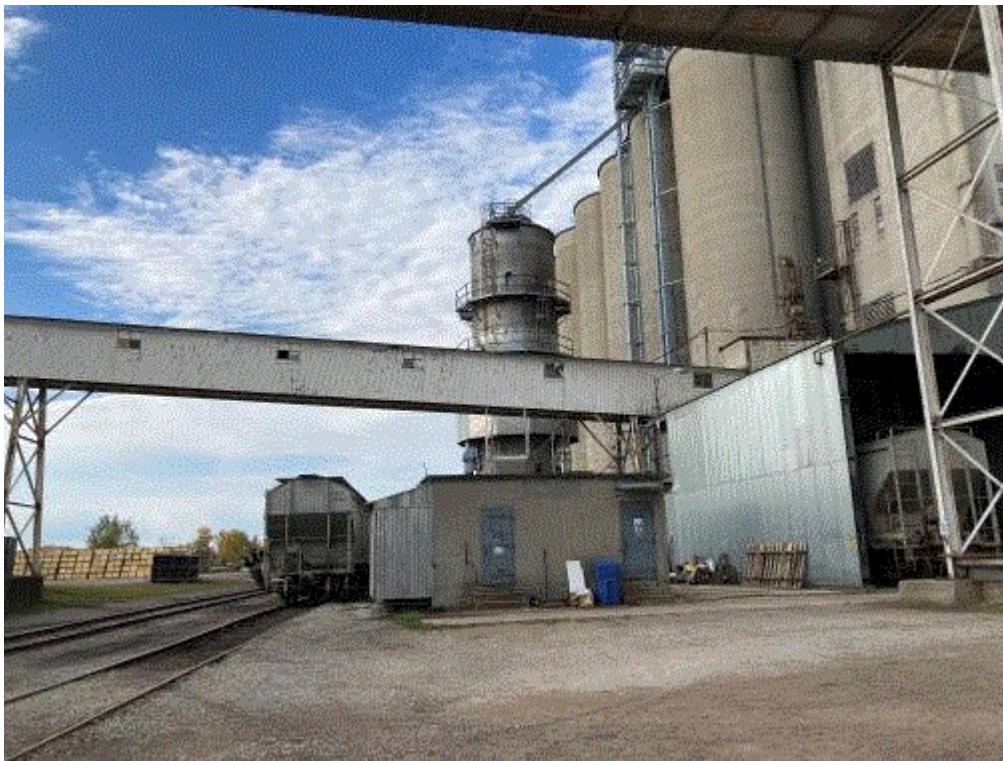
Image 7(Old House Dryer) : View of 3,000 bushel per hour Zimmerman column dryer.
