**DEPARTMENT OF ENVIRONMENTAL QUALITY
AIR QUALITY DIVISION
ACTIVITY REPORT: On-site Inspection**

FACILITY: Acument Global Technologies - Fenton Processing		SRN / ID: B7530
LOCATION: 2480 OWEN RD, FENTON		DISTRICT: Lansing
CITY: FENTON		COUNTY: GENESEE
CONTACT:		ACTIVITY DATE: 07/24/2023
STAFF: Daniel McGeen	COMPLIANCE STATUS: Compliance	SOURCE CLASS: MINOR
SUBJECT: Unannounced inspection of facility last inspected by AQD in 2018.		
RESOLVED COMPLAINTS:

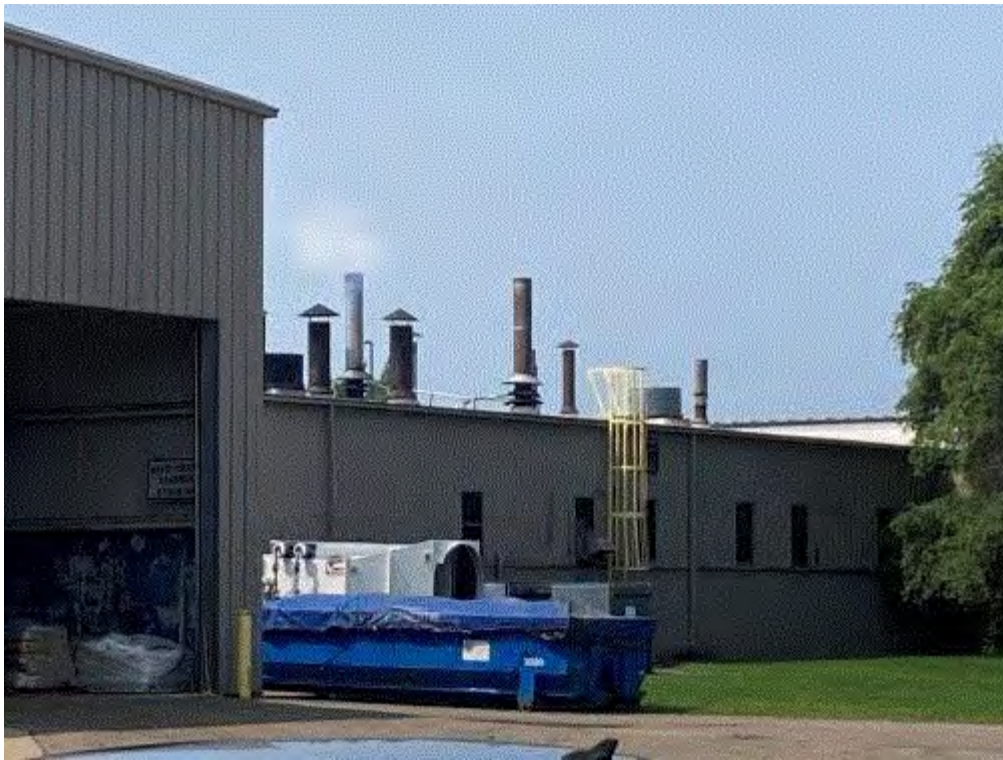
It could be seen that there was whitish opacity from EUHeatTreat1's post-wash stack, and occasionally the plume would downwash (please see attached photos). There did appear to be some steam involved, as there was a steam plume breakoff point visible at times, and some tailoff of 0-5% afterwards, but it was difficult to discern against the hazy white background of clouds. The plume was backlit, so it was not possible to obtain a proper visible emission reading.

Image 1(1) : Backlit opacity from EUHeatTreat1 post-wash stack.

No instances of noncompliance were found. However, AQD should return to the site in the future to determine opacity from the heat treating lines, as time and resources allow. On 9/30/2023, D. McGeen requested that the AQD Permit Section void General PTI 70-11, as the two coating lines covered by it have been removed.

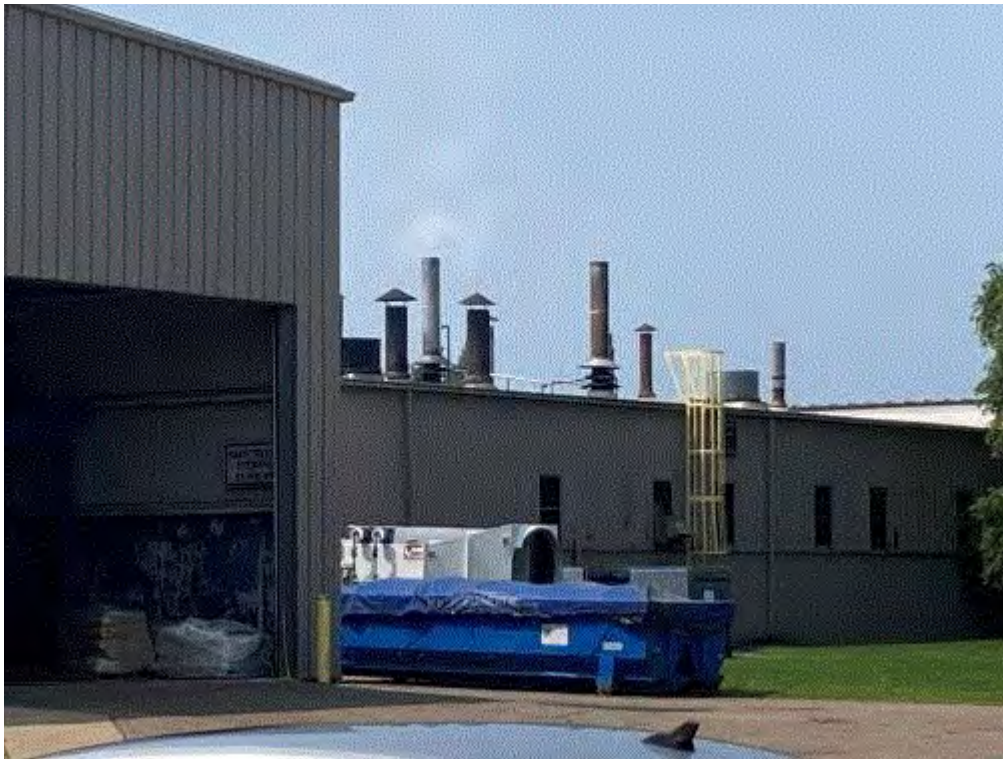
Image 2(2) : Continued opacity from EUHeatTreat1 post-wash stack.

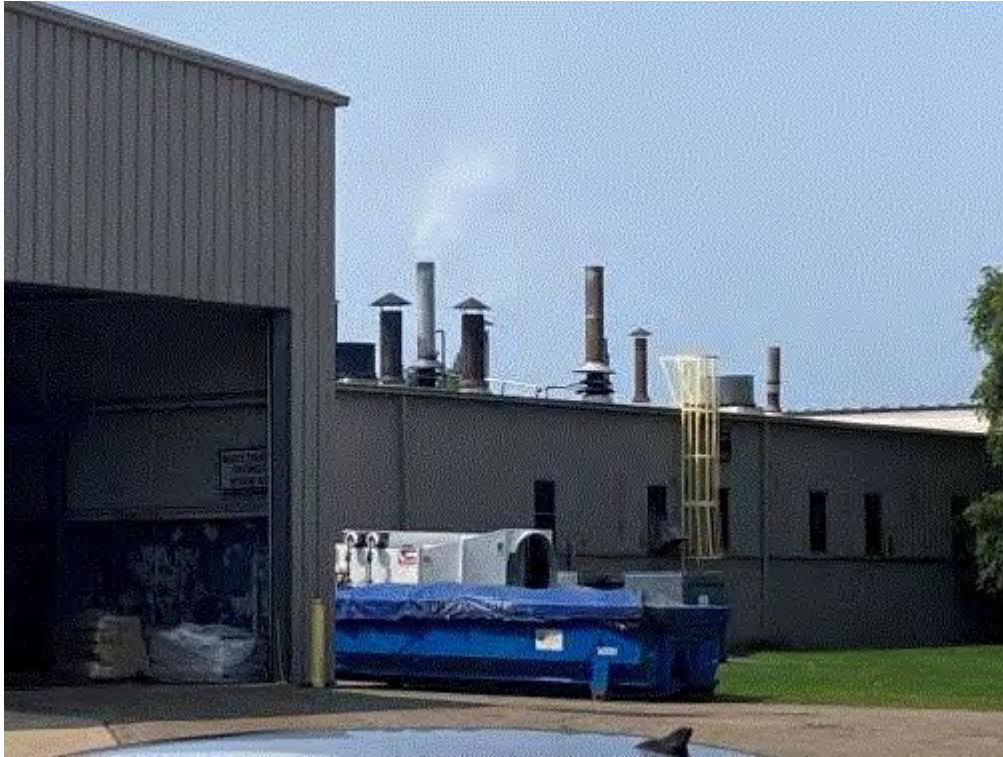
The scrubber for one of the two permitted plating lines was recently replaced with a new unit, although D. McGeen was not clear on if the EUTinZincChromate scrubber was replaced, or the EUZincNickel scrubber. The unit was said to be identical to the original, except for having a housing made of thicker material. Michigan Air Pollution Control (MAPC) Rule 285(2)(d) allows for replacement of air pollution control equipment with equivalent or more efficient equipment. The old unit is stored outside the plant, partially visible in the attached photos 1-4.

Image 3(3) : Continued opacity.

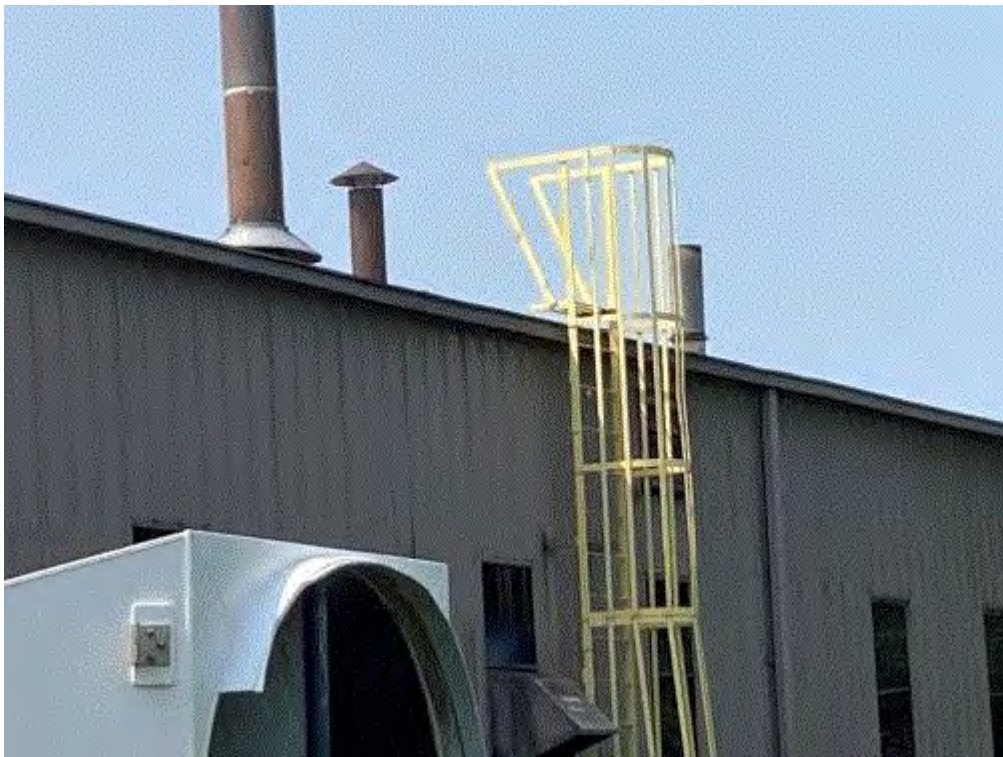
D. McGeen asked if it was possible to view the stacks from the east side of the plant, but it was not possible to get to a vantage point and still be on plant property. He asked if it was possible to go up on the roof, to take opacity readings. He was informed that there is a ladder with safety cage against the north wall of the plant, but contractors doing work on it had failed to reattach the top of the ladder and cage to the roof (please see attached photograph). D. McGeen agreed that it did not appear safe to try to access the roof this way.

Image 4(4) : Exterior ladder with safety cage not secured to plant roof. Do not climb if not secured.

D. McGeen asked about any other way to get on the roof. He was told their opacity reader uses a ladder that goes up through a hatch in the roof of a boiler room. T. Smith and D. McGeen attempted to access the roof this way. However, the ladder went no higher than the hatch in the roof, whereas having the rungs and side rails of a ladder go higher than a roof is an important safety feature. When T. Smith attempted to climb out onto the roof, he received a cut to his arm and it was decided that it would be safer to save the roof for a future occasion, when their exterior ladder with safety cage has been reattached to the roof properly. T. Smith subsequently cleaned and bandaged the cut on his arm.
