**DEPARTMENT OF ENVIRONMENTAL QUALITY  
AIR QUALITY DIVISION  
ACTIVITY REPORT: Scheduled Inspection**

<b>FACILITY:</b> Crop Production Services, Inc.		<b>SRN / ID:</b> B8875
<b>LOCATION:</b> 6901 SILBERHORN HWY., BLISSFIELD		<b>DISTRICT:</b> Jackson
<b>CITY:</b> BLISSFIELD		<b>COUNTY:</b> LENAWEE
<b>CONTACT:</b> Les Jones		<b>ACTIVITY DATE:</b> 03/28/2018
<b>STAFF:</b> Mike Kovalchick	<b>COMPLIANCE STATUS:</b> Compliance	<b>SOURCE CLASS:</b> MINOR
<b>SUBJECT:</b> Inspection of 3 ammonia tanks.		
<b>RESOLVED COMPLAINTS:</b>

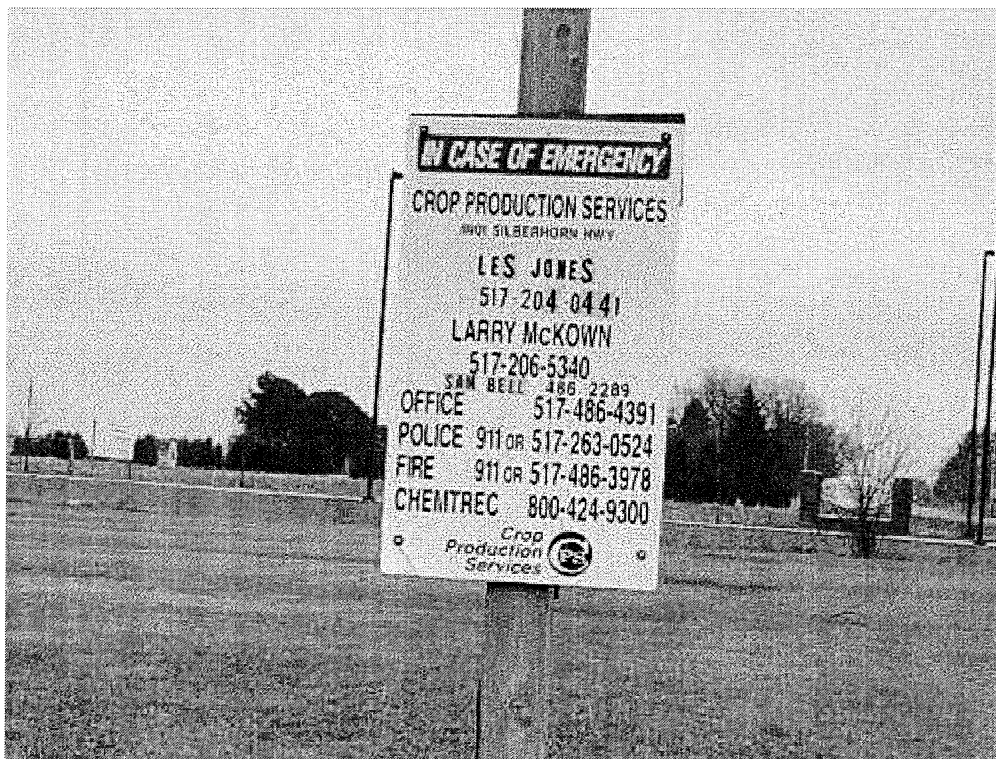
**Image 2(Sign) :** In Case of Emergency sign

1.16 A sign shall be present and conspicuously placed at the facility entrance stating the emergency phone numbers for the owner, primary operator, local and state police, local fire department, and ambulance service. [R336.1201a(1)]	March 28, 2018  Compliance	Several signs were in place.

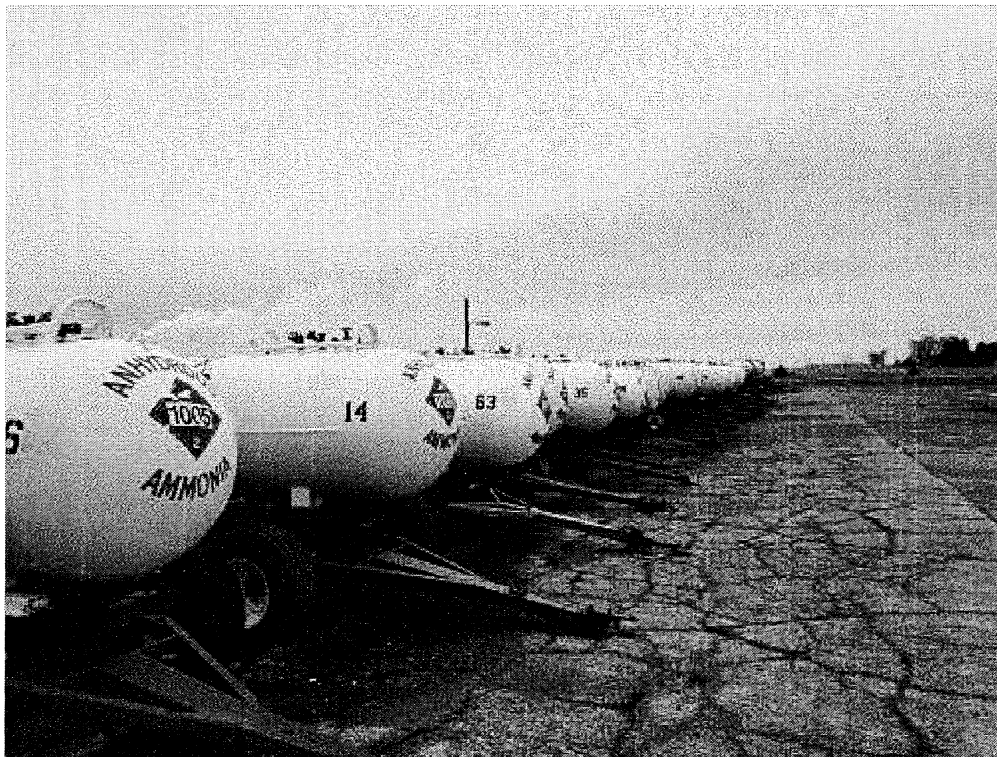
**Image 6(Nurse tanks) :** Nurse tanks.

Attachment (3) is example NTIP DOT inspection report for one of the nurse tanks. All of the nurse tanks were pressure tested last summer. (They are tested every 5 years.)
