**DEPARTMENT OF ENVIRONMENTAL QUALITY  
AIR QUALITY DIVISION  
ACTIVITY REPORT: Scheduled Inspection**

H278150349

<b>FACILITY:</b> Allied Motion (was Motor Products Division)		<b>SRN / ID:</b> H2781
<b>LOCATION:</b> 201 S Delaney Rd, OWOSSO		<b>DISTRICT:</b> Lansing
<b>CITY:</b> OWOSSO		<b>COUNTY:</b> SHIAWASSEE
<b>CONTACT:</b> Lisa Fisher , Material Coordinator		<b>ACTIVITY DATE:</b> 09/12/2019
<b>STAFF:</b> Daniel McGeen	<b>COMPLIANCE STATUS:</b> Non Compliance	<b>SOURCE CLASS:</b> SM OPT OUT
<b>SUBJECT:</b> Unannounced, scheduled inspection of opt-out source, conducted as a Partial Compliance Evaluation (PCE) activity, part of a Full Compliance Evaluation (FCE).		
<b>RESOLVED COMPLAINTS:</b>

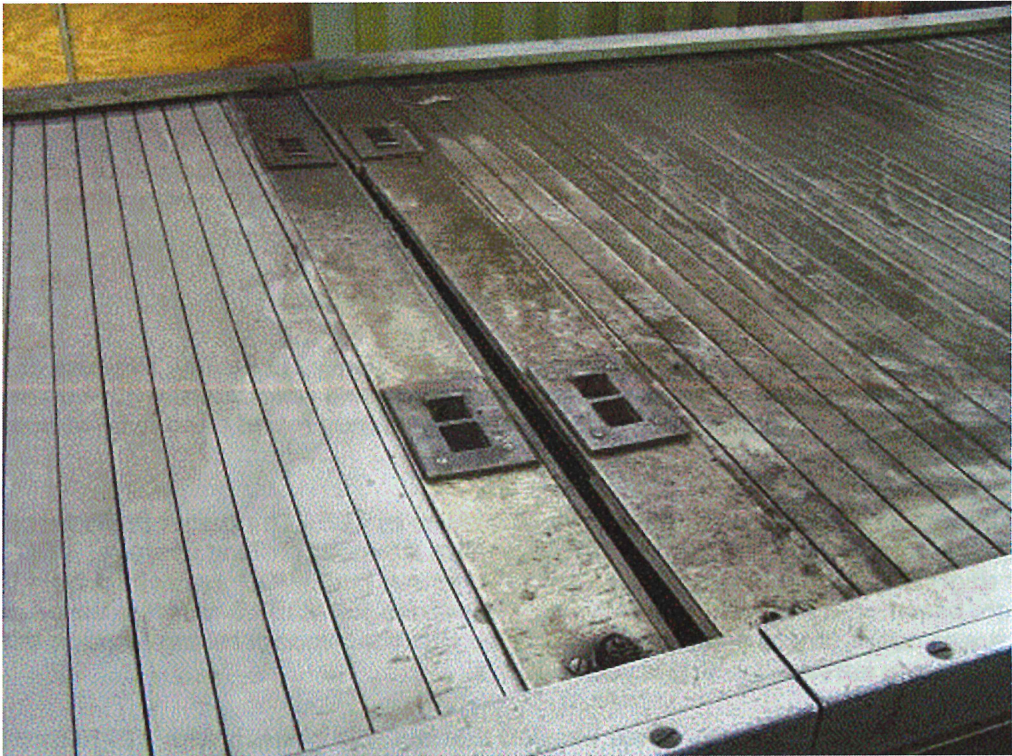
**Image 1(001)** : Rolling cover atop degreaser.

Because the rolling cover to the degreaser was open, I explained that Subpart T requires that the cover be closed when parts are not being removed from or lowered into the degreaser. Mr. Fisher explained that a load of parts had just been removed from the degreaser. He closed the rolling cover, which has a left and a right half. There was a gap at the front of the unit, when the left and the right halves of the cover were moved into the closed position, as shown in photos 001 and 002. Rubber or vinyl flashing or trim on the edges of the moving panels was seen to be crumbling, but even if the trim had been intact, the gap at the front edge of the degreaser cover was too large to have been sealed. This is a violation of 40 CFR Part 63, Subpart T, which requires that cover be maintained free of defects. I explained that a Violation Notice (VN) would be sent. Mr. Fisher indicated that they will correct the issue.

**Because the cover does not completely cover the opening of the degreaser, the above sub-rule has not been met.**

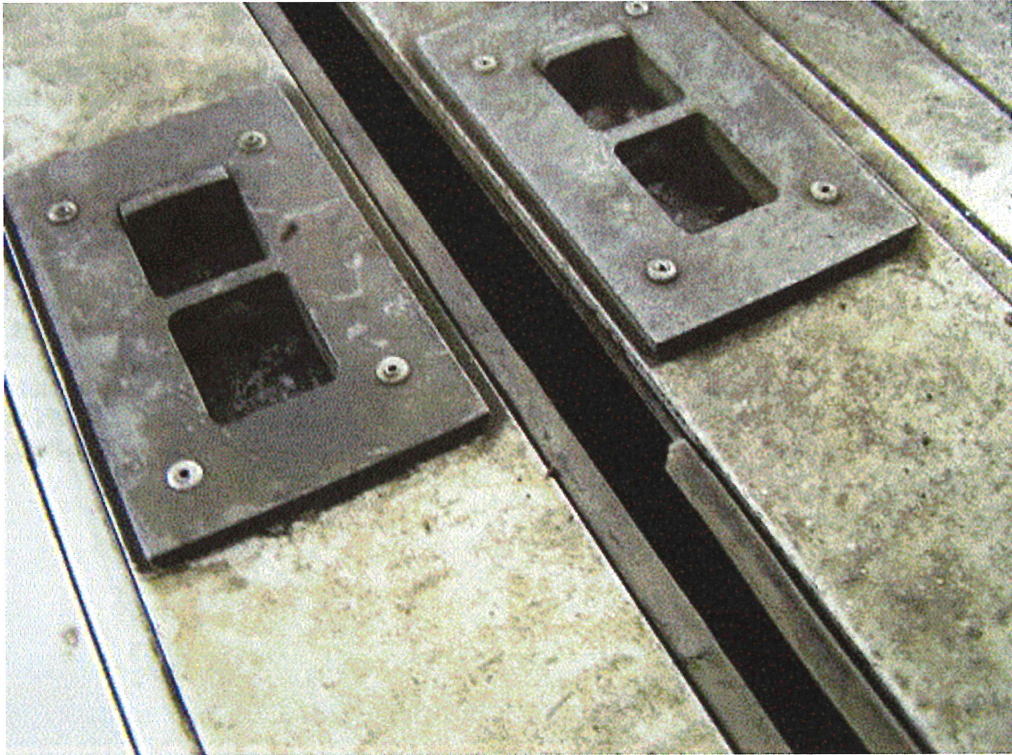
**Image 2(002)** : Gap in rolling cover.

**Because the cover does not close completely, and the rubber or vinyl trim which would help seal the opening is falling off, that can be considered a defect. The above sub-rule has therefore not been met.**

Because the cover does not close completely, and the rubber or vinyl trim which would help seal the opening is falling off, that can be considered a defect. The above sub-rule has therefore not been met.

**The Subpart T violations for the cover not completely covering the opening, and not being free of defects therefore constitute a violation of PTI No. 552-81C, SC EU-DEGREASER 1.4.**
